MX0023A-01A

# Modification Recommended Service Note

## InfiniiMax 25 GHz RC Probe Amp with AutoProbe 2 Interface

Serial Numbers: US00000000-US61479999, MY00000000-MY99999999

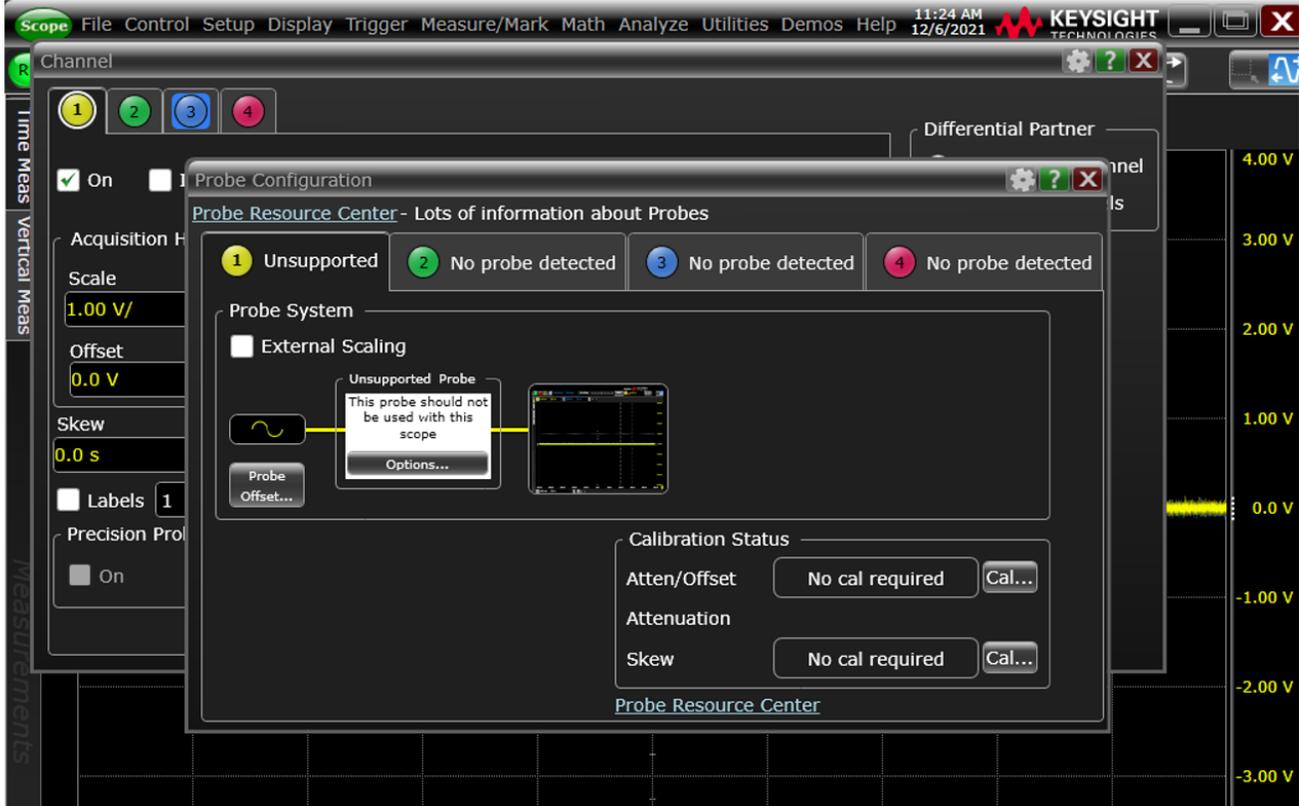
The early shipments of MX0023A probes have been found to 2 quality concerns that can cause probes to not be recognized when attached to the scope channel. Please see Figure 1.

1. AutoProbe Interface 2 Flex Circuit alignment
2. Capacitor failure

Please return defective probe amplifier to service center for repair.
