N1914A-04 SERVICE NOTE

N1914A EPM Series Dual-Channel Power Meter

Lack of Front Sensor Input for N1914A-Option 109

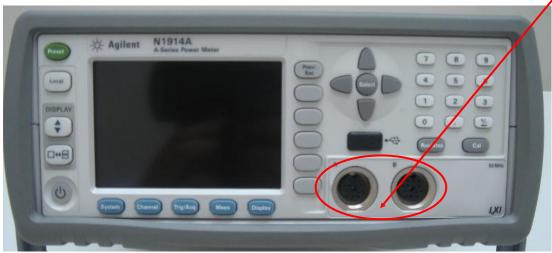
Figure 2

Sensor inputs are available in rear and front panel now

- 1. Agilent Service Center (SSU) are responsible to send the units back to factory via RTF for front sensor input installation.
- 2. Figure 1 and figure 2 show the physical condition of the N1914A option 109 after install the front sensor input. The sensor inputs are installed at front and rear panel of N1914A.
