N1996A-01

S E R V I C E N O T E

Agilent CSA Spectrum Analyzer, N1996A

Residual Responses due to Shield Problem on A4 Digital IF Assembly

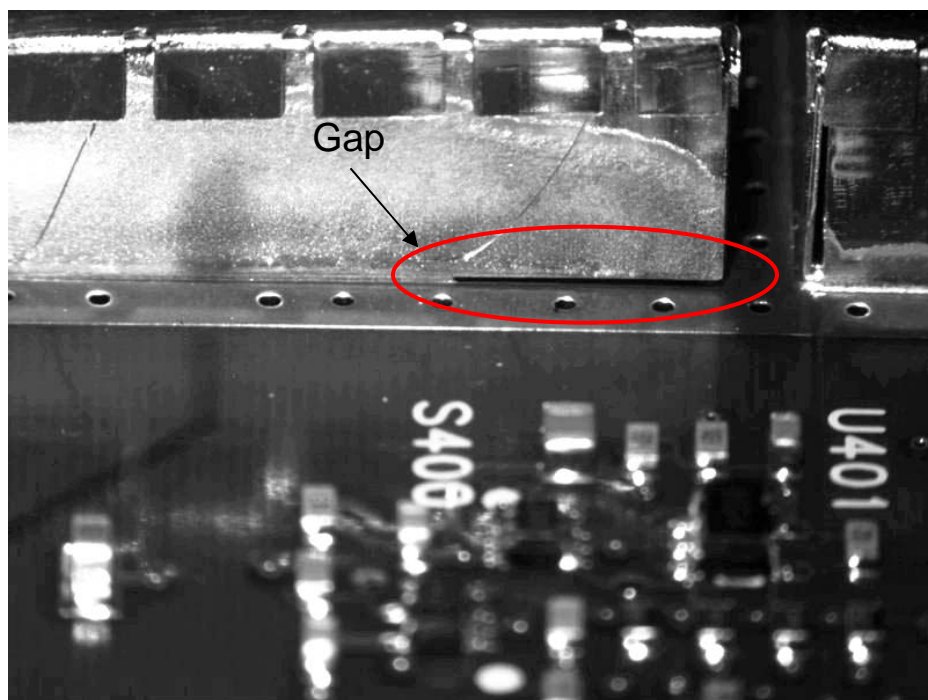
5. Inspect the shield frames using an eye loupe or magnifying lens. Ensure that the shield frames meet the following criteria:
 - a. Ideally, there should be a continuous fillet of solder along the outside and inside edges where the shield frame walls meet the pc board. If there is any gap in the solder fillet greater than 4 mm, re-solder to fill the gap. Refer to Figures 3 and 6. When soldering the edges of the shield walls, be careful not to accidentally touch any pc board components with the soldering iron.

Figure 3. Check that there is no gap longer than 4mm between shield wall and pc board footprint.

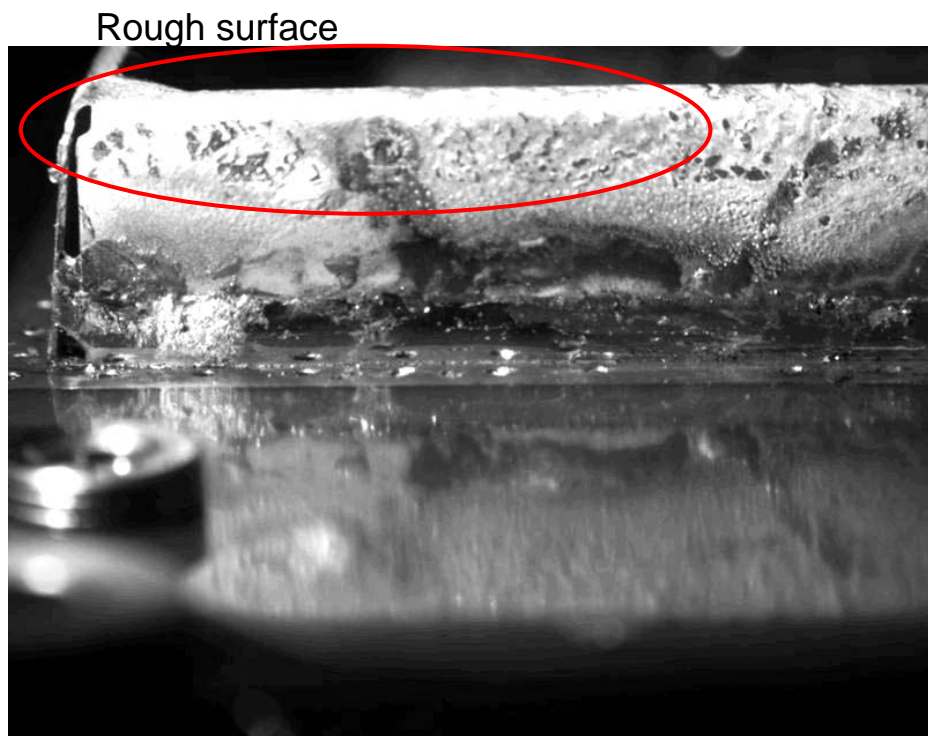
- b. Check that excess solder has not wicked up the side of the shield walls. Refer to Figure 4. The uneven surface created does not allow the shield lids to make good contact.

Figure 4. Ensure no excess solder wicked across the top of the shield walls. Uneven surface will prevent lid fingers to reside flat on the shields.

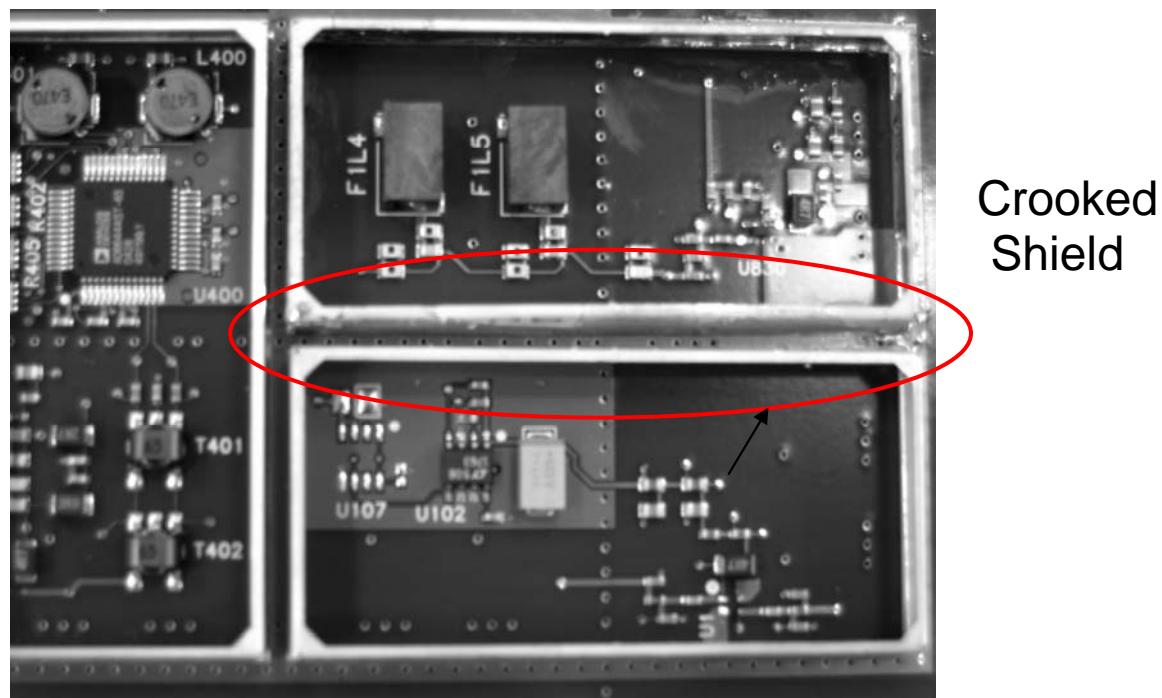
Figure 5. All shields must align properly to the pc board footprints. No bent or misaligned shields are allowed.

- c. Check that the shield frame walls align properly with the pc board footprint. Refer to Figure 5. If possible, re-solder the shield frame walls so that they are properly aligned. If this is not possible, replace the A4 DIF board with a new assembly.

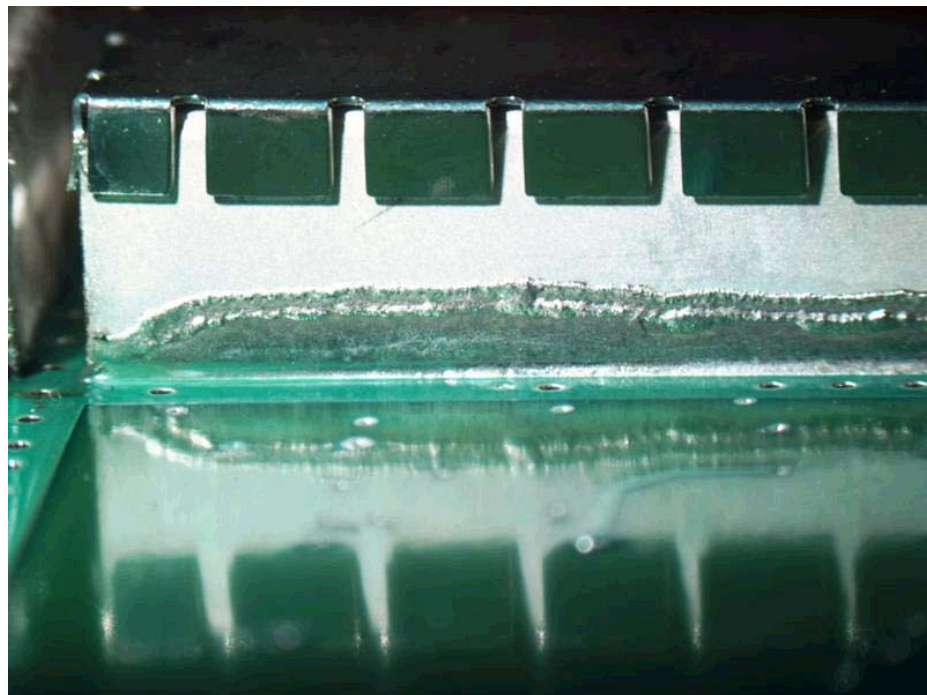
Figure 6. Correctly-soldered shield wall. Note that there is no excess solder wicked across the wall and the lid fingers rest uniformly on the shield
