**N1996A-01A**

## Agilent CSA Spectrum Analyzer, N1996A

### Residual Responses due to Shield Problem on A4 Digital IF Assembly

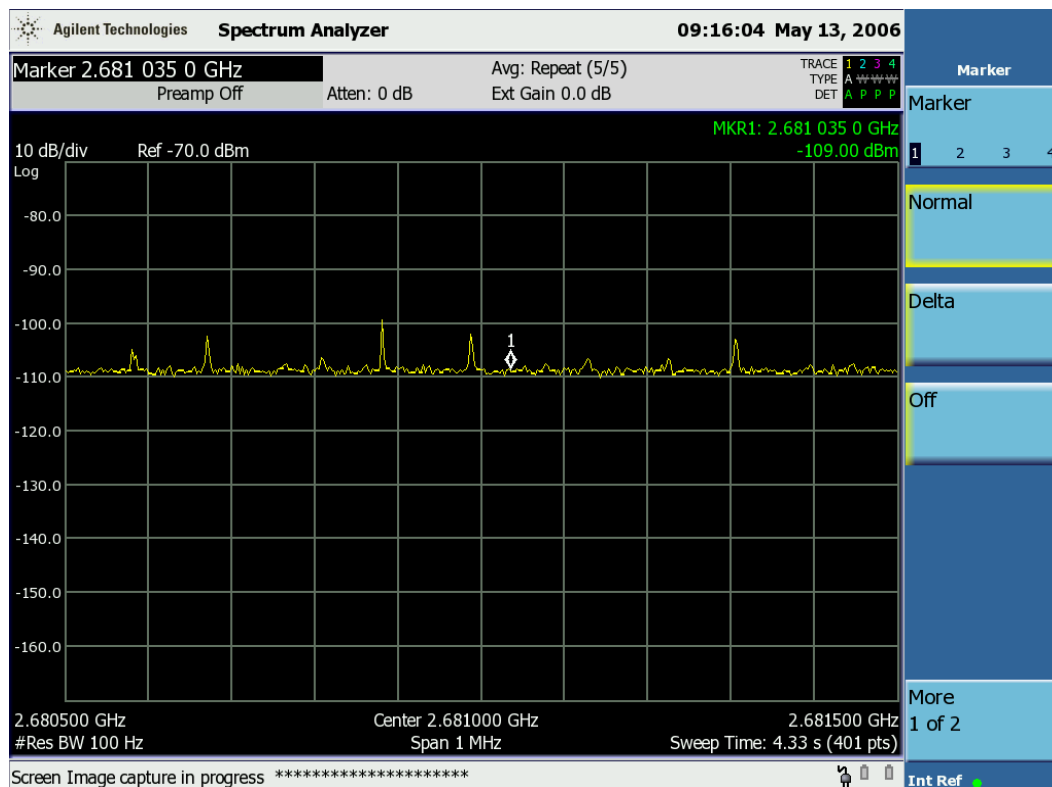
Figure 1: Marker Positioned on Average Noise Level

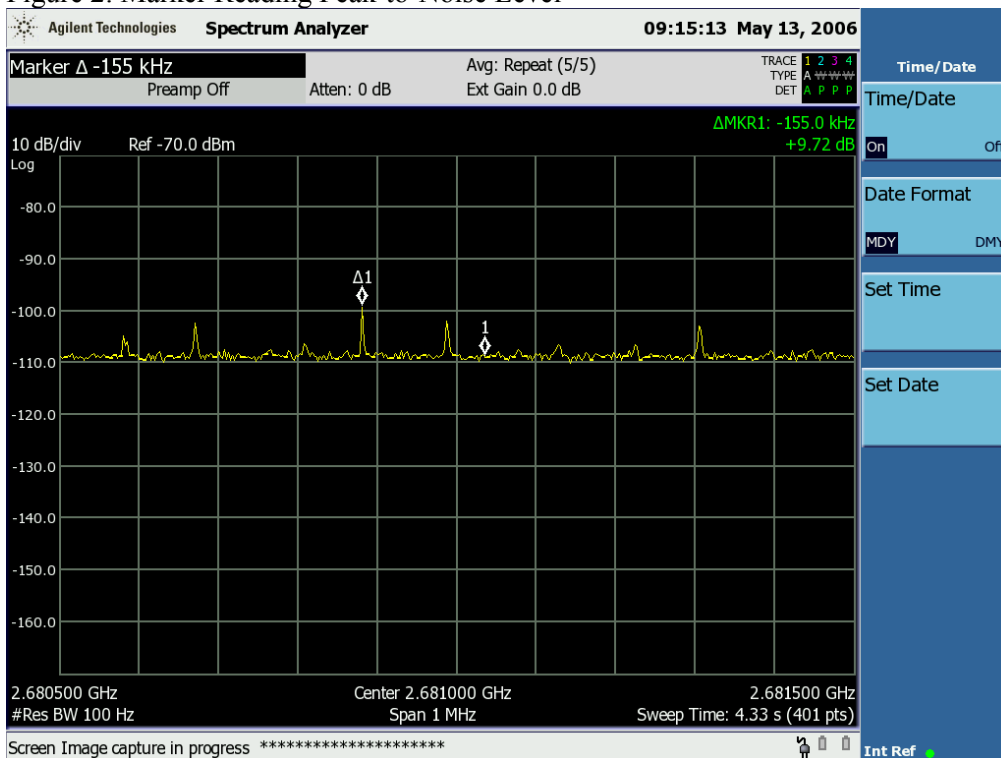
Figure 2: Marker Reading Peak-to-Noise Level

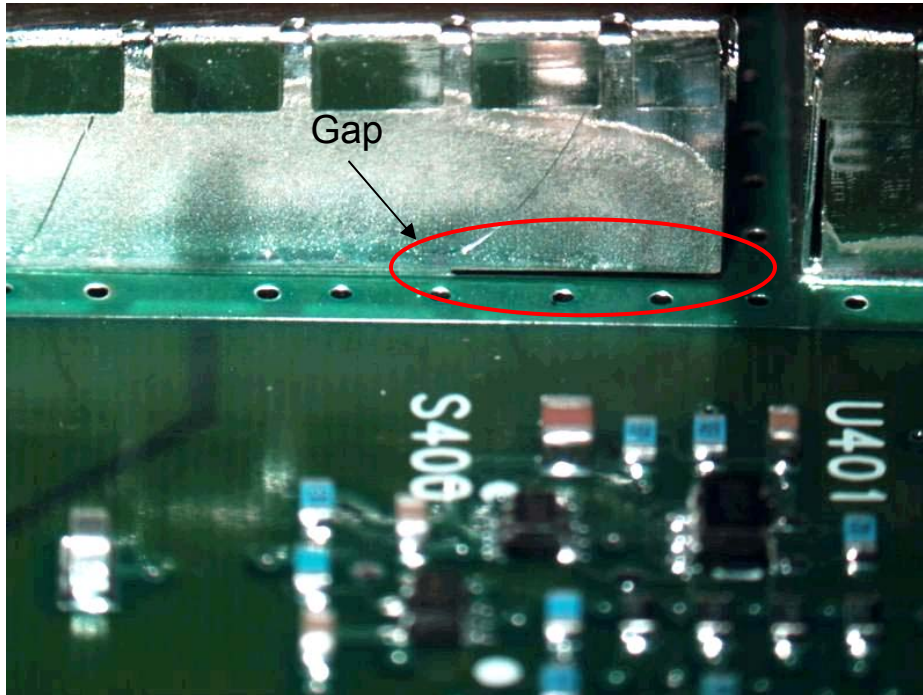
- a. Ideally, there should be a continuous fillet of solder along the outside and inside edges where the shield frame walls meet the pc board. On some pc boards, there will be a series of small gaps (approximately 2 mm) in the solder fillet. This is OK. If there is any gap in the solder fillet greater than 4 mm, re-solder to fill the gap. Refer to Figures 3 and 6. When soldering the edges of the shield walls, be careful not to accidentally touch any pc board components with the soldering iron.

Figure 3. Check that there is no gap longer than 4mm between shield wall and pc board footprint. Note that some pc boards will have a series of small (~2 mm), regularly-spaced gaps in the solder fillet. This is normal.

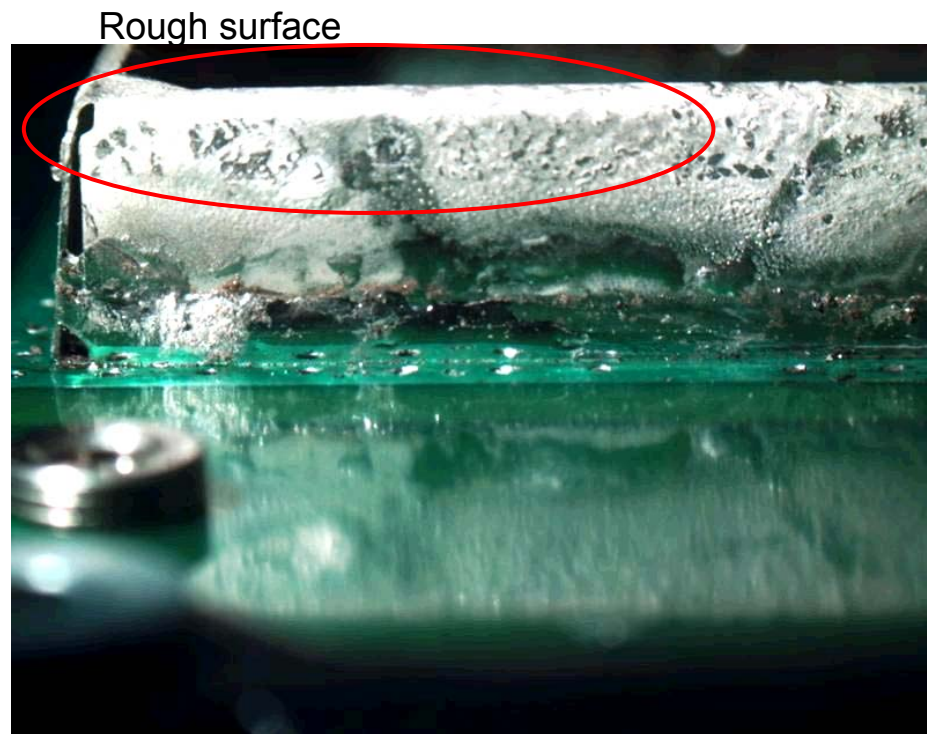
- b. Check that excess solder has not wicked up the side of the shield walls. Refer to Figure 4. The uneven surface created does not allow the shield covers to make good contact.

Figure 4. Ensure no excess solder wicked across the top of the shield walls. Uneven surface will prevent lid fingers to reside flat on the shields.

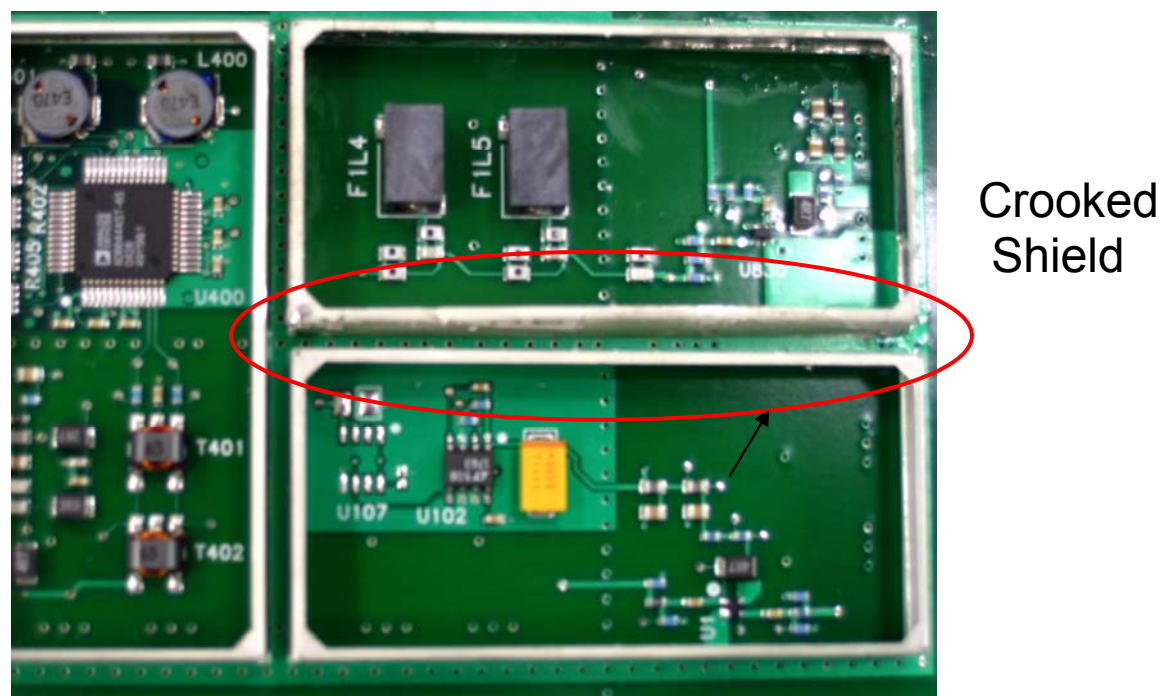
- c. Check that the shield frame walls align properly with the pc board footprint. Refer to Figure 5. If possible, re-solder the shield frame walls so that they are properly aligned. If this is not possible, replace the A4 DIF board with a new assembly.

Figure 5. All shields must align properly to the pc board footprints. No bent or misaligned shields are allowed.

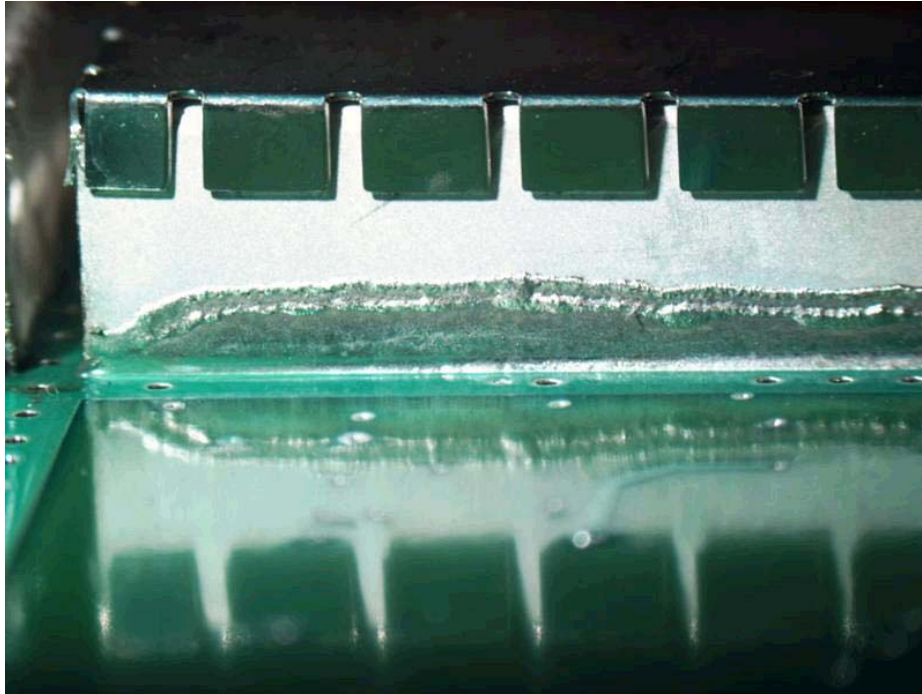
Figure 6. Correctly-soldered shield wall. Note that there is no excess solder wicked across the wall and the lid fingers rest uniformly on the shield
