**N1996A-01B**

Supersedes:  
N1996A-01A

## Agilent CSA Spectrum Analyzer, N1996A

### Residual Responses due to Shield Problem on A4 Digital IF Assembly

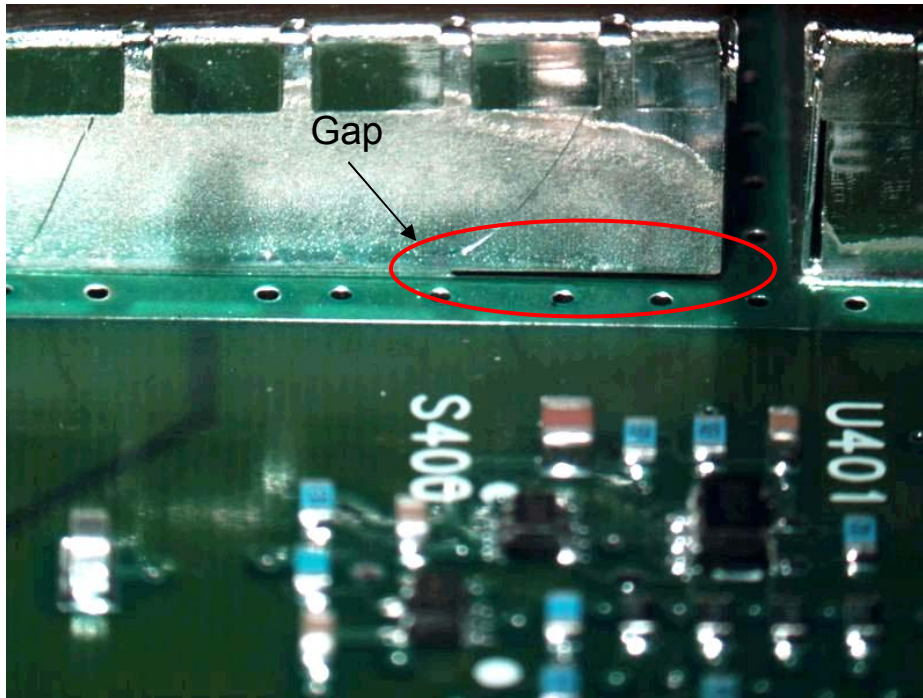
Figure 2. Check that there is no gap longer than 4mm between shield wall and pc board footprint. Note that some pc boards will have a series of small (~2 mm), regularly-spaced gaps in the solder fillet. This is normal.

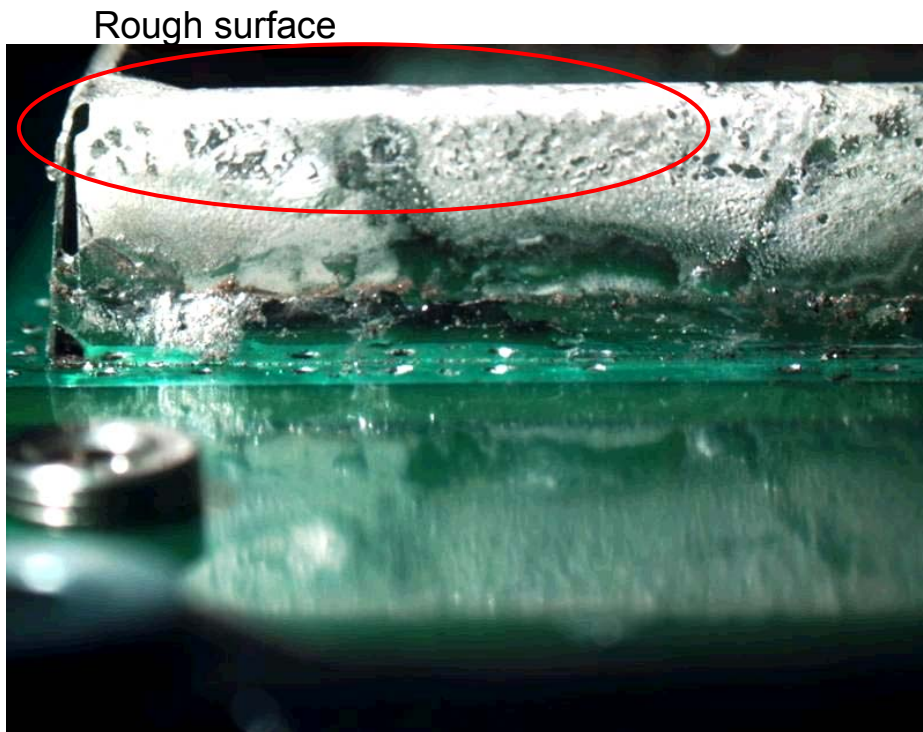
Figure 3. Ensure no excess solder wicked across the top of the shield walls. Uneven surface will prevent lid fingers to reside flat on the shields.

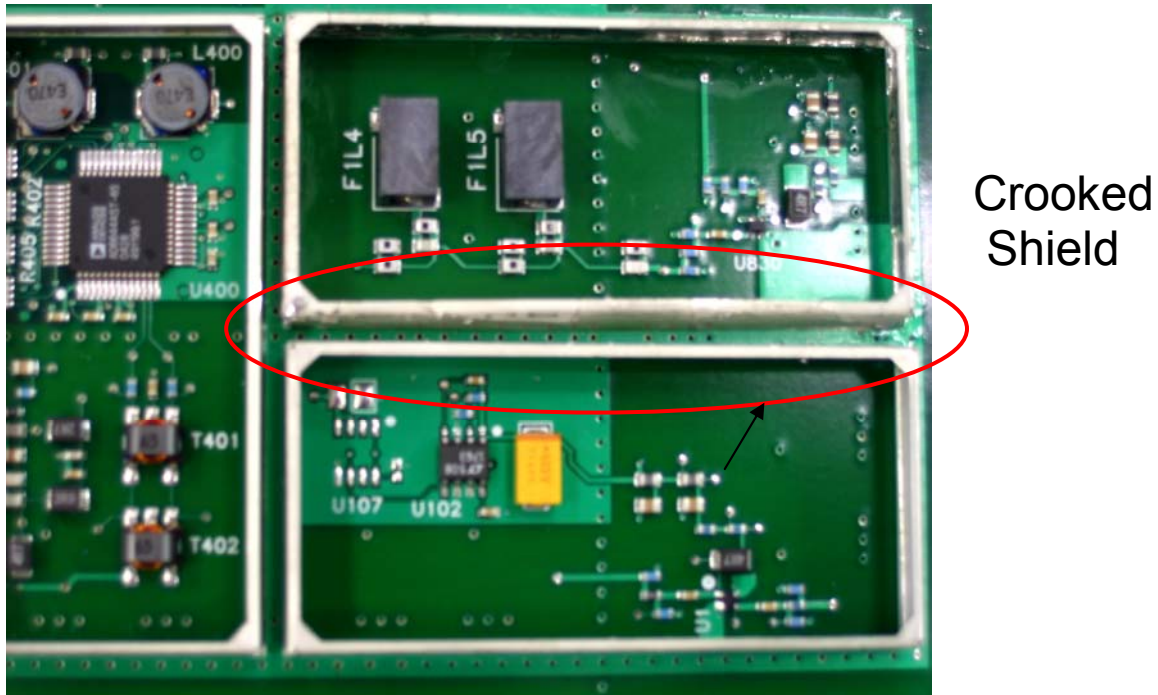
Figure 4. All shields must align properly to the pc board footprints. No bent or misaligned shields are allowed.

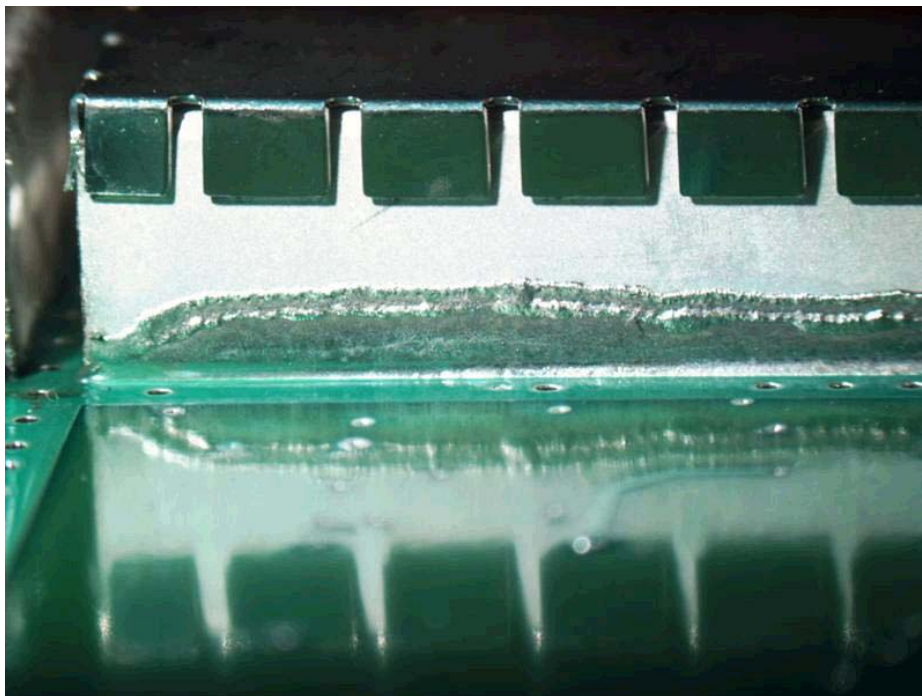
Figure 5. Correctly-soldered shield wall. Note that there is no excess solder wicked across the wall and the lid fingers rest uniformly on the shield
