N1996A-01C

Agilent CSA Spectrum Analyzer, N1996A

Residual Responses due to Shield Problem on A4 Digital IF Assembly

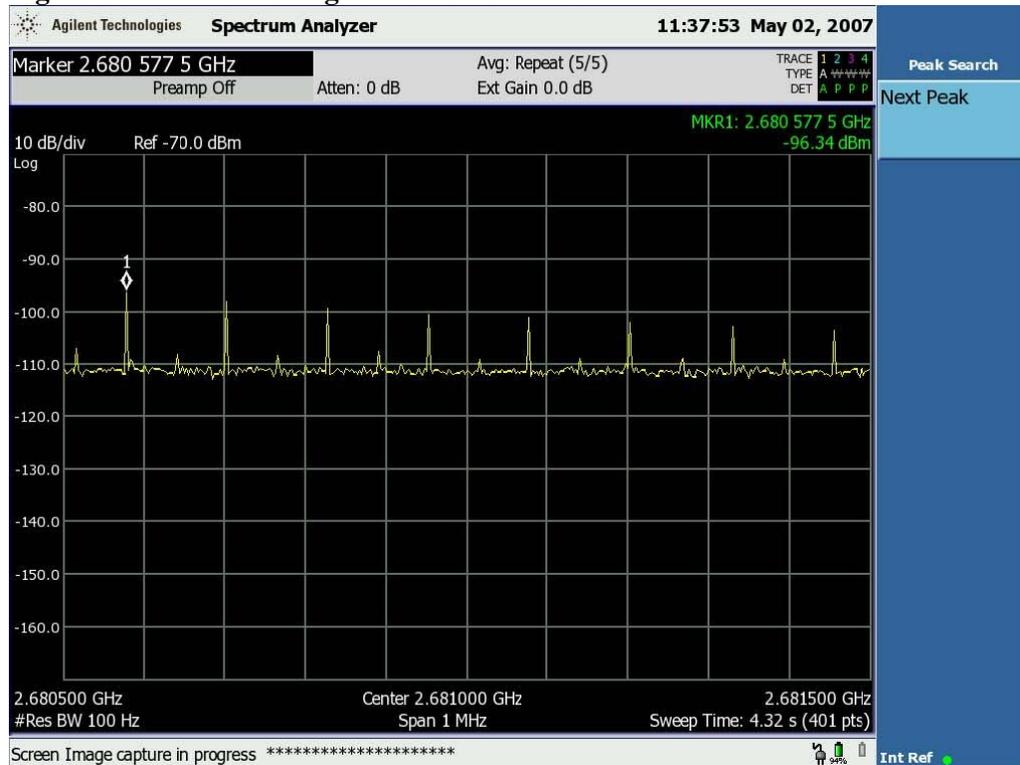
Figure 1: Marker Reading Peak Residual Level

- 1 Terminate the analyzer input with a 50 Ohm load.
- 2 Press **Mode, Spectrum Analyzer**.
- 3 Press **Mode Preset**.
- 4 Press **FREQ, Center Freq, 2681 MHz**
- 5 Press **SPAN, 1 MHz**
- 6 Press **AMPTD, Ref Level, -70 dBm**.
- 7 Press **BW, Res BW, 100 Hz**.
- 8 Press **Meas Setup, Avg Mode, Repeat**
- 9 Press **Avg Number, 5, Enter**
- 10 Press **Trace/Detector, Average**
- 11 Press **Single**. Wait until the message “Paused. Press Continuous or Single to Continue” appears on the status line at the bottom of the display.
- 12 Press **Peak Search**. The marker amplitude reading represents the level of the highest residual response. See Figure 1. Record this marker amplitude value in Table 1 in the Peak Residual Level column of the “As Received” row.
- 13 If the Peak Residual Level is above -100.0 dBm, the residual responses are too high. Proceed with Solution/Action.

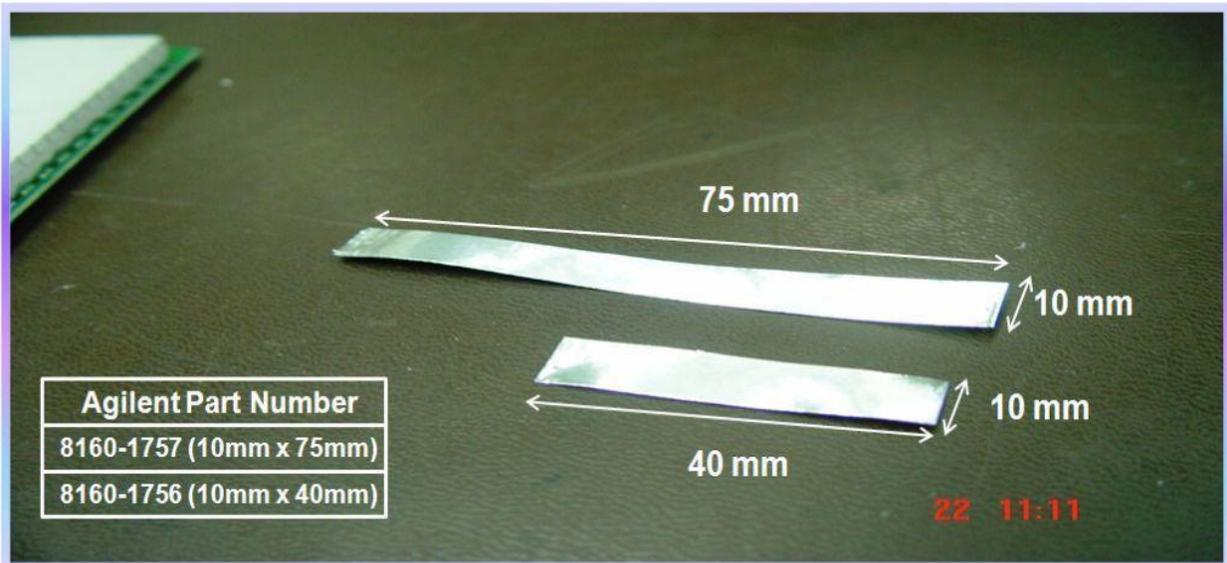
All the 9 large shield covers (5022-7816) on the DIF assembly are removed from the shield frame. The smaller shield cover (5022-2873) does not require any rework.

- 1 Remove the analyzer’s outer case as described in the Instrument Outer Case, Removal procedure in the N1996A Service Guide.
- 2 Remove the analyzer’s board cover as described in the Board Cover, Removal procedure in the N1996A Service Guide.
- 3 Remove A4 DIF assembly as described in the A4 IF Board, Removal procedure in the N1996A Service Guide.
- 4 Tape aluminum foil to the 9 large shields (Agilent Part Number: 5022-7816), the details of taping instruction is described as below:
