N4010A-03

S E R V I C E N O T E

N4010A Wireless Connectivity Test Set

Intermittent Power-Up Issues Or Error Messages

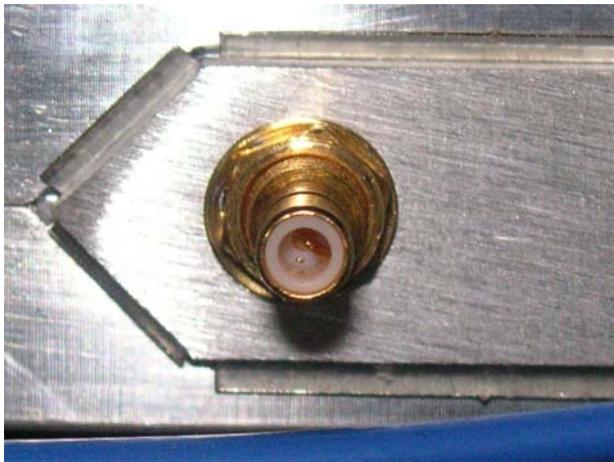
A tooling issue has resulted in the possibility of some N4010A RF Assemblies (i.e. RF Synthesizers) being damaged at connector P4. All RF Assemblies that may have been damaged have been traced to the instruments listed on the front page of this Service Note.

An instrument whose RF Assembly is damaged at connector P4 may exhibit one or more of the following issues:

- Intermittent power-up.
- Error messages “HW ID 3 Missing” and “HW ID 5 Missing”.
- Error messages that indicate “Inaccessible”, “Missing”, or “Corrupt” calibration files.

Figure 2: Example - Damaged RF Assembly

If there are signs of damage to either the RF Assembly or the cable, then both must be replaced. Once the instrument has been re-assembled, it must be fully re-calibrated.

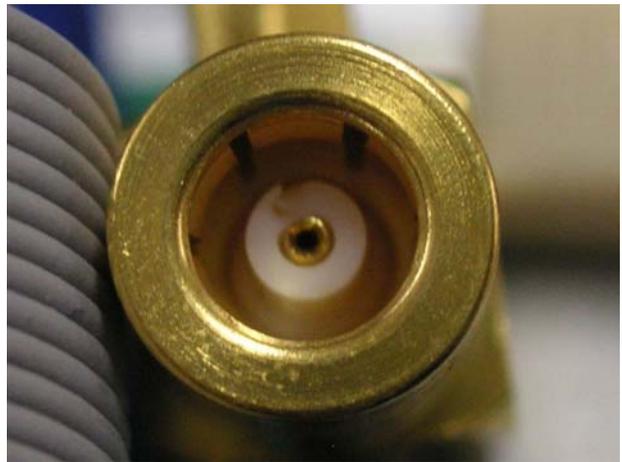
Figure 3: Example - Damaged Cable
