**N4010A-08****S E R V I C E N O T E**Supersedes:  
NONE**N4010A Wireless Connectivity Test Set****Serial Numbers: MY46320255 / MY47230414**[Note: Additional units outside of this range are listed on the last page of this Service Note]**RF Assembly Reliability Issue****To Be Performed By: Agilent-Qualified Personnel****Parts Required:**

**ADMINISTRATIVE INFORMATION**

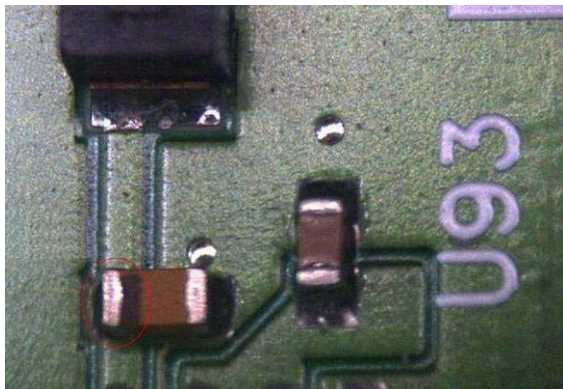
*Figure 5*

- (d) The polarity of C160 is indicated by a dark brown stripe at the positive electrode. The correct orientation of C160 is shown in Figure 5, whilst Figure 6 shows the wrong orientation of C160. If the orientation of C160 is correct, then proceed to step 2(g), otherwise continue to step 2(e).

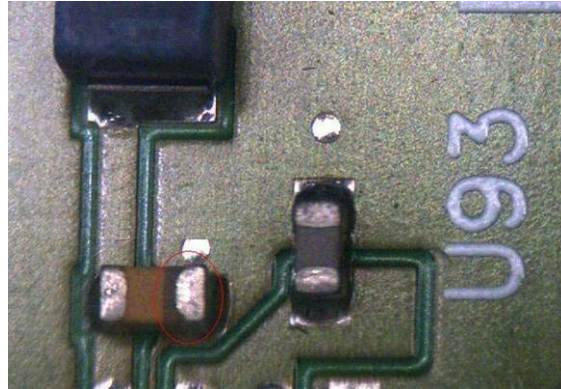
*Figure 6*

This Service Note addresses a manufacturing defect that was introduced to the N4010A RF Assembly during 2007 that went undetected for several months. This error relates to the placement of a 1uF tantalum capacitor on a low DC voltage supply line – the capacitor was fitted using the wrong polarity, causing it to de-rate over time. If the capacitor de-rates to the point that it fails, the N4010A RF Assembly will no longer work correctly.
