N4850A-01

S E R V I C E N O T E

N4850A Digital Analysis Probe

Installation of spacer to eliminate grinding fan noise

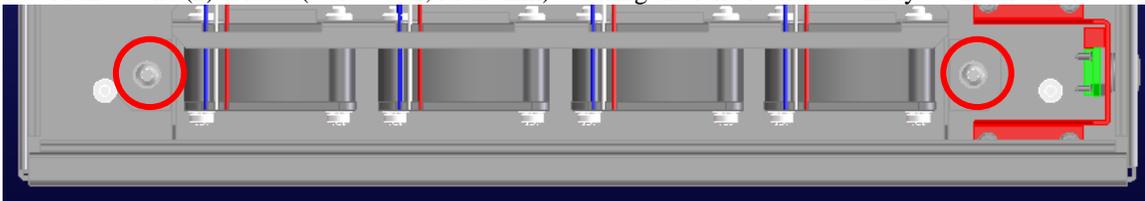
Some units exhibit a mechanical fan noise after shipping/transportation. The root cause of this issue is that the clearance for the fan assembly did not allow for worst case parts tolerances. On the defective units it is likely that the mechanical tolerances of parts allowed for the fan cable to slide out of its routing cavity onto the top of the fan housing during shipment. The cable sliding out of position put extra pressure on the fan housing, causing the deflection of the fan housing that interferes with the rotation of the fan blades.

9. Remove the PCA
10. Remove the (2) screws (0515-0372, M3x8mm) securing the fan bracket assembly to the chassis

11. Remove the fan bracket.
12. Add the (2) washers (3050-2249, 6mm OD, .5mm thick) to the chassis stand-off and replace the fan bracket assembly – effectively lifting the fan bracket assembly .5mm higher in the chassis.
