N4860A-01

S E R V I C E N O T E

N4860A Digital RF Stimulus Probe

Installation of spacer to eliminate grinding fan noise

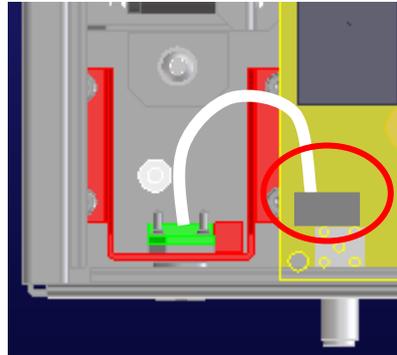
Some units exhibit a mechanical fan noise after shipping/transportation. The root cause of this issue is that the clearance for the fan assembly did not allow for worst case parts tolerances. On the defective units it is likely that the mechanical tolerances of parts allowed for the fan cable to slide out of its routing cavity onto the top of the fan housing during shipment. The cable sliding out of position put extra pressure on the fan housing, causing the deflection of the fan housing that interferes with the rotation of the fan blades.

1. Remove the (4) cover screws (0515-0372, M3x8mm). *Set aside for re-use.*
2. Remove the cover
3. Remove the (4) hex stand-off hardware (0380-1631 M3x16mm) securing the PCA into the chassis. *This hex stand-off hardware will be replaced with new hardware upon re-build.*
4. Remove the remaining (5) screws (0515-0372, M3x8mm) securing the PCA into the chassis. *Set aside for re-use.*
5. Unplug power connector cable from PCA
