N5173B-07A

Information Only Service Note

N5173B X-Series MXG μW ave Signal Generator

The Problem – Recommending using Refurbishment Part Number for Self Test 1105 and 1304 failures due to excessive reverse power by user.

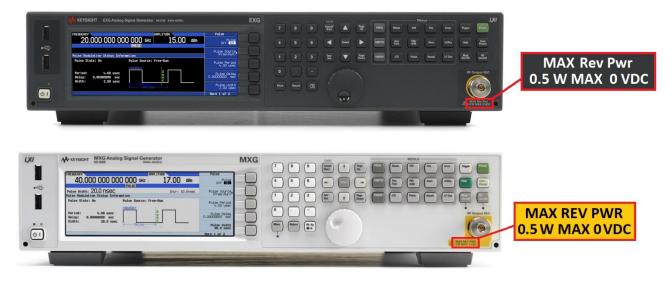
The N5173B signal generator has a very low tolerance for reverse RF power, and no tolerance at all for DC voltage applied to its RF output. The maximum values for these are listed below and can be seen on the instrument front panels as seen in Figure 2 for both instrument color schemes.

Maximum Reverse RF Power = 0.5 Watts Maximum DC Voltage = 0 Volts

- 2. Provide the maximum reverse power specifications for the instrument to them.
 - 3. Encourage the customer to evaluate their use of the instrument to determine if there is any way that they could be applying reverse power to the instrument's RF output and take the necessary action to make the to prevent future reoccurrence.
