**N5181A-01A**

**S E R V I C E**

**N O T E**

## N5181A MXG Analog Signal Generator

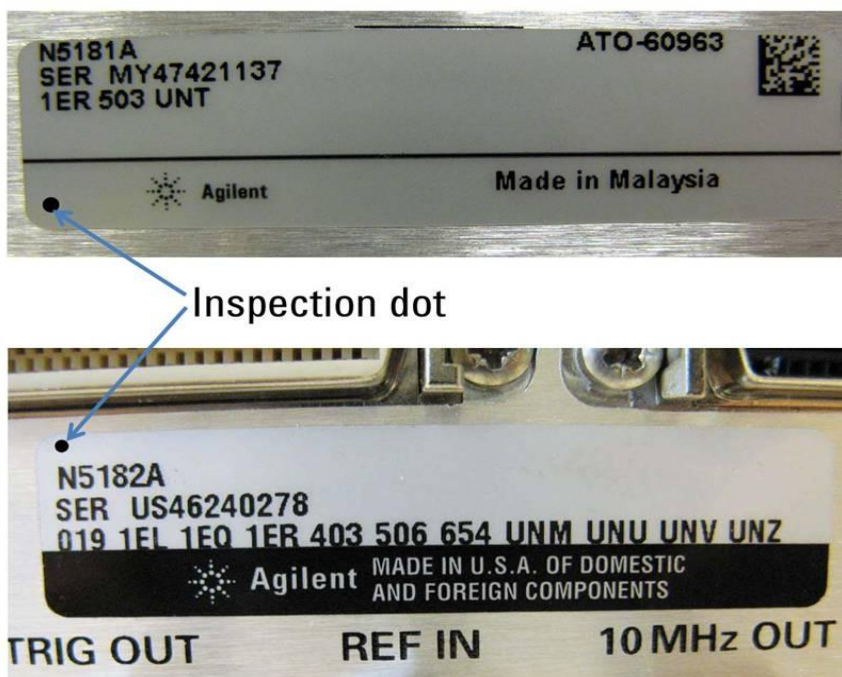
1. Check the rear panel serial tag for a small black inspection dot (see images below). If a black dot is present, similar to what is depicted, the instrument has been checked and no further action is required. If the dot is missing proceed to step 2.
