N5181A-05**S E R V I C E****N O T E**Supersedes:
None**N5181A MXG Analog Signal Generator**

Blank (Dark) LCD front panel may be caused by shorted LCD wires.

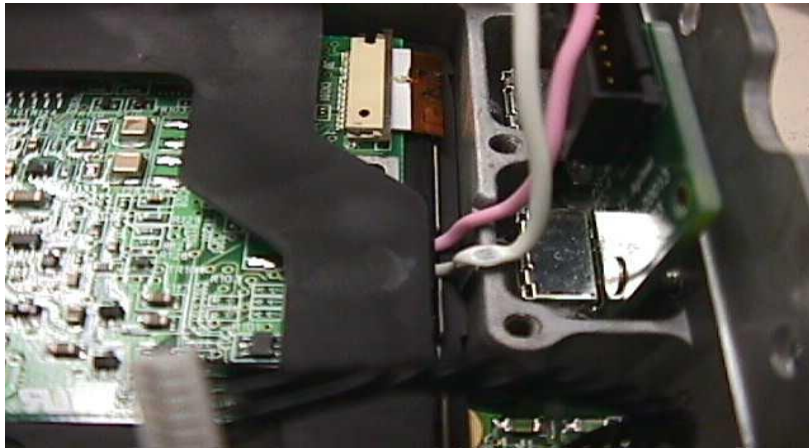
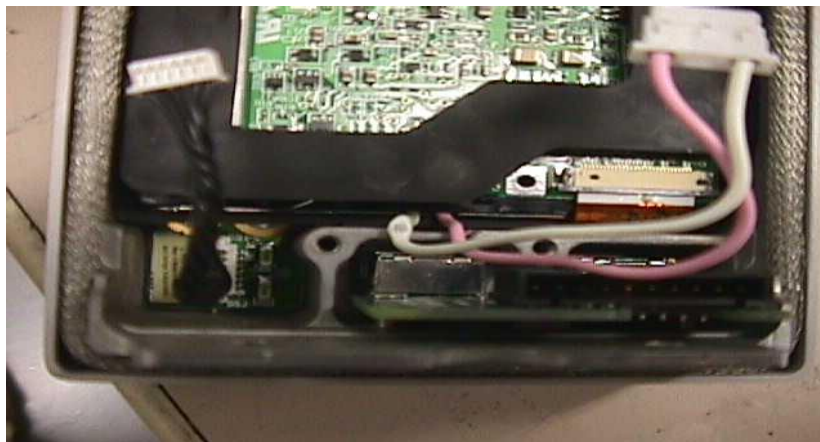
There has been a few random N5181A MXG Signal Generators discovered in the field with pinched Liquid Crystal Display (LCD) power leads. Though this is not a safety concern, the pinched LCD leads may overtime, become shorted resulting in a dark LCD display.

A N5181A MXG Signal Generator that appears to be operating correctly; unit turns-on, fans are functioning and the green power-on switch LED is visible but the front panel LCD screen is dark, may be the result of shorted power leads.

It is suggested that at the time of contact, the LCD leads be inspected for the possibility that the LCD leads are pinched. The LCD leads should move freely as they pass between the sub-panel sheet metal and the front panel casting. When in doubt, remove the front panel sub-panel in accordance with the MXG Service Guide. If the leads are found pinched, but no short has occurred. Reposition the affected lead(s) and if deemed necessary, apply insulating tape to the affected area. Re-assembly the front panel according to the MXG Service Guide ensuring the leads are no longer pinched.

When troubleshooting a MXG with a dark LCD, inspect for the pinched power leads as a possible cause of the dark display. If the leads are found pinched resulting in a physical short, replace the LCD assembly (P/N: N5180-60024) in accordance with the MXG Service Guide.

Additionally, it is recommended when LCD leads are uncovered as being shorted, the front panel Key Pad (P/N: N5180-60021) should also be replaced. While there is no direct empirical proof that the RPG on the Key Pad assembly has been damaged, a connection between shorted LCD lead(s) and the possibility of latent future RPG failures has been made, leading to a proactive desire to replace both assemblies.
