N5182A-01

S E R V I C E

N O T E

N5182A MXG Vector Signal Generator

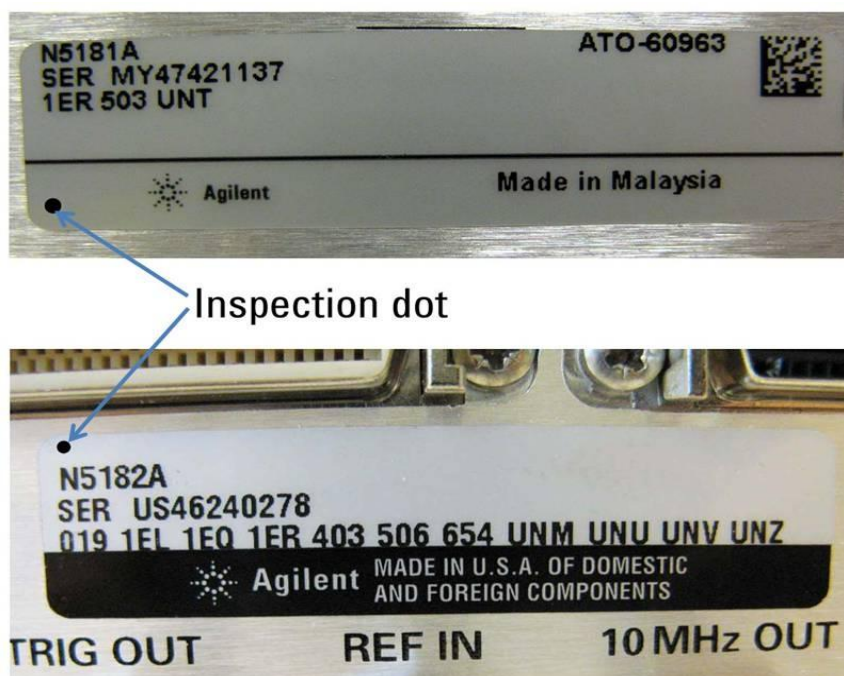
1. Check the rear panel serial tag for a small black inspection dot (see images below). If a black dot is present, similar to what is depicted, the instrument has been checked and no further action is required. If the dot is missing proceed to step 2.

3. If the RF board P/N: **N5180-60099** serial number falls within the range of **23080500004** thru **23081200228**, arrangements should be made so the instrument can be sent to an Agilent Service facility for inspection and if necessary, warranted repair.
4. If the RF board serial number does not match the serial numbers listed, using a permanent marker, it is suggested that a black dot be placed on the serial tag as shown in step 1. Doing so will assist in future quick recognition that a specific unit has been inspected or repaired. Further, the instrument does NOT need to be returned to Agilent and can be put back into use.
