N5182A-01A

N5182A MXG Vector Signal Generator

August 7, 2008

“Batch related component issue may result in a non-functioning instrument”.

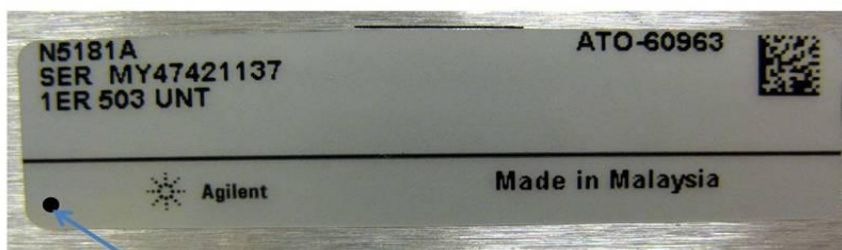
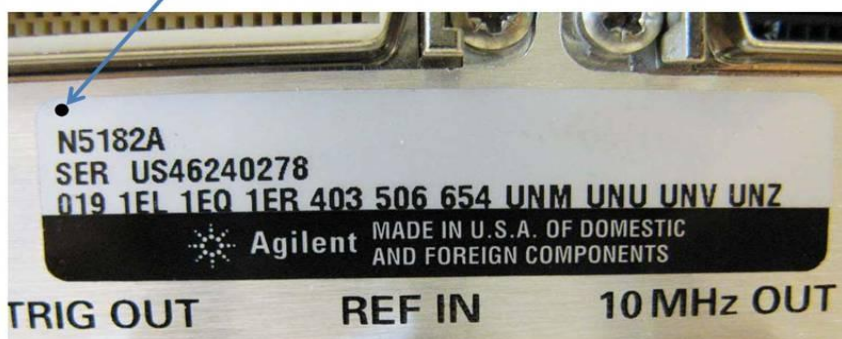
Inspection dot

1. Check the rear panel serial tag for a small black inspection dot (see images below). If a black dot is present, similar to what is depicted, the instrument has been checked and no further action is required. If the dot is missing proceed to step 2.
