N5183B-07

# Information Only Service Note

## N5183B X-Series MXG $\mu$ Wave Analog Signal Generator

**The Problem** – Potential for Damage Caused by Hipot Safety Testing

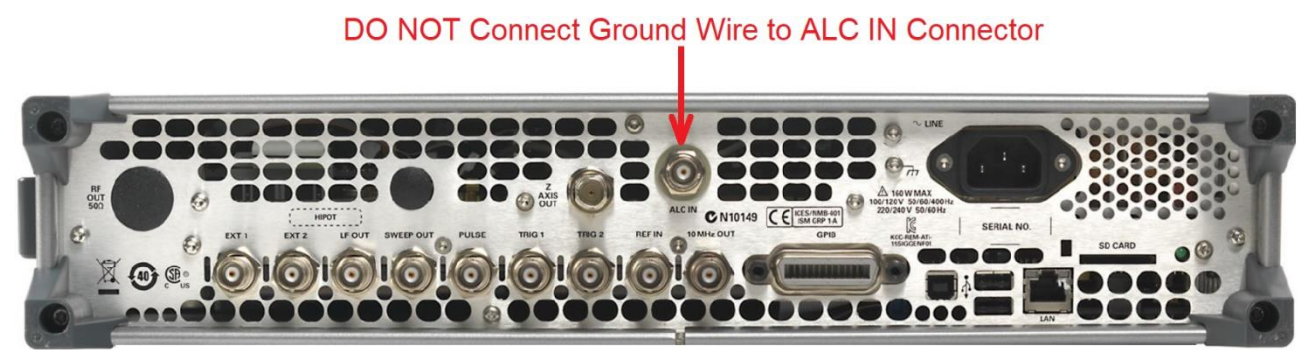
It has come to our attention that instruments have been damaged using a Hipot tester when performing incoming and outgoing safety testing on these instruments. These safety testers require that a ground wire from the tester be connected to the instrument chassis. This connection is often made to the outer conductor of one of the rear panel BNC connectors. The problem occurs when the ground wire is connected to the ALC IN rear panel BNC connector outer conductor when the test is run. Connecting the ground to this point is a problem because the ALC IN connector outer conductor is not connected to the chassis of the instrument. It is isolated from the chassis ground with a plastic washer. Not only is this an invalid point to connect the ground wire to for this test, it also sends the high voltage level directly into the sensitive ALC input circuitry.

The typical failure symptoms of an instrument that has been exposed to this is the failure of Self Tests 407, 1107, 1108, 1112 (some or all of these). The parts that will be damaged are on the A7A1 Microwave ALC Control board, so the power level accuracy test will most likely fail as well.

Do not connect the Hipot safety tester ground wire to the ALC IN connector shield.

It is also recommended that a static safe protective cap be put on the ALC IN connector before it is given to your logistics team so that nobody will be able to easily connect the ground wire to it when they perform a safety test. This will also help to protect it if it goes through an incoming inspection safety test once it has reached its destination.
