N9100A-03

S E R V I C E N O T E

N9100A 4080 series Parametric Test System

Industrial PC requires SATA digital cable and DVI extension cable to replace

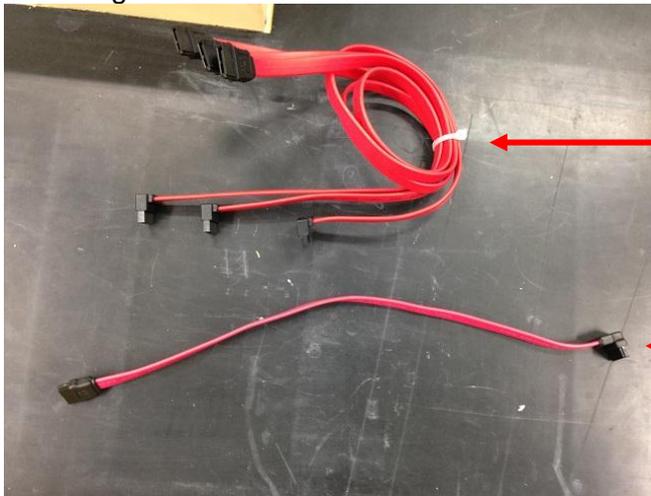
SATA digital cable:

Old cable is longer (=1m)

New cable (PN 8121-2464) is shorter (=30cm)

Remove industrial PC from system cabinet, and replace PN 8121-2464 SATA digital cables (x 3ea) and PN 8121-2649 DVI extension cable.

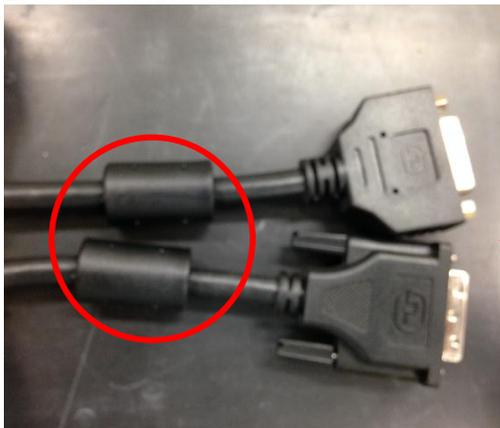
DVI extension cable:

Old cable has ferrite core on both sides

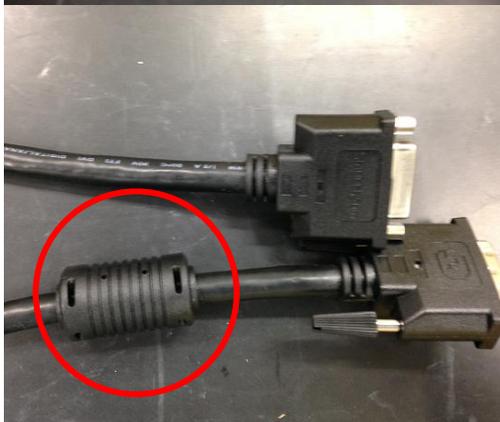
New cable (PN 8121-2649) has ferrite core on only one side
