**N9923A-01**

# **S E R V I C E N O T E**

## N9923A – FieldFox - Handheld Network Analyzer

**A potential reliability problem with the System Board has been identified. After an indefinite time of use, the instrument may exhibit an ADC Overload Error.**

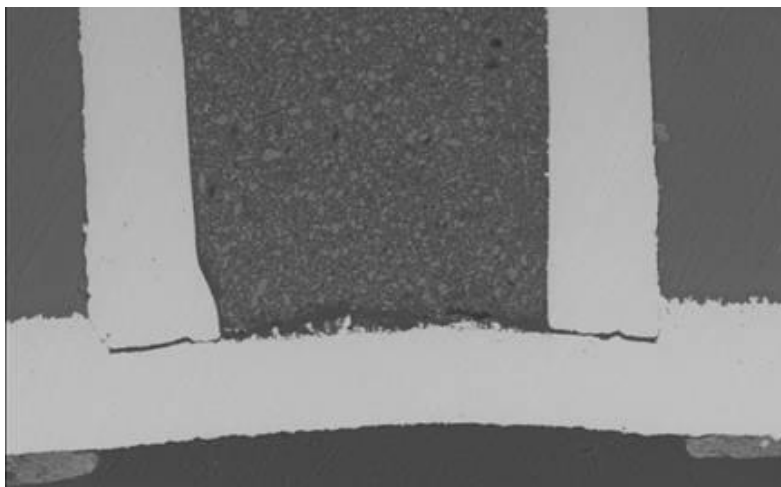
System Board analysis shows that several resistance measurements between traces across vias are not meeting specification. Further analysis of boards reveals via crack lines (see image) in current (rev. 6) and previous versions of the boards. To fix this problem, new boards (rev. 7) are being manufactured using a different base material.

Replace the old System Board (rev. 6 or below) with a new one (rev. 7). Refer to the N9923A Service Guide for instruction on replacing the system board. To view this Service Guide information, use the following steps:
