MODIFICATION RECOMMENDED

N9923A-01A

S E R V I C E N O T E

N9923A – FieldFox - Handheld Network Analyzer

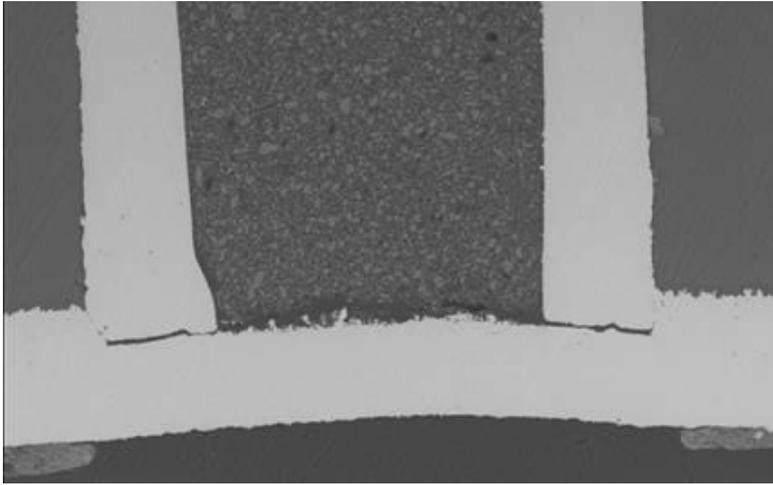
System Board analysis shows that several resistance measurements between traces across vias are not meeting specification. Further analysis of boards reveals via crack lines (see image) in current (rev. 6) and previous versions of the boards. To fix this problem, new boards (rev. 7) are being manufactured using a different base material.

Replace the old System Board (rev. 6 or below) with a new one (rev. 7). Refer to the N9923A Service Guide for instruction on replacing the system board. To view this Service Guide information, use the following steps:
