## P9001A-02

# S E R V I C E N O T E

P9001A Agilent P9000 series Massively Parallel  
Parametric Test System

Industrial PC requires SATA digital cable and DVI extension cable to replace

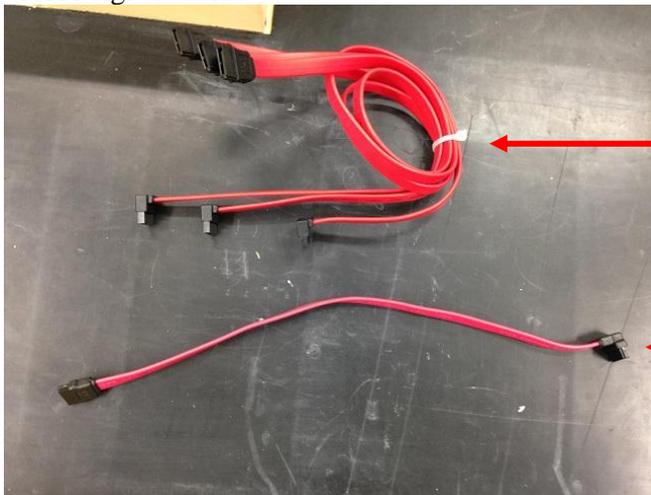
SATA digital cable:

Old cable is longer (=1m)

New cable (PN 8121-2464) is shorter (=30cm)

Remove industrial PC from system cabinet, and replace PN 8121-2464 SATA digital cables (x 3ea) and PN 8121-2649 DVI extension cable.

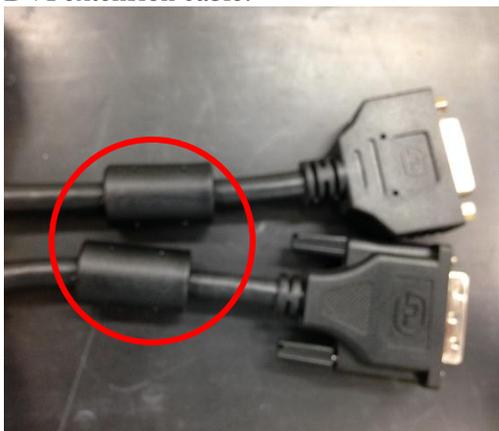
DVI extension cable:

Old cable has ferrite core on both sides

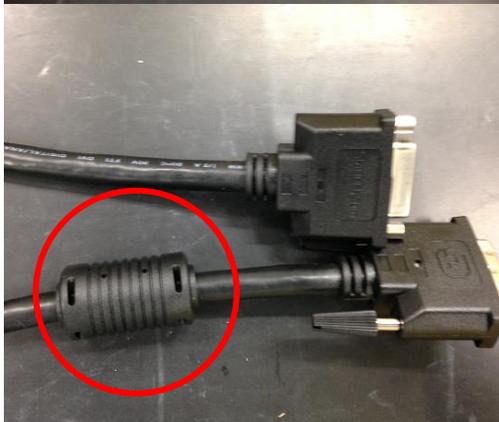
New cable (PN 8121-2649) has ferrite core on only one side
