P9371A-03

Information Only Service Note

P9371A Vector Network Analyzer, 300 kHz to 6.5 GHz, 2-port

Firmware update requirement to A.15.75.22 or newer for P9371A with MY573, SG573 serial prefix.

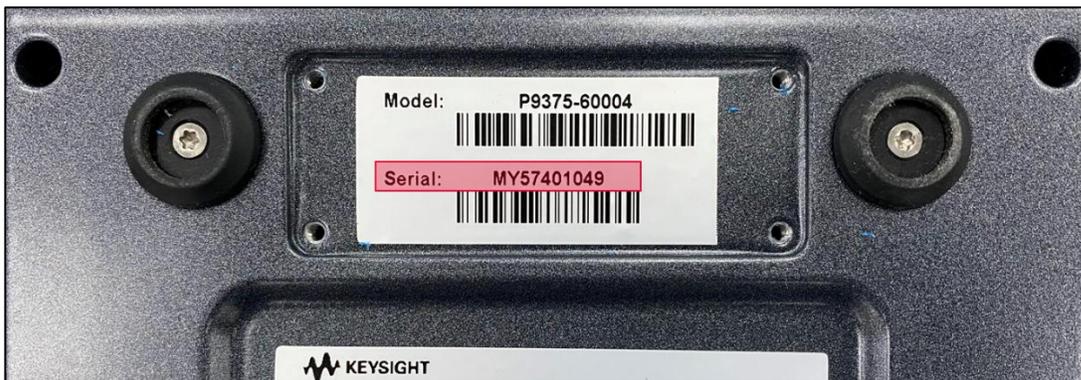
For repaired P937xA, to identify the chassis generation, refer to the hardware serial number break as follows. Shown below is an example of MY574 HW serial number with old chassis HW.

HW generation	Chassis Serial number
Old	MY574xxxxx
New	MY575xxxxx
