T1250A-03

Modification Recommended Service Note

T1250A Smart RF Switching Unit

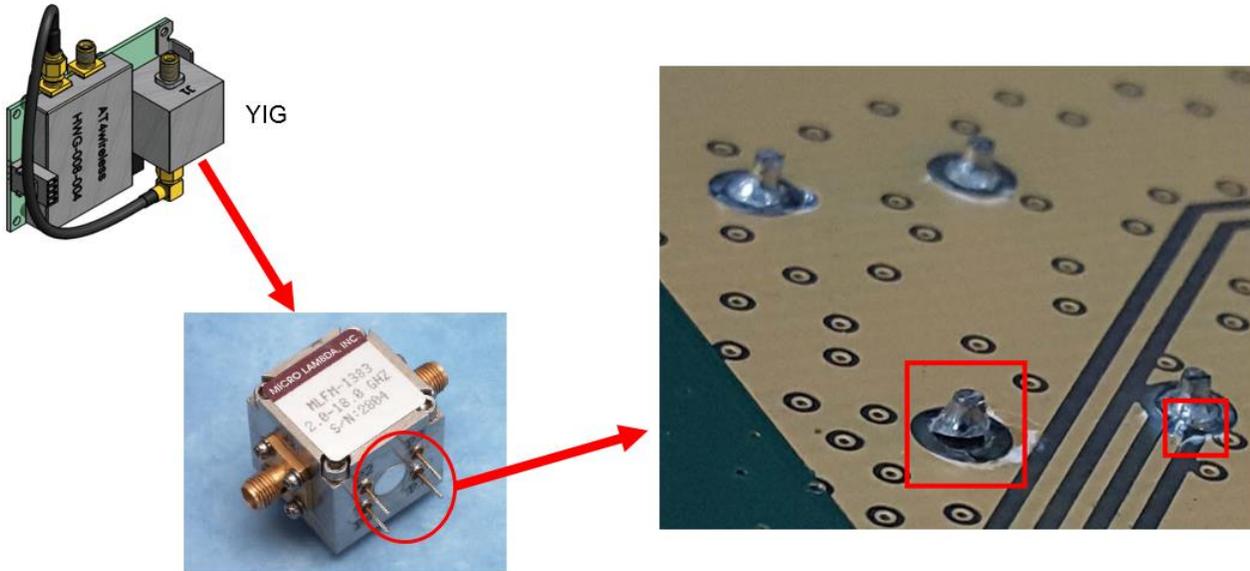
A careful inspection of the YIG filter module PCB of failing units revealed solder cracks in the YIG filter pins:

- 1- At factory assembly stage, an RF cable was attached to the YIG filter, before the metal plate that attaches the YIG filter to the PCB was properly attached to the PCB. That torque may cause the solder cracks. This is the most probable cause.

- 1- A change was immediately included in the Assembly procedure. The RF cable must be connected after the YIG module has been installed in the T1250A chassis, so that the YIG filter pins are not forced during assembly stage.
- 2- A design change was defined:
 - Short term solution: add hot glue between the component and the PCB, as it is shown in the following pictures:
