T2010A-01

Modification Recommended Service Note

T2010A LTE Wireless Communications Test Set

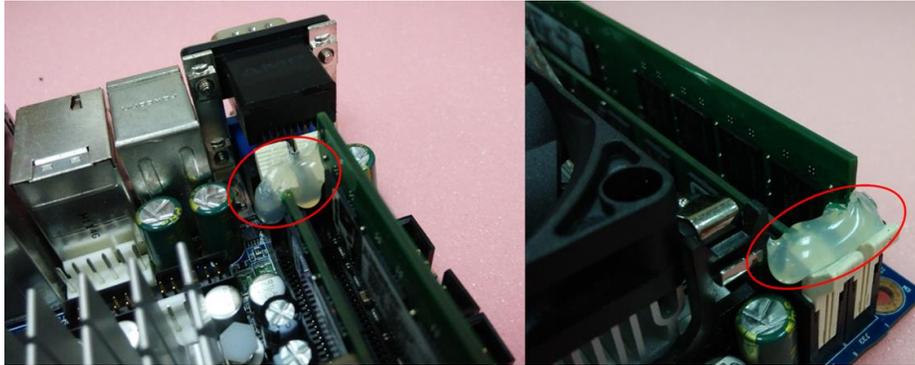
If RAM modules are not well engaged to the PC board memory slots, they are not detected by the PC board, and the instrument does not boot up.

Check that the RAM modules are secured with hot melt glue as shown in the following pictures:

The glue must be applied all the way down from the locker to the memory slot, and both RAM modules must be tied together (i.e. building a “bridge” between the latches).

- I. If the RAM modules are correctly glued, NO action is required.
- II. If no glue is present, apply the holt melt glue.
- III. If a different glue (yellow colour) had been used, remove the existing glue, and apply the holt melt glue.
- IV. If it had not been applied correctly, remove the existing glue, and apply the holt melt glue properly.
