U1733C-01

Modification Available Performance Enhancement Service Note

U1733C Handheld LCR Meter

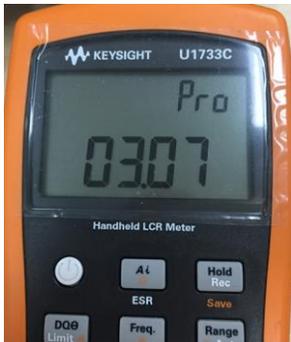
U1733C handheld LCR meter with firmware revision 3.06 will show incorrect resistance value when measuring resistance (DCR measurement) below 7MΩ on 20MΩ range.
To resolve the problem, update the firmware of your LCR meter to firmware revision 3.07.

1. Verify if your U1733C LCR meter is with firmware revision 3.06 by following the step written on page 26 of the user guide.
2. Perform firmware update to firmware revision 3.07. You may obtain the firmware file from the product firmware page on Keysight.com.
3. Follow the steps written on the product firmware page to update the firmware of your meter.
4. Once the firmware update is completed, verify if your LCR meter is with firmware revision 3.07.

5. Firmware revision 3.07 will resolve the incorrect resistance measurement value when measuring below 7MΩ on 20MΩ range.
