U2001A-03

S E R V I C E N O T E

U2001A 10MHz – 6GHz USB Sensor

Difficulty to attach USB power sensor cable to power sensor unit.

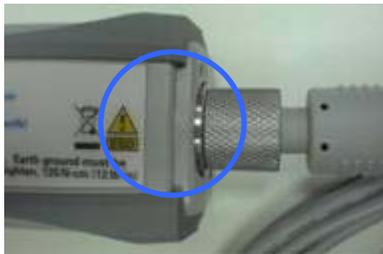
Figure 1: USB power sensor cable fully attached to power sensor unit

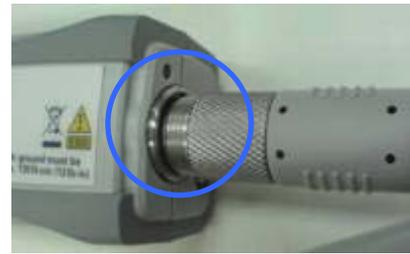
When the USB power sensor cable is attached to the power sensor unit, user may find it difficult to attach the cable to the power sensor unit.

Figure 2: USB power sensor cable not fully attached to power sensor unit

- 1) If user have not used the cable (new unit), kindly contact Agilent for free of charge part replacement.
- 2) If user face difficulty to attach the cable to the power sensor unit, kindly contact Agilent for free of charge part replacement. Kindly scrap the used cable.
