# Modification Recommended Service Note

Supersedes:  
U7179-81000-01

## U7179-81000 - 16-Channel High Current Load Card up to 15A

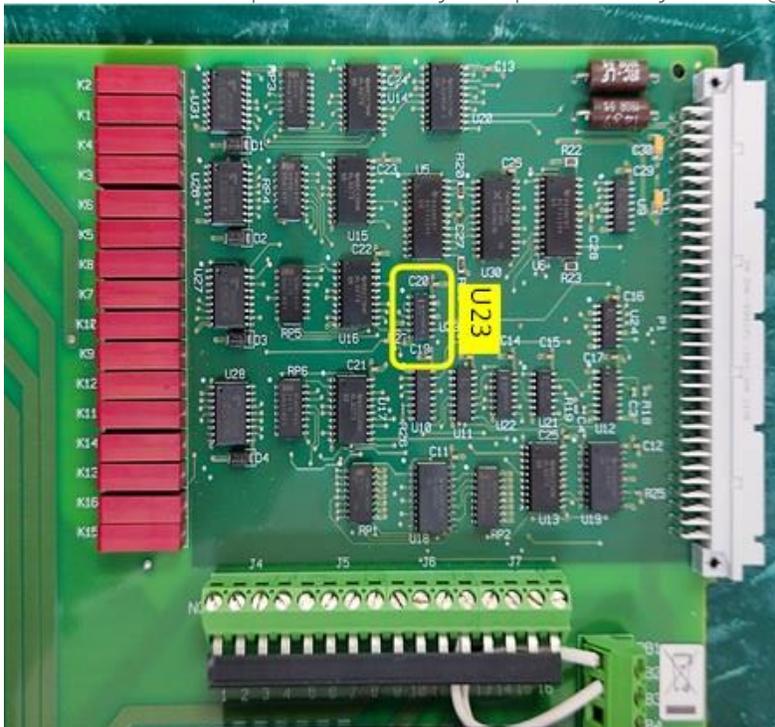
1. Perform a visual inspection to verify component body markings on the IC U23.

2. If the manufacturer mark indicates NEXPERIA or NXP, the card is identified as affected.
3. If the manufacturer mark indicates TEXAS INSTRUMENTS, no action is required.

When the U7179A load card encounters a wrong hardware ID detection issue and the U23 IC on the U7179A load card is recognized as being from the NEXPERIA or NXP manufacturer, replace the U7179A load card with a new card (U7179-81000 or U7179-89000). Otherwise, assume there are no timing issues with the U7179A load card and do not proceed with this service instruction.
