# Modification Recommended Service Note

## U7179-81000 - 16-Channel High Current Load Card up to 15A

Affected products: U8972A, U8989A, U8989AS, U8989B, U8989BS, E2240A, E2230B, E6198B, E8786B, E8780B

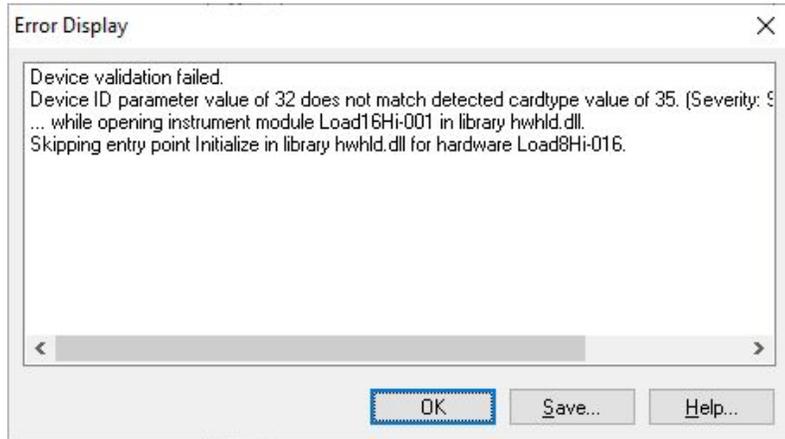
Figure 1. TestExec error

When all load cards are populated in the E6198B SLU (refer to Figure 2), the hardware ID of the U7179A load card in the left-most slot (slots 1 or 3) is not recognized correctly. The correct ID for U7179A card is 32, while the invalid IDs that have been observed could be 33, 35, 36, 37, 38, 39, 40, 41, 44, 46, and 47 (not fixed).

i.e. TestExec gives the following error message when it starts:

When the U7179A load card encounters a wrong hardware ID detection issue and the U23 IC on the U7179A load card is recognized as being from the NEXPERIA or NXP manufacturer, replace the U7179A load card with a new card (U7179-81000 or U7179-89000). Otherwise, assume there are no timing issues with the U7179A load card and do not proceed with this service instruction.

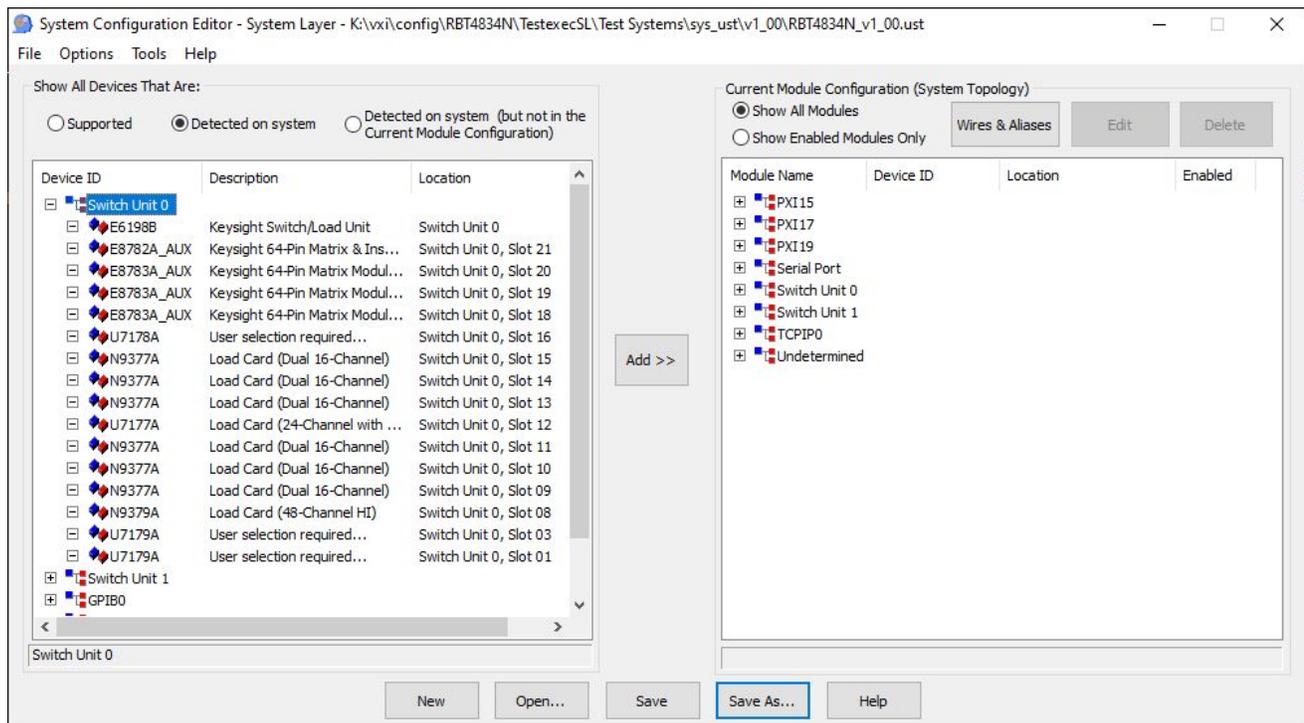
Figure 2. SCE screenshot

Hardware ID detection error only occurs if there are 10 or more cards in the SLU and happens at the left-most slot of the U7179A card. It is determined that a delay in control signals that are fed to the ID

IC from the specified manufacturers will result in a different U7179A ID. This delay causes the time mismatch on the timing diagram thus affecting U7179A ID signals.

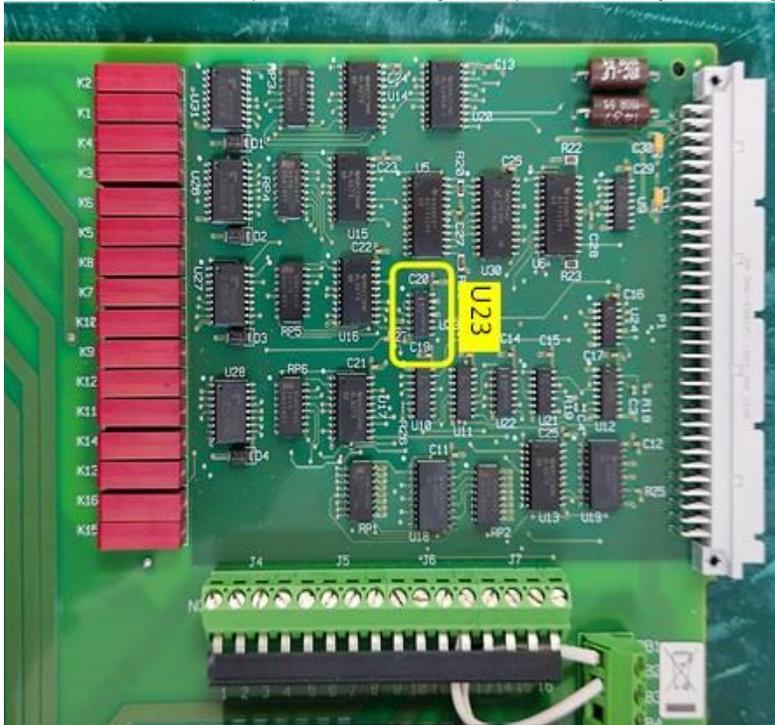
1. Perform a visual inspection to verify component body markings on the IC U23.

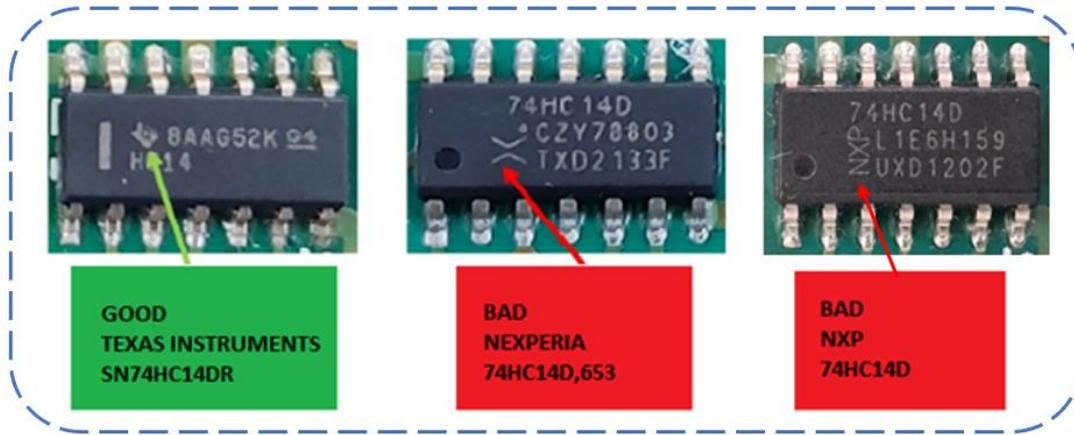
Manufacturer Identification

2. If the manufacturer mark indicates NEXPERIA or NXP, the card is identified as affected.
3. If the manufacturer mark indicates TEXAS INSTRUMENTS, no action is required.
