U9405A-05

Modification Recommended Service Note

U9405A – i1000 Small Foot Print Inline and OffLine systems

The Problem – i1000 software cannot detect Fixture Control Board sensors states

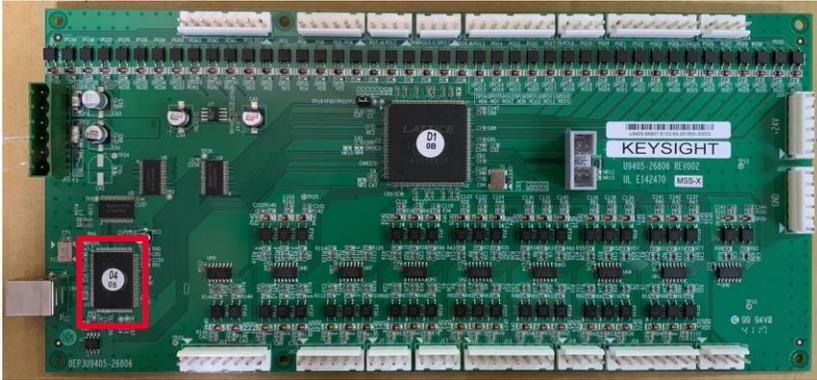
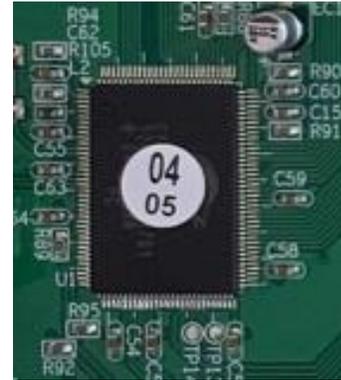
The version of Cypress USB driver that supports Win7 32bit is version 3.5.7. This will not work with the new firmware version 0405. I1000 software will not be able to detect any states of the Fixture Control board IO. This affects all versions of the i1000 software.

If your system is using a new version of the Fixture Control Board with firmware 0405, you must upgrade the Cypress USB driver to version 3.4.5.
