N5183B-08A

Information Only Service Note

N5183B X-Series MXG μW ave Signal Generator

The Problem – Recommending using Refurbishment Part Number for Self Test 1105 and 1304 failures due to excessive reverse power by user.

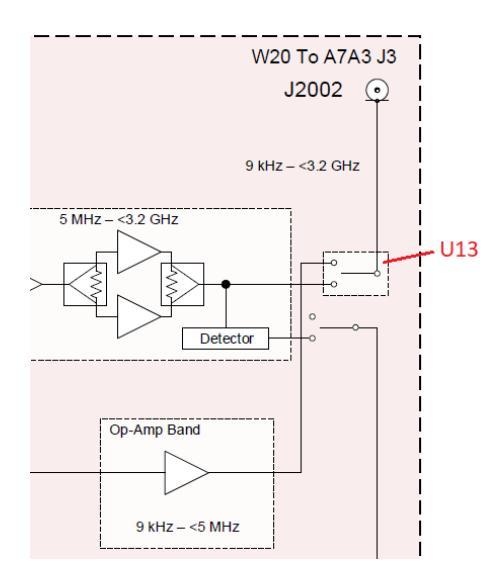
Figure 1 - A3 RF Output Switch - U13

The component level part on the A3 RF assembly that typically gets damaged under these conditions is the RF output solid state switch (U13) as shown in Figure 1, which is taken from a block diagram in the instrument service guide.

When U13 is damaged in this way it may either be stuck in one position or the other, or it may not pass any signals at all.

- a) Replacement part for repair to use refurbishment part number because the damage is most likely caused by excessive reserve power being applied to the RF output by the user.

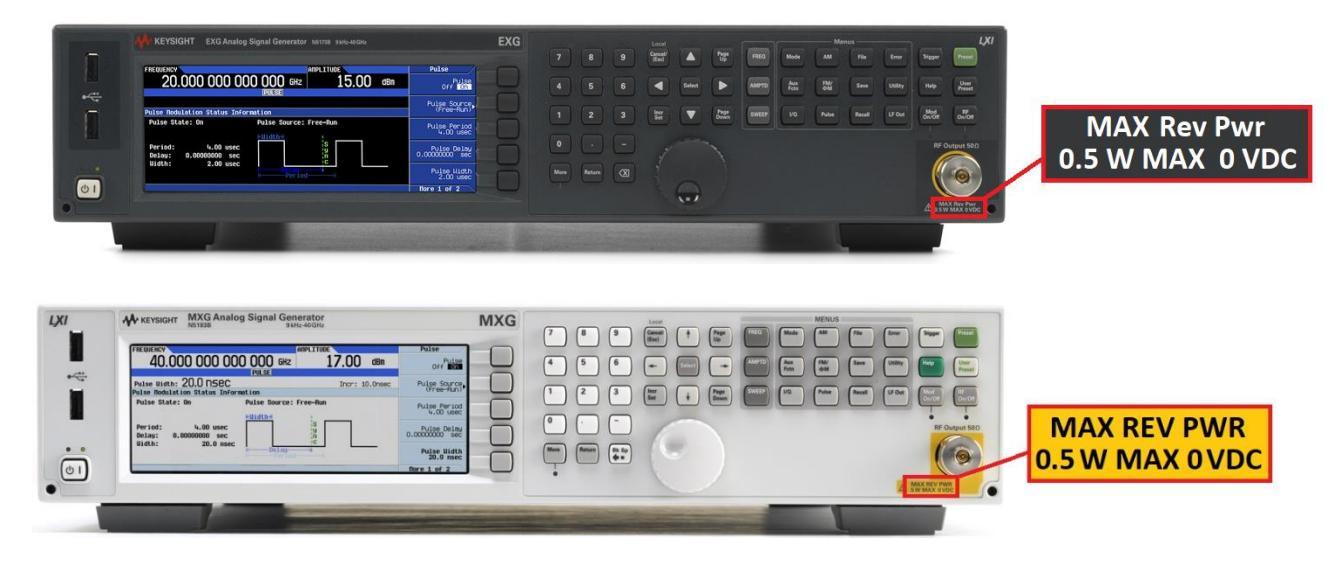
The N5173B signal generator has a very low tolerance for reverse RF power, and no tolerance at all for DC voltage applied to its RF output. The maximum values for these are listed below and can be seen on the instrument front panels as seen in Figure 2 for both instrument color schemes.

Maximum Reverse RF Power = 0.5 Watts Maximum DC Voltage = 0 Volts
