Scanning Microwave Microscopy for Semiconductor Failure Analysis

Application Note

Wenhai Han
Agilent Technologies

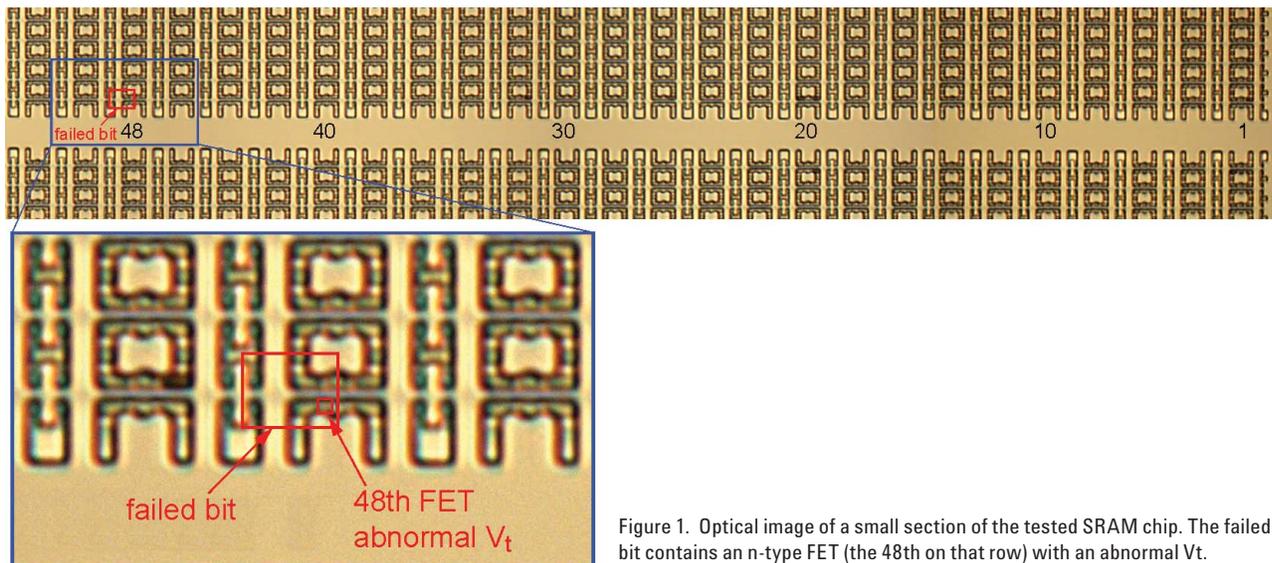
Figure 1. Optical image of a small section of the tested SRAM chip. The failed bit contains an n-type FET (the 48th on that row) with an abnormal V_t .

The sample being tested was a depackaged 250 nm static random access memory (SRAM) chip. A standard SRAM unit bit cell contains six field effect transistors (FETs), two p-type FETs in an n-doped well and four n-type FETs in a neighbor p well. Among thousands of bit cells on the chip, one was found failed. Inside the failed bit, one n-type FET was measured having an abnormal threshold voltage V_t . It was the 48th n FET on that row, as shown in Figure 1. Scanning microwave microscopy was tried, attempting to find any unusual properties of the transistor different from other normal transistors.

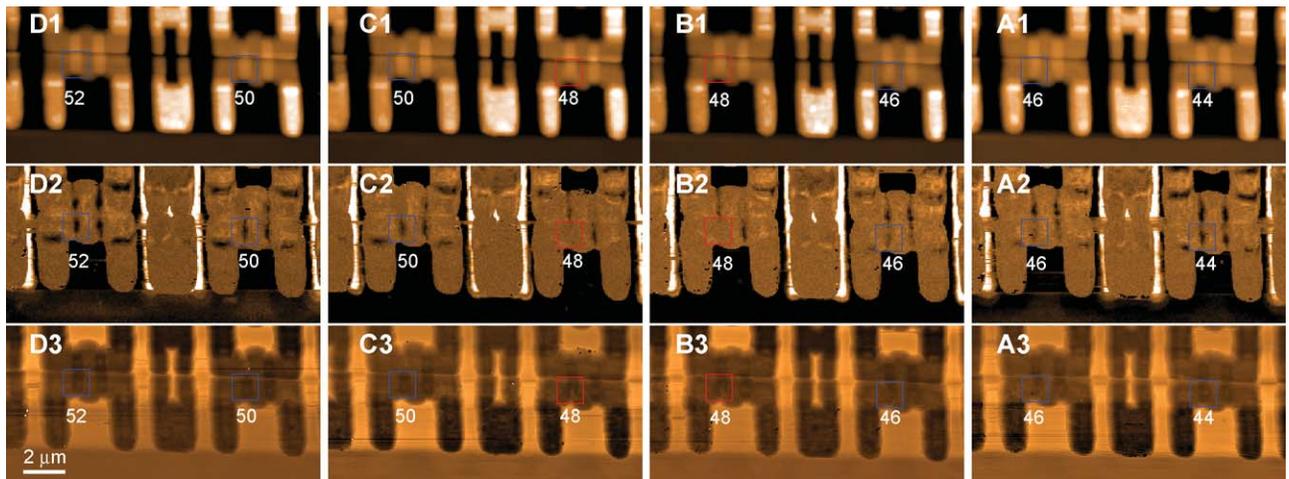
Figure 2. Four sets (A, B, C, and D) of scanning microwave microscopy images on the failed SRAM chip. Each set contains topography (top), dC/dV (middle), and VNA amplitude (bottom) images acquired simultaneously. The red squares outlined the failed 48th n-type FET, and the blue squares are normal n FETs on the same row.

To accurately identify any possible problem with sufficient details, every two pairs of FETs on the same row as the failed FET were scanned, from the 43rd/44th pair through the 51st/52nd pair, as shown in Figure 2. Total of four sets of images (A, B, C, and D) were acquired under the same conditions. Each set contained topography (top), dC/dV (middle), and VNA amplitude (bottom) images obtained simultaneously. For illustration purpose the even number n-type FETs on the same row as the failed FET were outlined with squares in all images.

The topography images of the 48th n FET, outlined by the red squares in Figures 2 B1 and C1, didn't appear to have any structure difference compared to the normal n FETs (blue squares as well as the unmarked ones in all of the topography images). They were also very similar to those seen on other SRAM samples [2, 4]. In the dC/dV images, however, the difference was quite noticeable. Every normal n FET (blue square) consistently showed a dark area near the center. The dark (low) value in the dC/dV image represented p-type dopant of the well in the channel. The 48th n FET, on the other hand, was completely flat without any contrast, as shown in the red squares of both Figures 2 B2 and C2. The missing p-dopant signal in the 48th n FET clearly indicated a change of dopant structure of the channel area of the transistor. The VNA amplitude images of the 48th n FET, if examining carefully from Figures 2 B3 and C3, also showed some different structure from other normal n FETs. It indicated a different capacitance/impedance value.

Scanning microwave microscopy has been demonstrated is capability of doing semiconductor failure analysis. Images of dopant concentration measured from the dC/dV signal on a defect SRAM chip clearly identified an unusual dopant structure of the failed n FET, different from other normal n FETs. Capacitance images measured from the VNA amplitude also showed certain different contrast of the transistor. This experiment has shown that the scanning microwave microscope can be a convenient direct-imaging tool to probe a variety of electric failures in semiconductor devices not visible from surface topography structure on scales of micrometers to nanometers.
