3070-75B-S

S E R V I C E N O T E

Agilent 3070 Board Test Systems

POSSIBLE "SHOCK PINCH" HAZARD

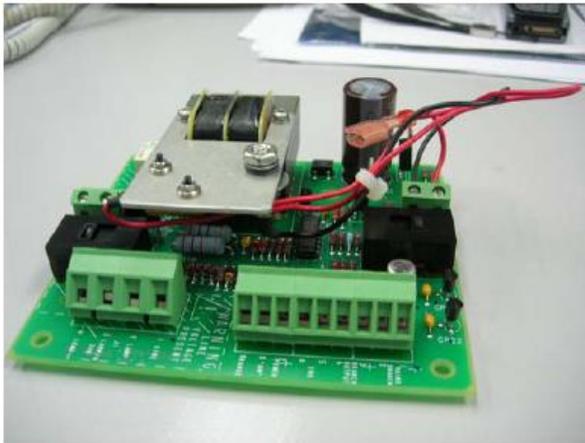
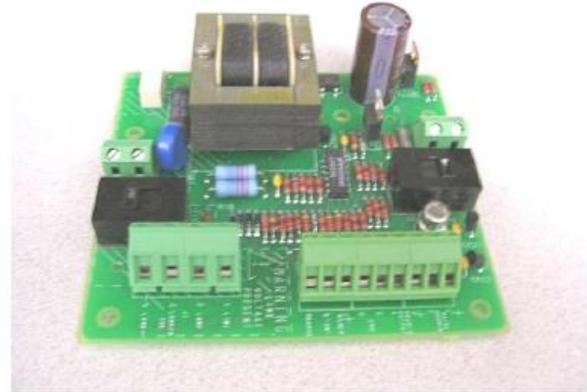
Fig 1

The solution is to replace the E1135-66501 control board in the PDU with a newer version (Fig 1) that incorporates a voltage regulator to the magnetic contactor.

New E1135-66501

Old E1135-66501

Investigations revealed that the DC voltage supplied to the 0490-2318 from the E1135-66501 control board were higher than specified as there was no voltage regulation. Over time, excess heat can damage the coil of the magnetic contactor which leads to the described safety hazard.

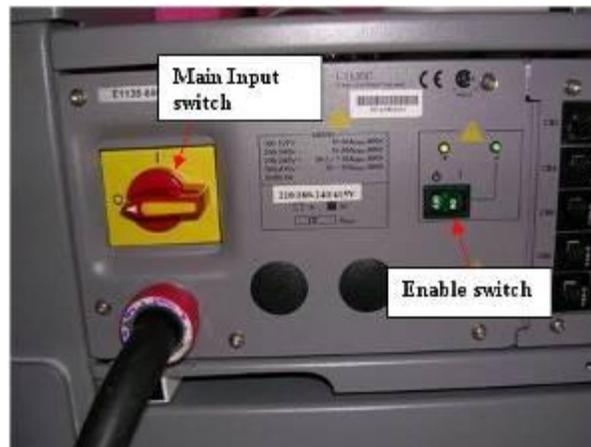
Fig 2

1. Shutdown the 3070 system using the standard operating procedure.
2. The E1135C has a mains disconnect device. Set this Main Input Switch to "0" (Fig 2). This is a safety feature to prevent the accidental turn-on of power from the mains while carrying out the job as described in this safety service note.

21. Turn on the PDU enable switch. (Fig 2).
22. Test the safety feature of the PDU by pressing the EMO switch. The power will shut off immediately. This is observed by a click sound while the enable light will turn from green to yellow. The enable switch remains at the '1' position.
23. Return the EMO switch back to its normal position.
24. Turn the enable switch to '0' position and wait for 5 seconds before turning it back to '1' position.
25. Observe the click sound and the green enable light.
26. Startup the 3070 system using the standard operating procedure.
27. Upon job completion, fill out and install the Service Note label (Part Number N7200-84366) to the PDU.

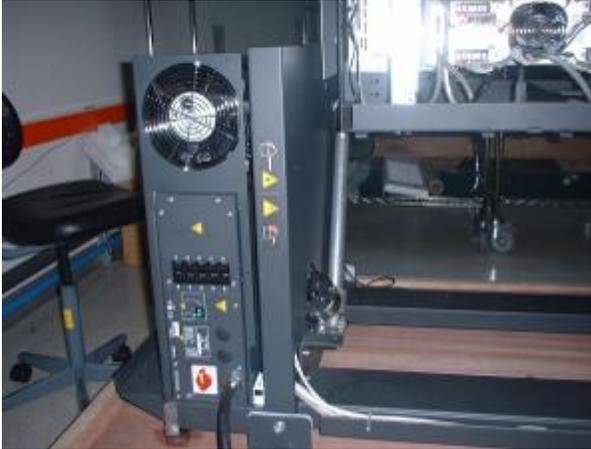
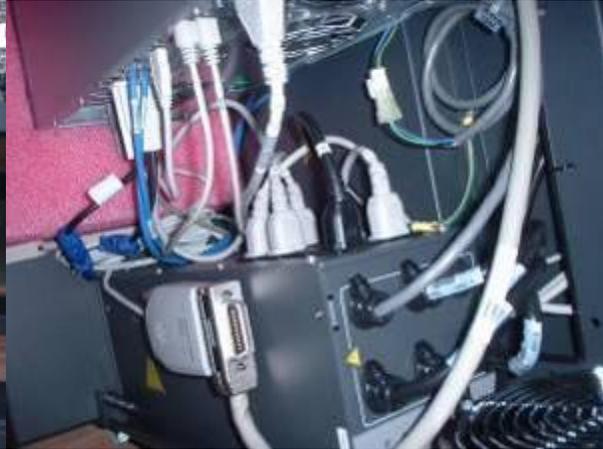
**Fig 3**

3. Remove the POD housing cover to gain access to the PDU.
4. Unplug the power cords at the back of the PDU and remove the PDU from the system for disassembly (Fig 3 & 4). The power cords on the side of the PDU cannot be easily removed, so place the PDU horizontally on the floor near the system in such a way the power cords are not affected.

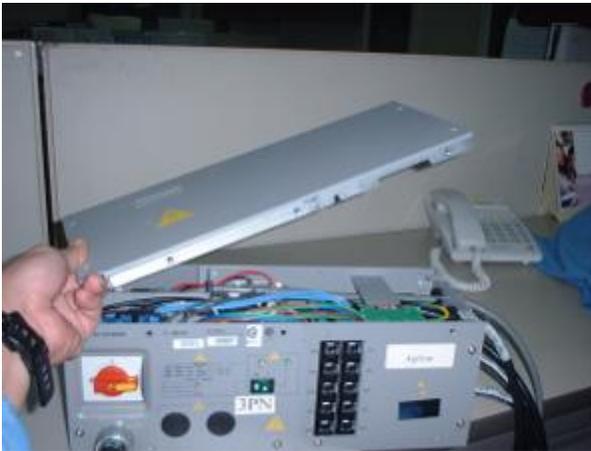
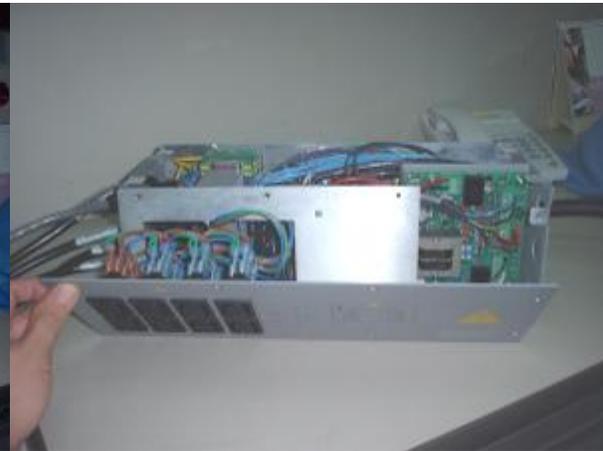
**Fig 5**

5. Remove the 17 M3.5 Torx screws holding the top and back covers of the PDU (Fig 5 & 6) using a T10 Torx driver. This needs to be done to access the E1135-66501 Control Board.

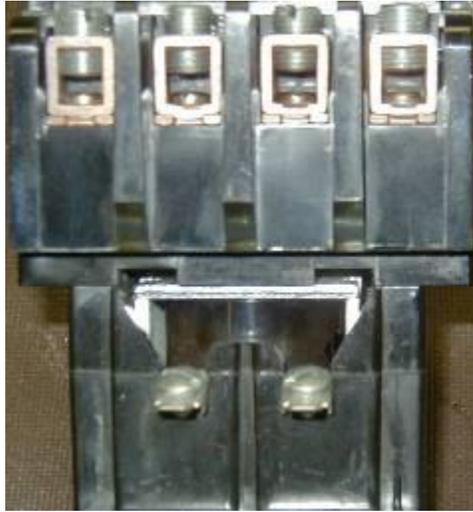
Fig 7

6. After opening the PDU. Inspect the contactor housing for cracks and “white” powdery type material (Fig 8). If the contactor has been or is suspected to be damaged, the entire PDU must be replaced by following the PDU Replacement procedure. If the contactor is good (Fig 7) continue with step 9.

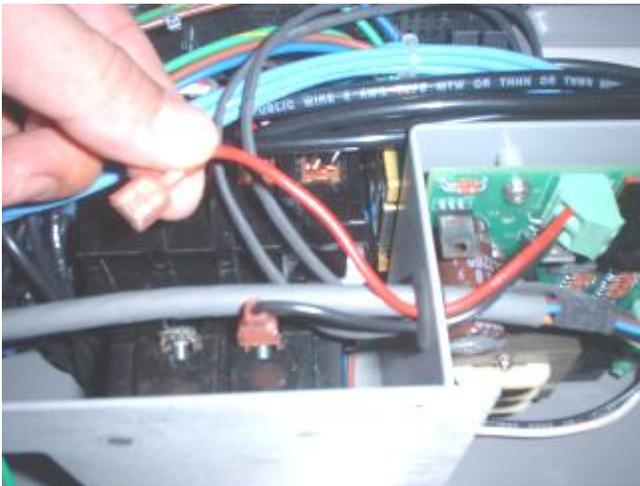
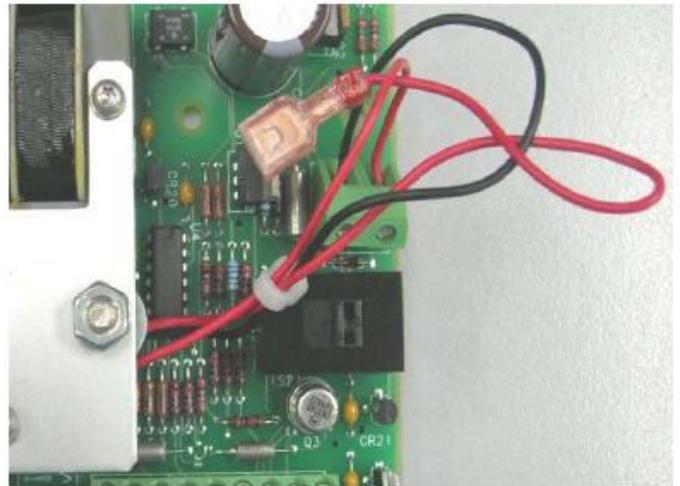
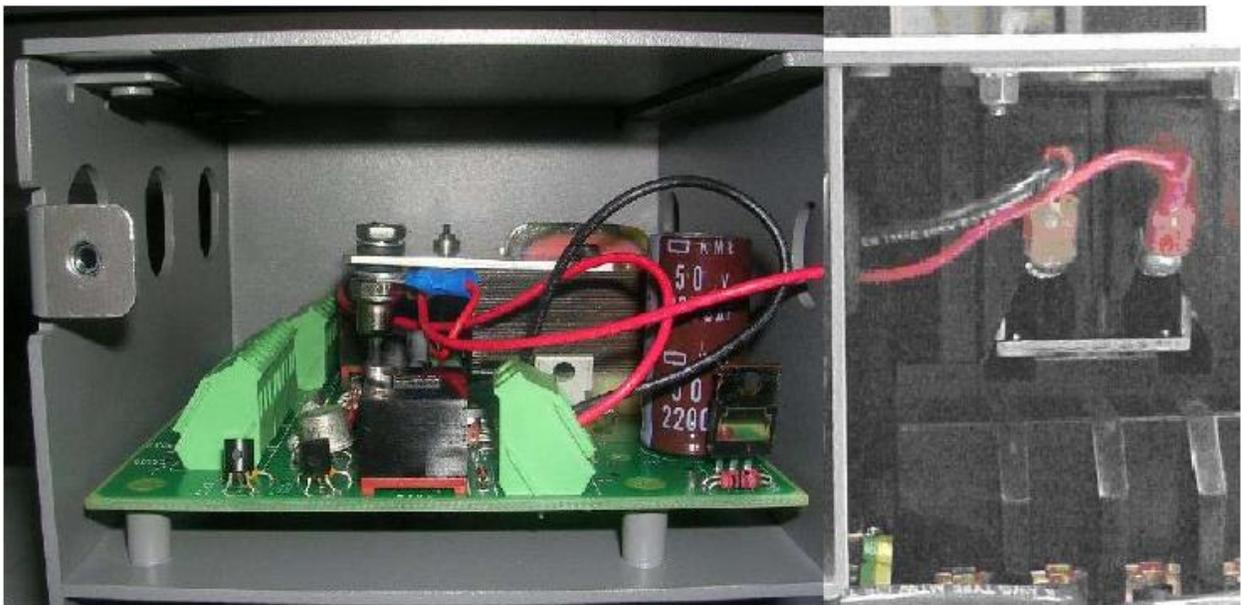
14. Figures 13, 14 and 15 show the new control board wiring.

(New Control board with voltage regulator)

Fig 15 (New Control board with voltage regulator)
