4288A-03

S E R V I C E N O T E

4288A 1 kHz/1 MHz Capacitance Meter

Incorrect items for instrument setup screens might be displayed on rare occasions

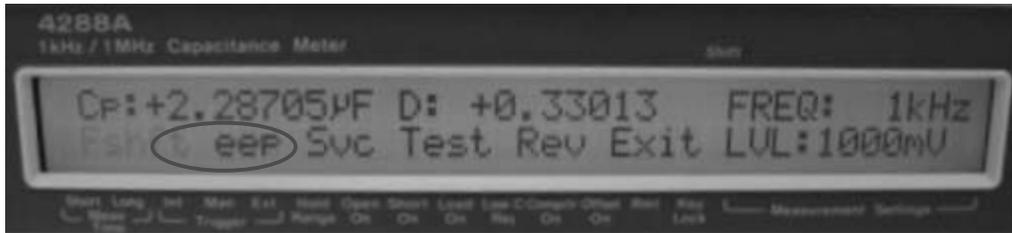
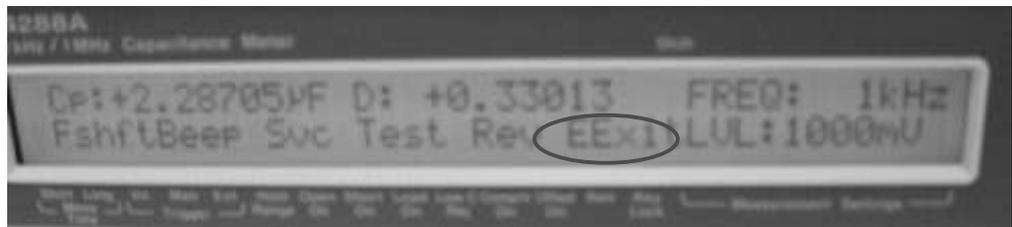
Some of the instruments specified above may have a defective LCD assembly. When a front panel key or [← ↓], [↑ →] key is pressed for setting the instrument, incorrect items for the instrument setup screen might be displayed on rare occasions due to its LCD assembly failure. The figures below show examples of the incorrect items.

Replace the LCD assembly with a new one.
