hp Model 4800A Vector Impedance Meter  
serials prefixed 805 and below

Thermistor A17R14 Replacement  
hp Modification Kit 04800-61043

Modification Kit 04800-61043 is a replacement kit for thermistor 0837-0045 in the hp Model 4800A Vector Impedance Meter, serials prefixed 805 and below. Later instruments do not use the thermistor.

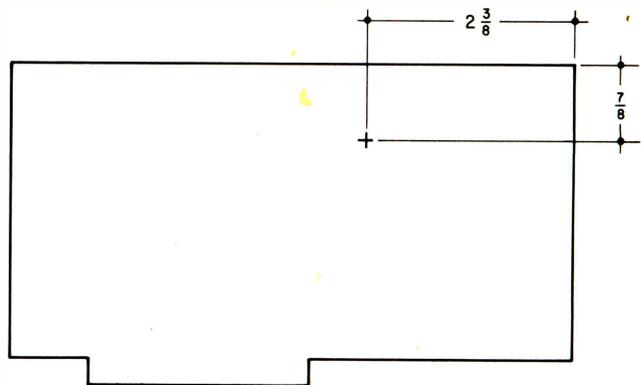
Figure 1. Feedthru Location - A17 Board

1. Remove power from instrument.
2. Remove R1, 2.87 K resistor mounted on TEST-OPERATE Switch, S1. (located between XA14 and XA16).
3. Remove A17 (Stock No. 04800-61002) from the instrument. Remove thermistors R14 and R15 including shock absorber and strap.
4. Replace R13 with jumper.
5. Drill ( $7/32''$ ) (5.5 mm.) hole in location shown in Figure 1. **CAUTION:** Start with a small size drill and enlarge hole in steps to prevent drill from seizing.
6. Install press-fit feedthru.

7. Connect short wire from hole "A" (Figure 2) to feedthru on back side of board.

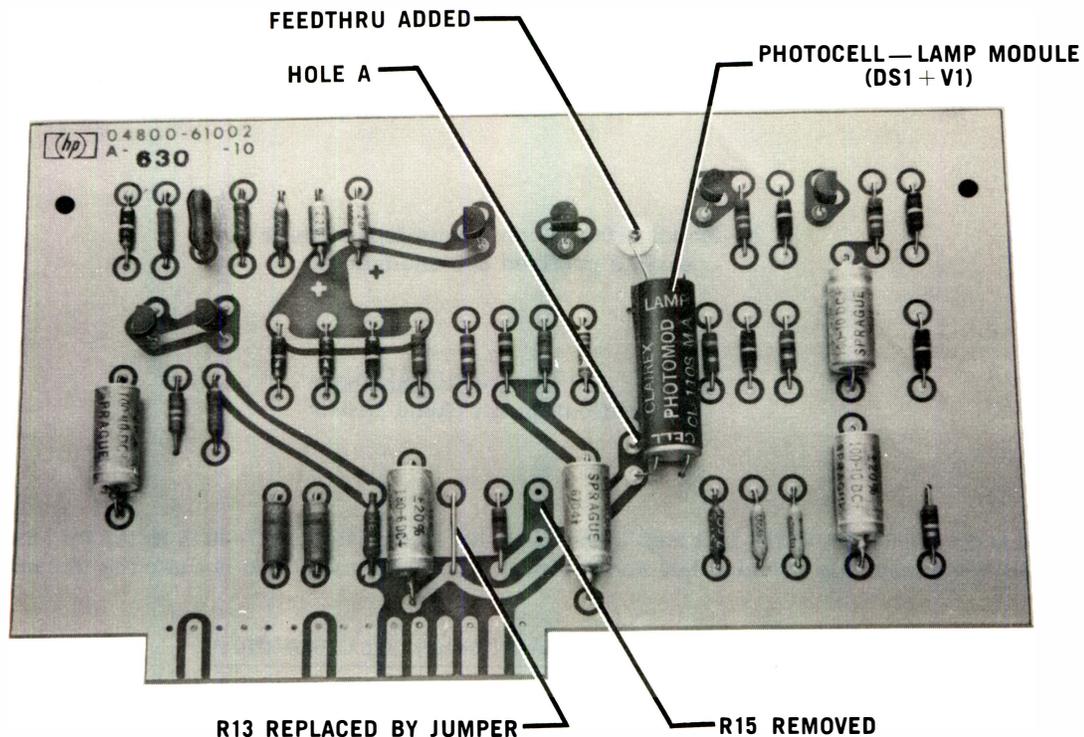
Figure 2. A17 After Modification

8. Install photocell-lamp module, DS1 + V1. Cell end of module is mounted closest to the plug-in connections.

Figure 2 shows A17 after modification.

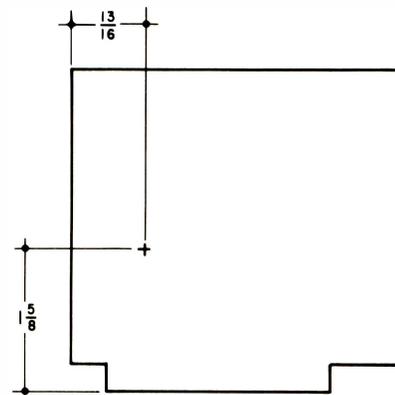
Figure 3. Feedthru Location - A14 Board

12. Drill ( $7/32''$ ) (5.5 mm.) hole in location shown in Figure 3. As in step 4 above, enlarge hole in steps to final size.

13. Install feedthru; clip lead off back of board.

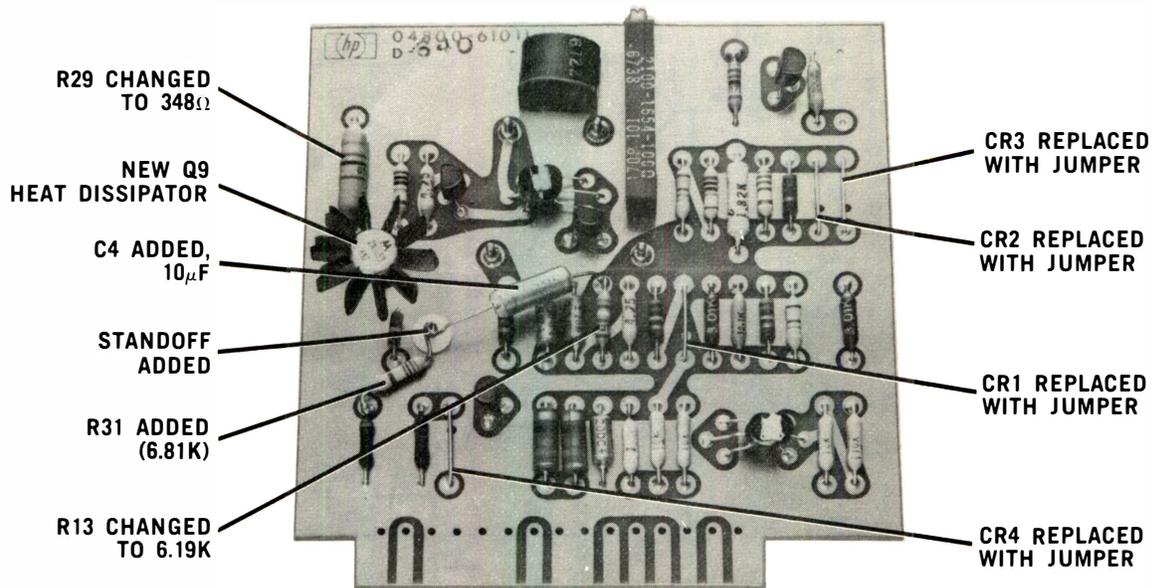
Figure 4. A14 After Modification

14. Replace R13 with 6.19 K $\Omega$ .

15. Replace R29 with 348  $\Omega$ .

16. Connect R31, 6.81 K $\Omega$  from feedthru to R30. Tack-solder to R30.

Figure 4 shows A14 after modification.

17. Connect C4, 10  $\mu$ F from standoff to R13. Note polarity: + lead to feedthru.

18. Place heat dissipator on new Q9; install on board with  $1/2''$  leads. Leads must be long enough to allow moving Q9 and heat dissipator away from chassis. Q9 case must not be grounded; it is electrically connected to the collector.

19. Reinstall A14. Check clearance of A14Q9 heat dissipator. This completes the modification.

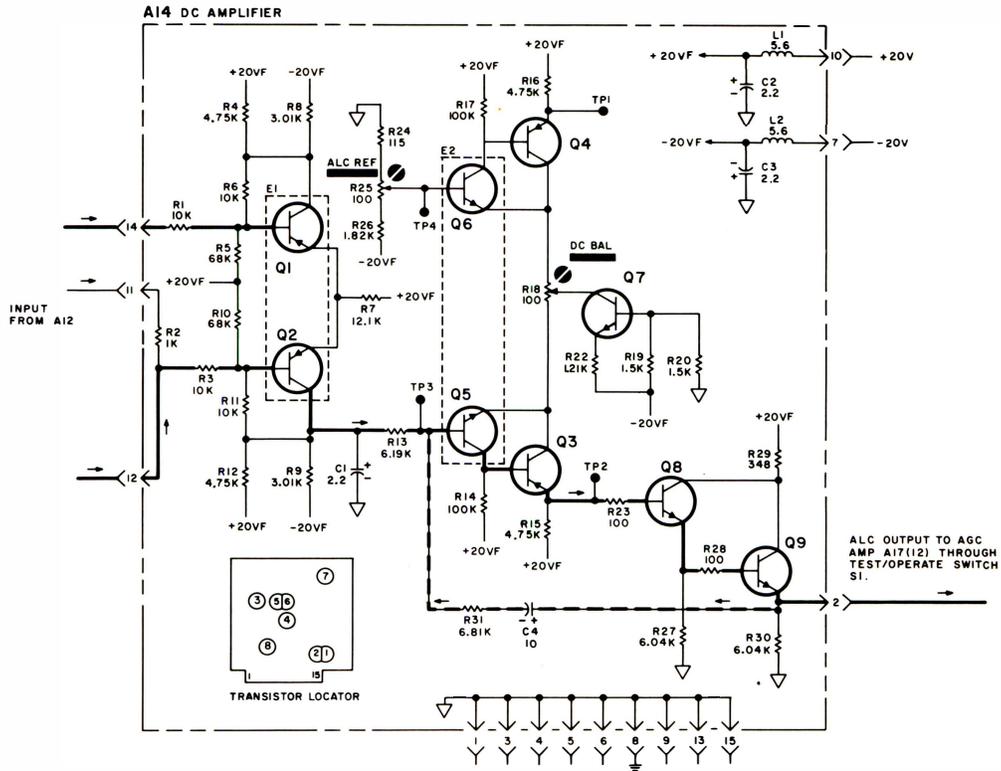
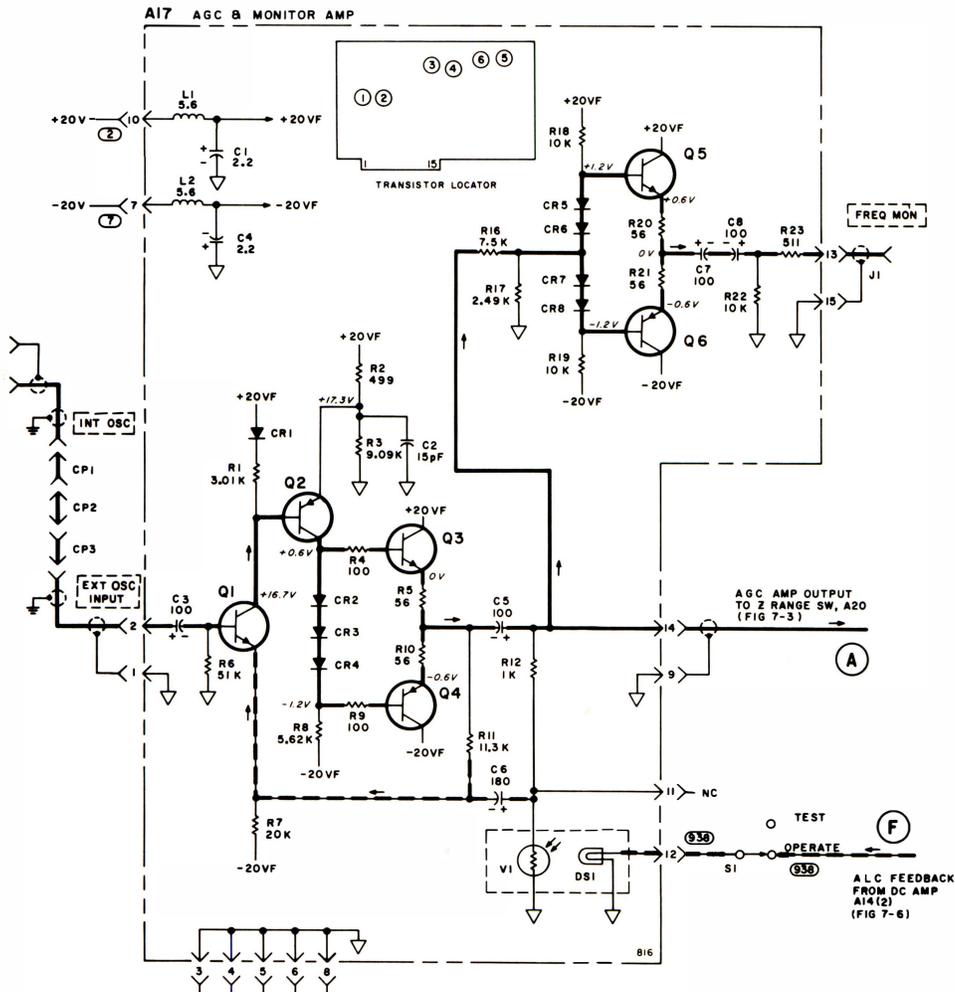
Revised A14 and A17 schematics are included in this Service Note which should be kept for future reference.
