5DX-79-S

S E R V I C E N O T E

5DX Series II, Series 2L, Series 3 and Series 5000 Systems

POSSIBLE ELECTRICAL SHOCK HAZARD

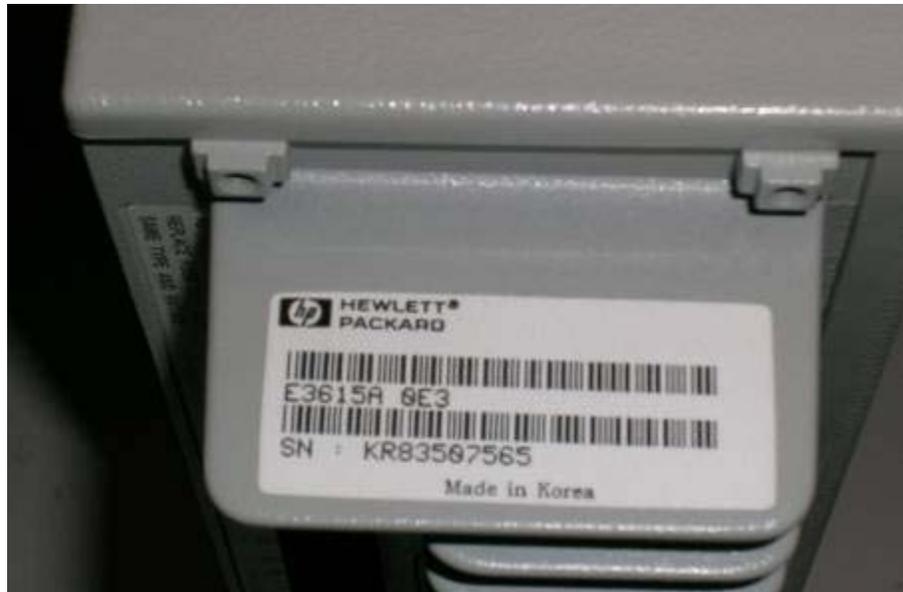
Check to see if the E3615A installed in 5DX falls within the serial number range of affected instruments.

- KR83506197 through KR99999999
- MY40000001 through MY40002138
- SG40000001 through SG40002138

If the E3615A serial number falls within the above ranges continue with next step, if not skip to step 13.

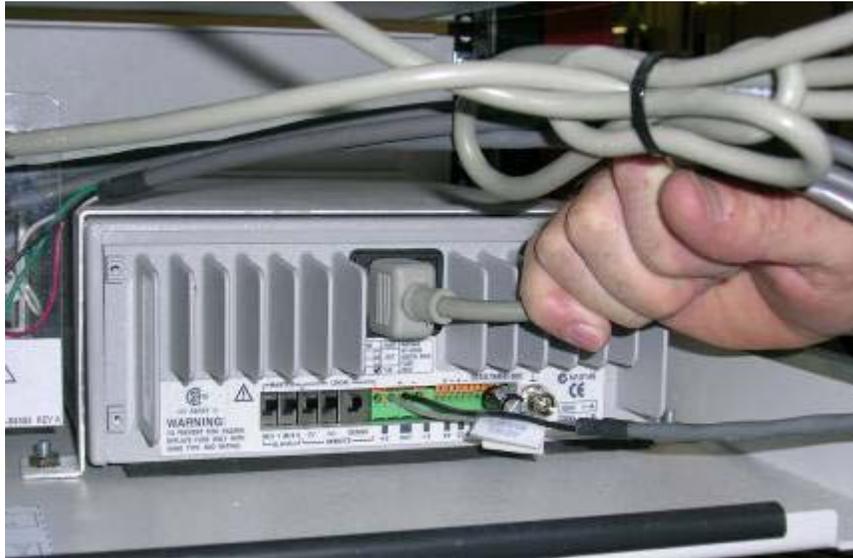
If the AC line cord is pulled in a side-to-side direction the AC module can be pulled out of the rear of the instrument exposing the AC voltage line conductors.

4. With the power cord securely inserted in the “AC Module” forcibly pull the power cord to the right side two times and see if the “AC Module” pulls out from instrument.

5. If the “AC Module” pulls out of instrument you will need to replace the E3615A. If the “AC Module” remains in place skip to step 13.

6. Remove defective E3615A and scrap.
7. Install new E3615A in Electronics Cabinet.
8. Replace Electronic Cabinet side Panel.
9. Perform the 5DX System Startup procedure found in the System Administration Guide
 - After turning on PDU and before running Automatic Startup: Turn on E3615A and set the Voltage and Current readings obtained in step 1.
10. Close the Electronic cabinet access doors.
11. Run MTFXY and MTFCE procedures. These procedures are located in the on-line “5DX Service Quick Reference Guide” under “Optimize Image Focus”.
12. Run 5DX C&A procedures.

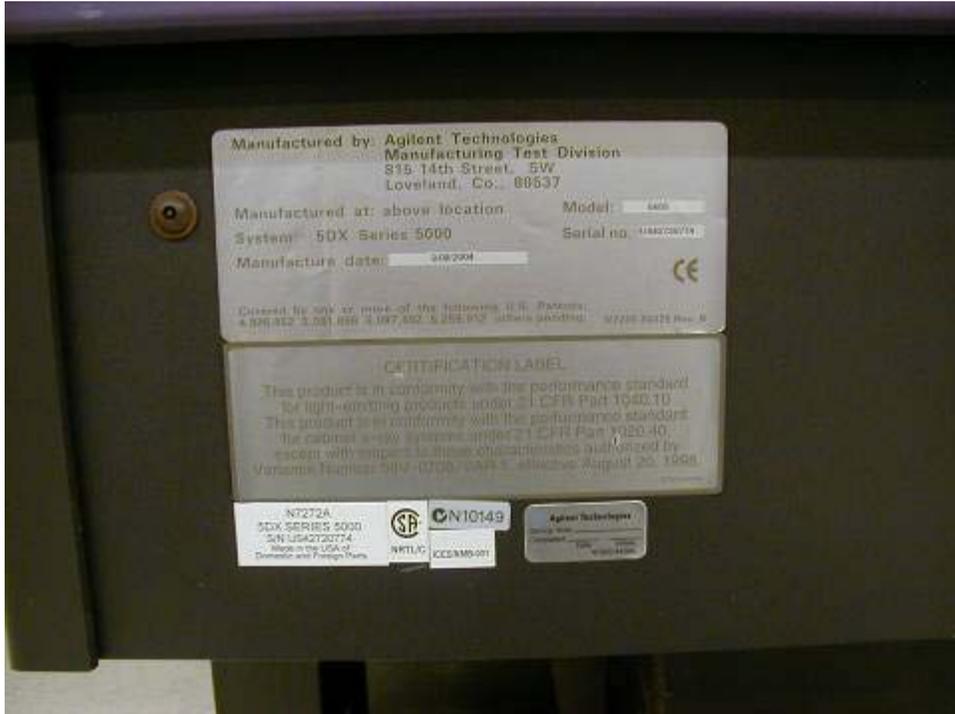
- Fill out and affix the Service Note label (Part Number N7200-84366) to the 5DX System. The following photo shows the location of the label area on the 5DX cabinet.
