5DX-82A-S

S E R V I C E N O T E

Agilent 5DX Series 2L, Series 3, and Series 5000 Systems

The E1135A/B/C PDU may not turn off when the EMO switch (emergency stop) is pressed.

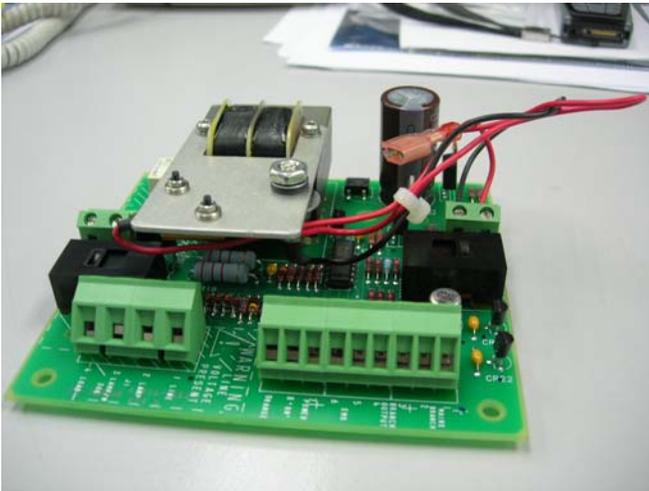
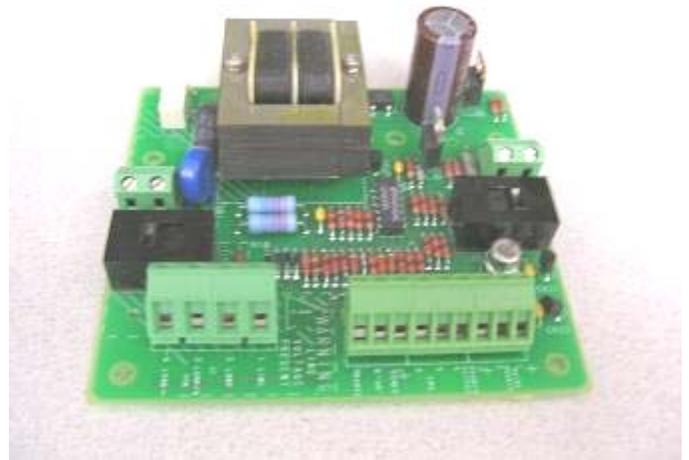
Figure 1

The solution is to replace the E1135-66501 control board in the PDU with a newer version (Figure 1) that incorporates a voltage regulator to the magnetic contactor.

New E1135-66501

Old E1135-66501

Investigations revealed that the DC voltage supplied to the 0490-2318 from the E1135-66501 control board was higher than specified as there was no voltage regulation. Over time, excess heat can damage the coil of the magnetic contactor which leads to the described safety hazard.

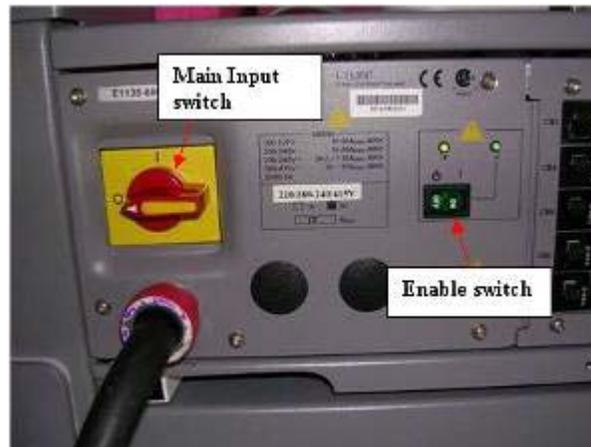
Figure 2

1. Perform the 5DX System long term shutdown procedure found in the System Administration Guide
2. The E1135C has a mains disconnect device. Set this Main Input Switch to “0” (Figure 2). This is a safety feature to prevent the accidental turn-on of power from the mains while carrying out the job as described in this safety service note.

19. Remove any “Lock Out / Tag Out” devices before proceeding.
20. Turn on the PDU by setting the Main Input Switch to “1” (E1135C’s ONLY!!!)
21. Turn on the PDU enable switch (Figure 2).
22. Test the safety feature of the PDU by pressing the EMO switch. The power will shut off immediately. This is observed by a click sound while the enable light will turn from green to yellow. The enable switch remains at the ‘1’ position.
23. Return the EMO switch back to its normal position.
24. Turn the enable switch to ‘0’ position and wait for 5 seconds before turning it back to ‘1’ position.
25. Observe the click sound and the green enable light.
26. Perform the 5DX System Startup procedure found in the System Administration Guide
27. Upon job completion, fill out and install the Service Note label (Part Number N7200-84366) to the PDU.

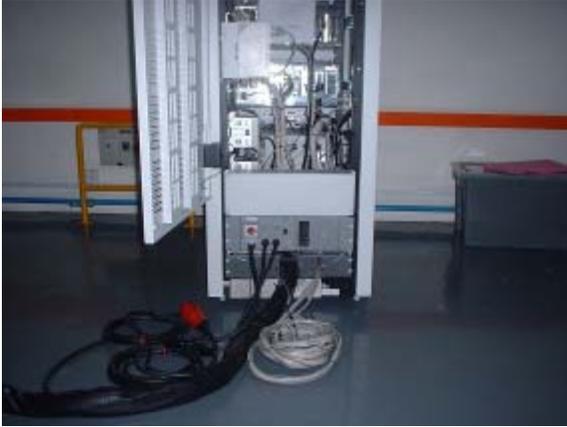
Figure 3

5. Unplug the power cords at the back of the PDU and remove the PDU from the Electronic Bay for disassembly (Figures 3 & 4). The power cords on the side of the PDU cannot be easily removed, so place the PDU horizontally on the floor near the system in such a way the power cords are not affected.

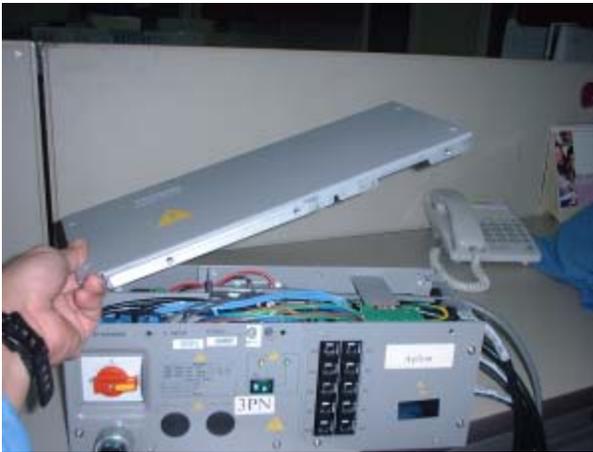
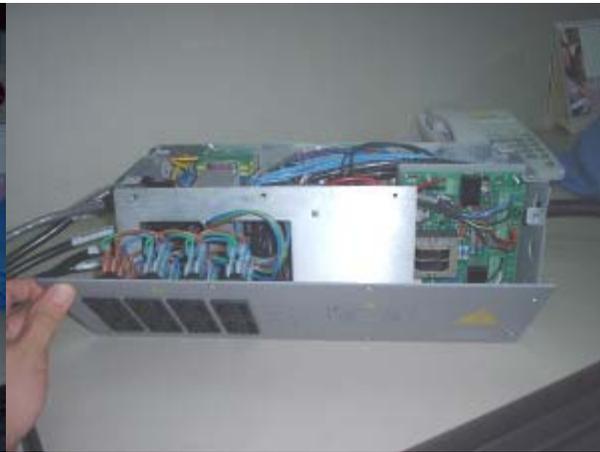
Figure 5

6. Remove the 17 M3.5 Torx screws holding the top and back covers of the PDU (Figures 5 & 6) using a T10 Torx driver. This needs to be done to access the E1135-66501 Control Board.

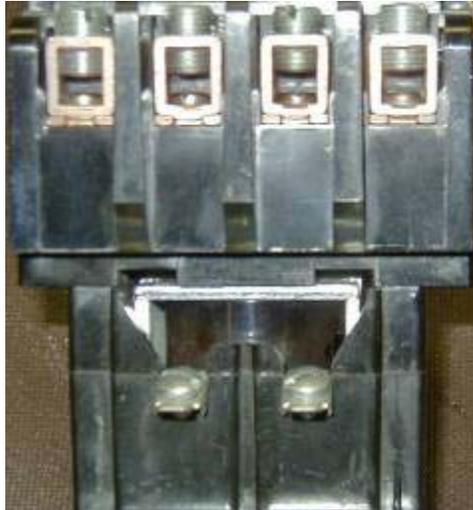
Figure 7

7. After opening the PDU. Inspect the contactor housing for cracks and “white” powder type material (Figure 8). If the contactor has been or is suspected to be damaged, the entire PDU must be replaced by following the PDU Replacement procedure. If the contactor is good (Figure 7) continue with step 8.

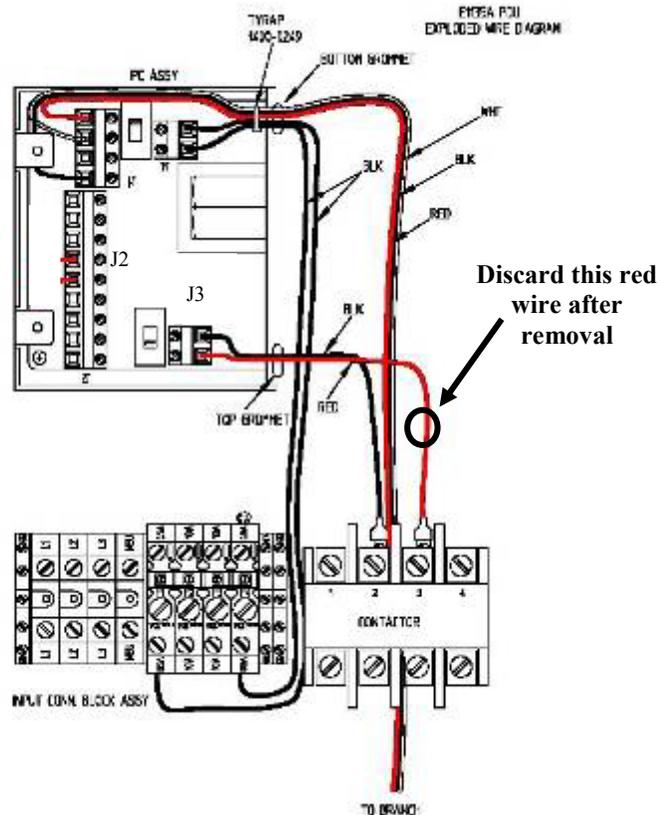
Figure 9

8. Remove the wires from the control board by using a small flat blade screwdriver. (Figure 9)
9. Make note of wire connections to J2 of control board.
10. Discard the red wire that was connected between “Contactor pin 3” and “J3 pin 1 control board”.

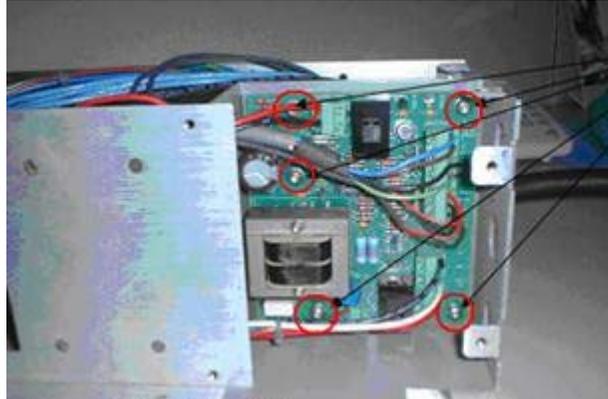
Figure 10

11. Remove the five M4 Torx screws holding the E1135-66501 control board to the PDU using a T20 Torx driver. (Figure 10)

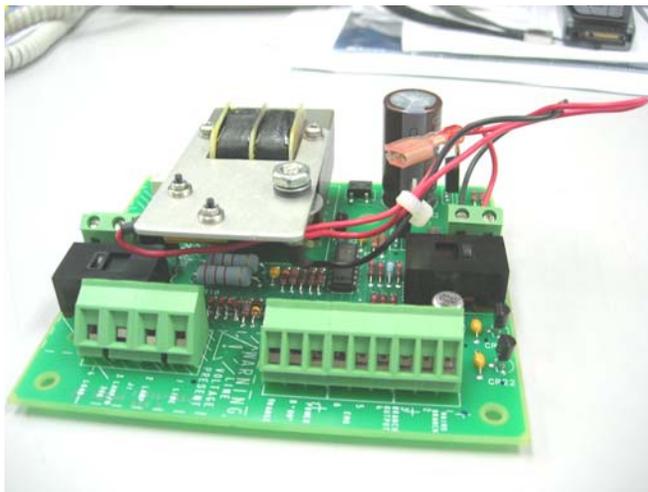
Figure 11

12. Remove the old control board from the PDU and discard.
13. Install the new control board (Figure 11) into the PDU using the five M4 Torx screws removed in step 12. Tighten these screws using a T20 Torx driver and torque to 16 inch-lb (1.81 n-meter)

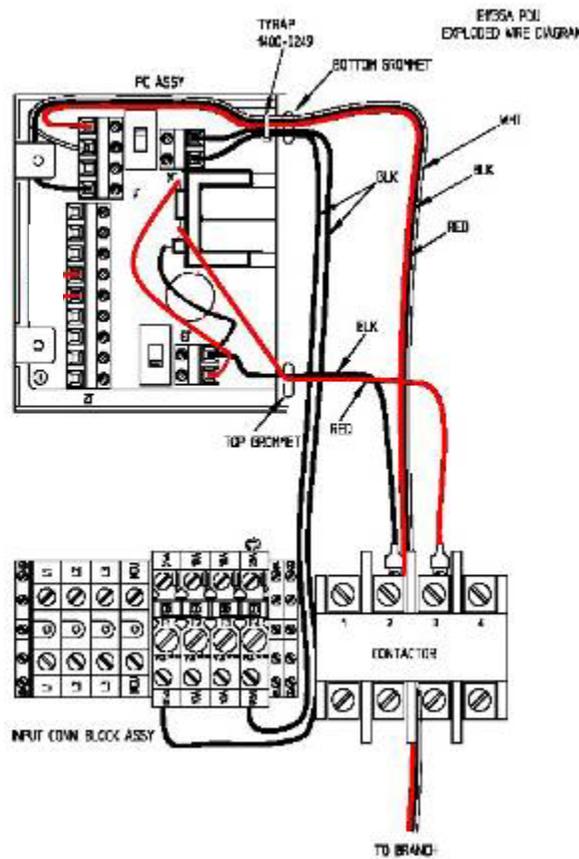
- Re-wire the control board using the wiring diagram in Figure 12 and wires removed from J2 on the control board in step 9.

Control Board to Contactor Connections		
Black Wire Contactor Pin 2	to	Control Board J3 pin 2
Black Wire Control Board J3 pin 2	to	Regulator on Control Board
Red Wire Contactor Pin 3	to	Regulator on Control Board
Red Wire Control Board J3 pin 1	to	Regulator on Control Board

Note: Wires from Regulator to J3 on control board are already connected when received from SPO.

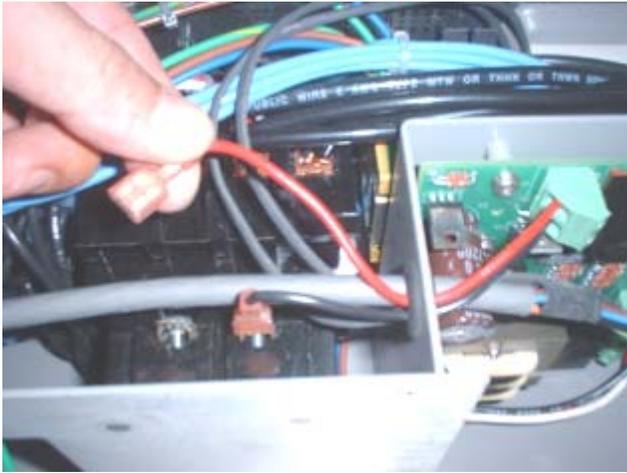
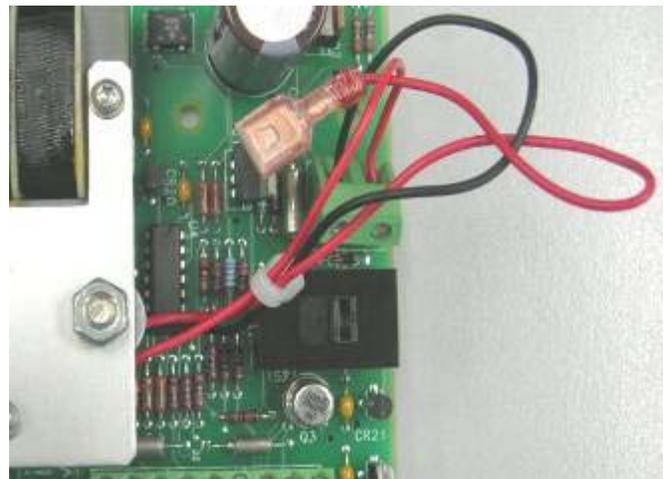
Figure 13

15. Figures 13, 14 and 15 show the new control board wiring.

(New Control board with voltage regulator)
