6645A-08

Modification Recommended Service Note

6645A DC power supply, 0-120 V, 0-1.5 A, 180 W. GPIB

The Problem – 6645A exhibited out of specification values for 61.0V to 61.7V at front panel read back readings.

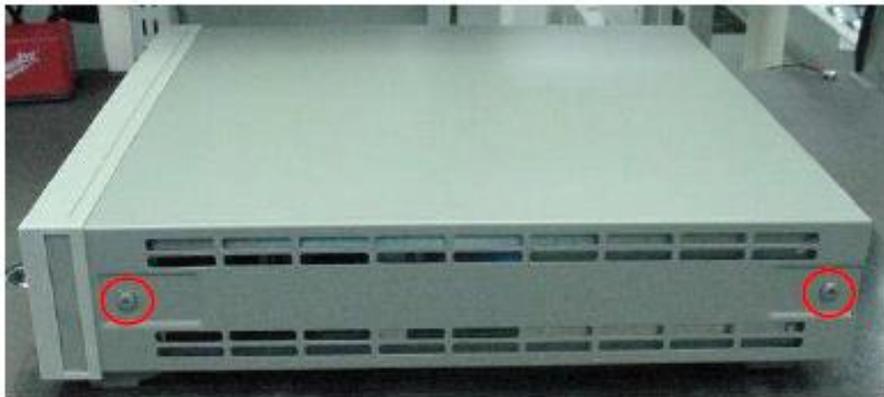
1. Remove 2 screws from each side as shown.

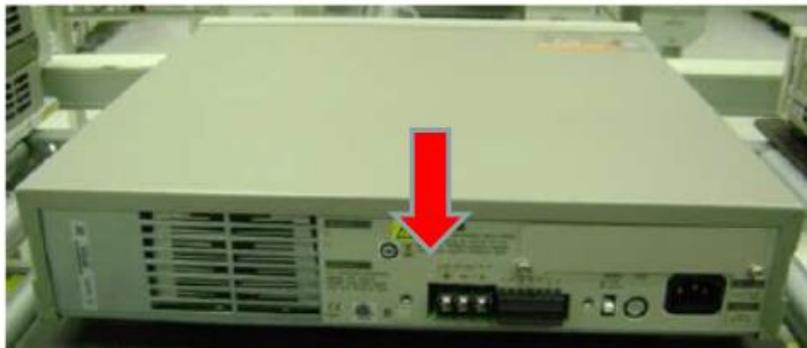
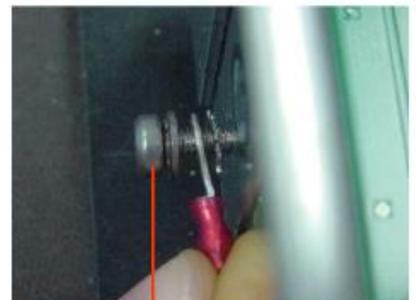
GND CABLE SCREW

2. Slide cover out over chassis and remove the top cover. Then, remove the screw and ground cable.

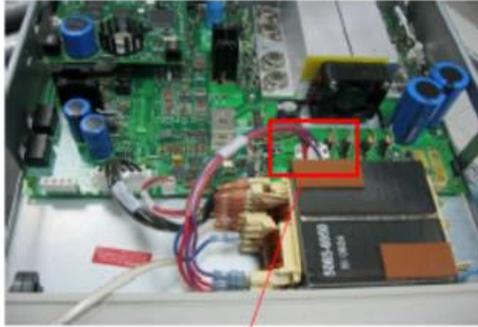
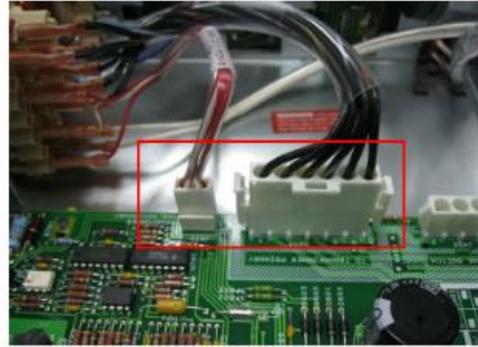
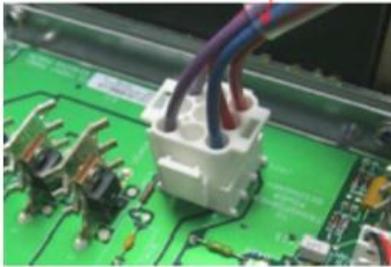
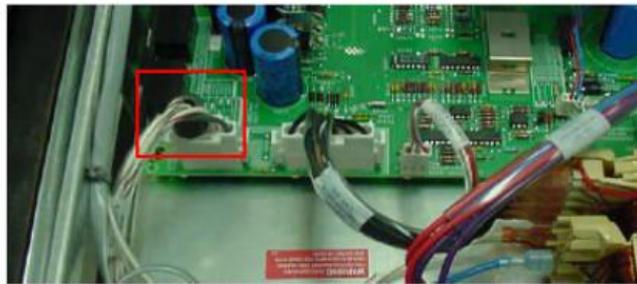
3. Disconnect cables.
 - a. Disconnect the cable assembly 5080-2206 from PCA J401 location
 - b. Disconnect cable from transformer to PCA location J600 and J452.
 - c. Disconnect cable from switch J450

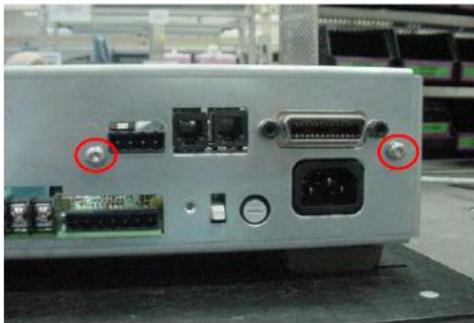
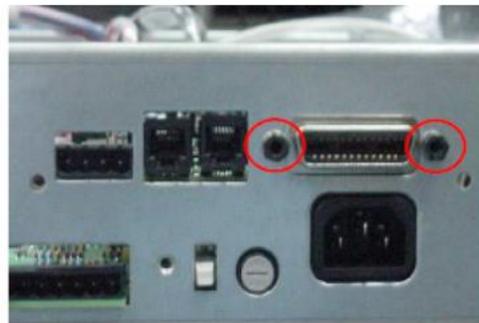
4. Remove 5 screws as shown.

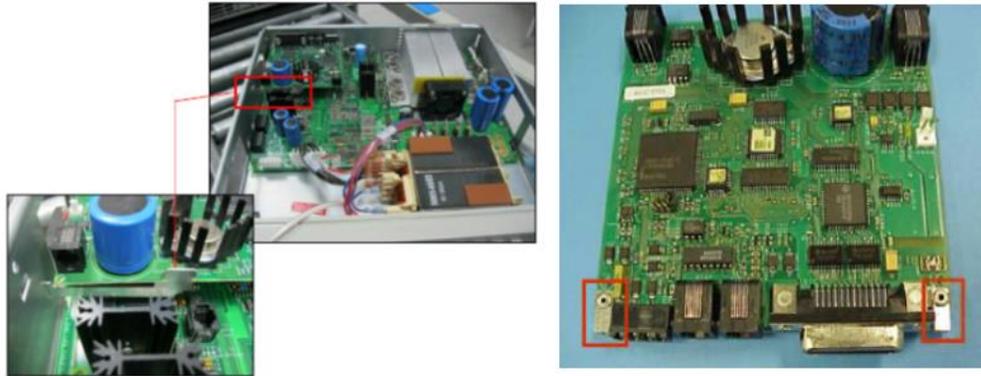
5. Remove bracket and GPIB PCA as shown.

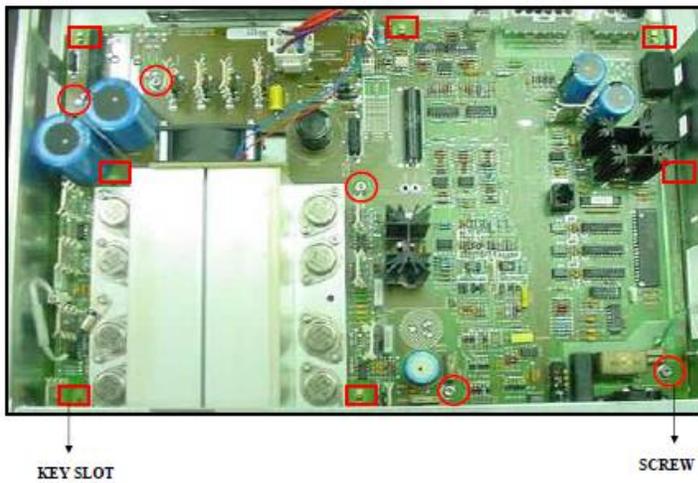
- Remove 5 screws from the main board and slide out the PCA from the 7 slots, then remove the main PCA from chassis.

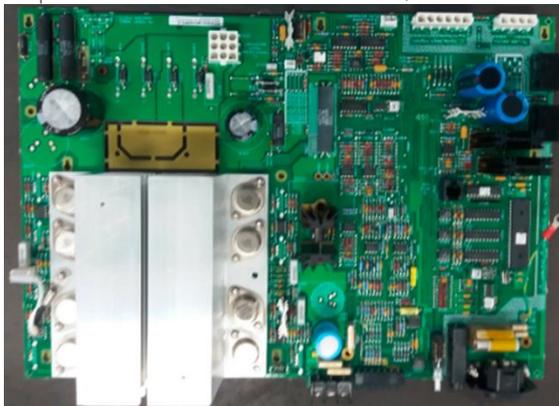
- Replace with a new PCA board (06645-61030)

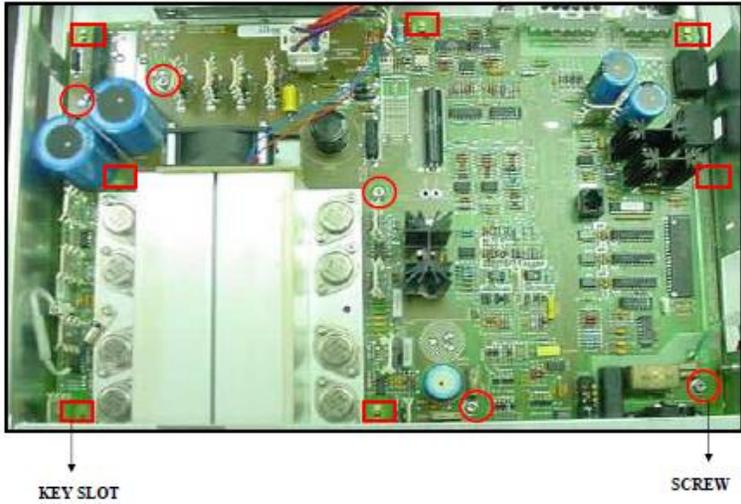
- Place PCA into chassis on key slot 7 positions and push to lock in position at 7 locations. Use 5 screws to secure the board to chassis.

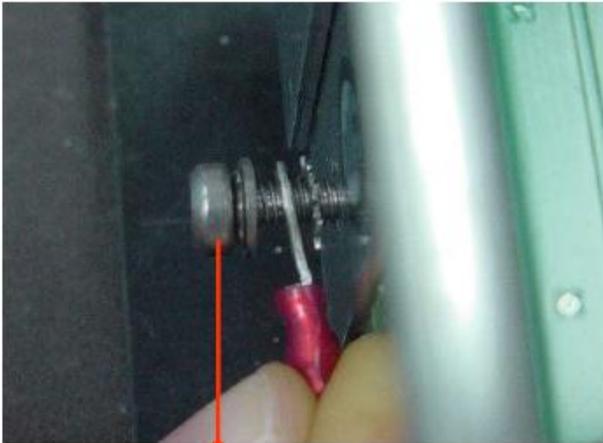
SCREW, CONNECTOR AND WASHER

9. Attach ground wire on chassis follow the order of screw, connector and washer as shown. Tighten the screw into PEM nut in chassis.

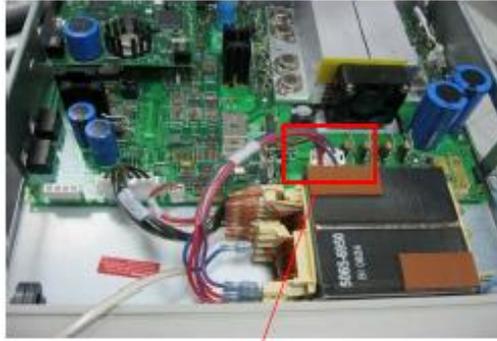
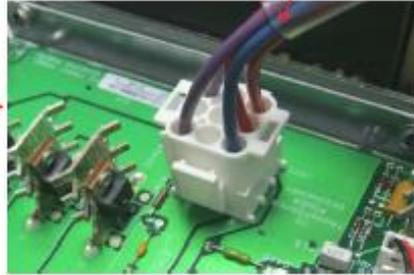
2 PURPLE
2 RED
1 BLUE

10. Connect cable assembly (5080-2206) from transformer to J401 PCA as shown.

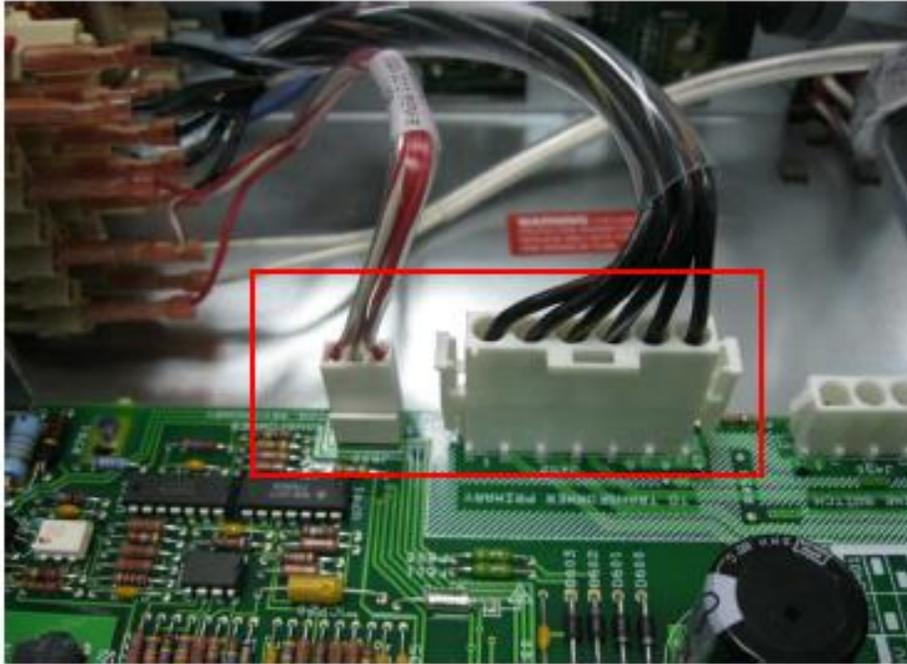
- a. Connect transformer cable to PCB as shown.
- b. Connect 5080-2213(red and red/white) to J600.
- c. Connect 5080-2205(1 black/green,1 black/yellow, 1 black/red, 1 black/orange, 1 black white, 1black to J452)

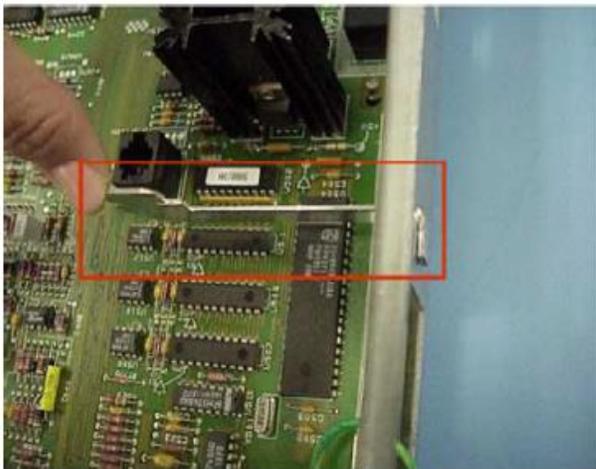
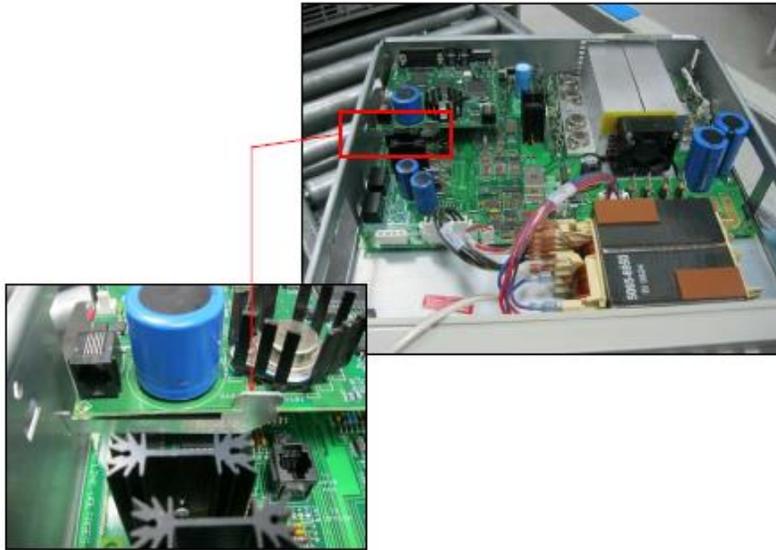
12. Slide bracket into side of chassis as shown. Place GPIB board in unit, swing TAB into notch in PCB as shown.

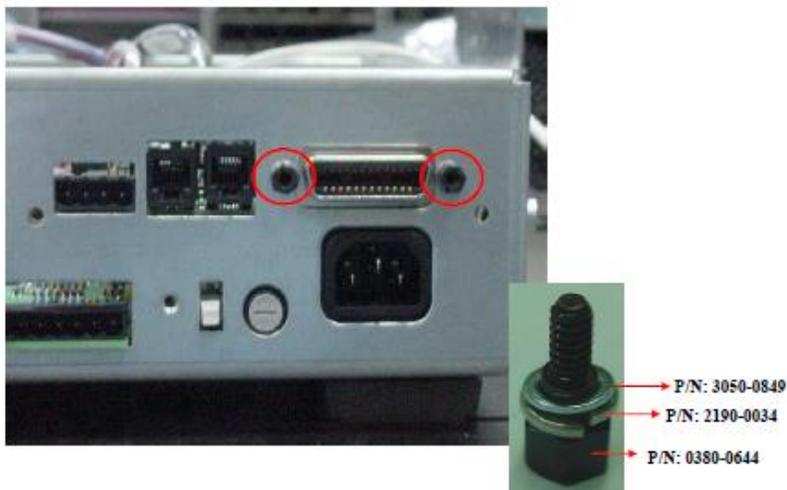
13. Use 2 flat washers, 2 split washers and 2 nuts and mount the GPIB board to rear panel.

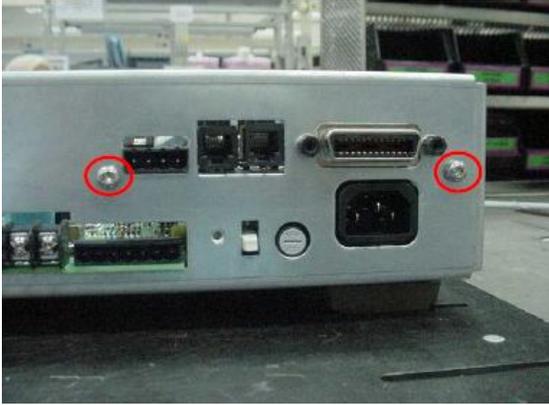
14. Secure with 2 screws as shown.

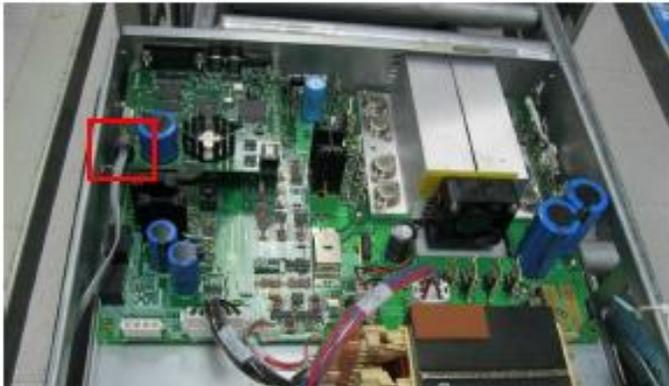
15. Connect long phone cable to J108 GPIB board as shown.

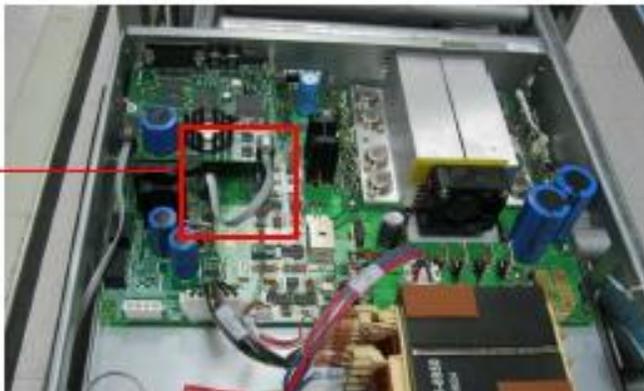
16. Connect short phone cable from J107 GPIB to J501 main PCA.

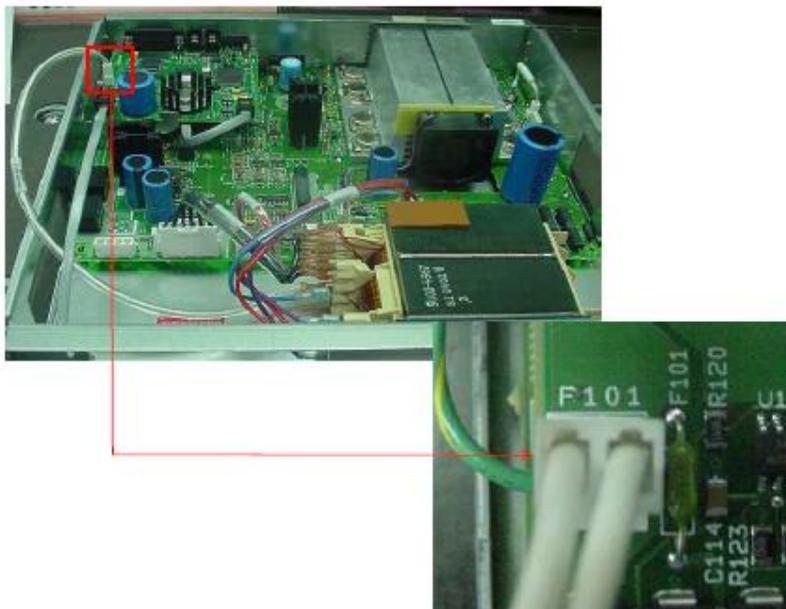
17. Connect cable (5080-2209) to F101 GPIB from the transformer.

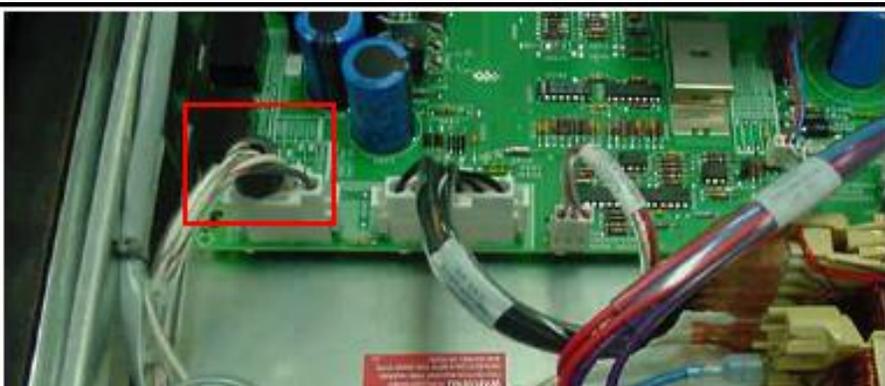
18. Insert the cable to J450 main PCA.

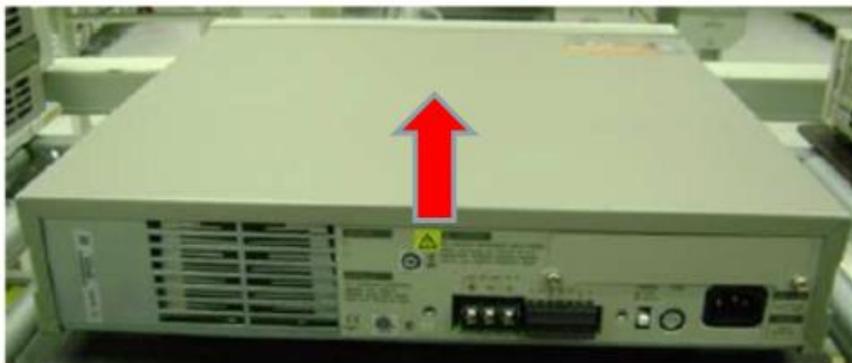
19. Slide in the cover to chassis.

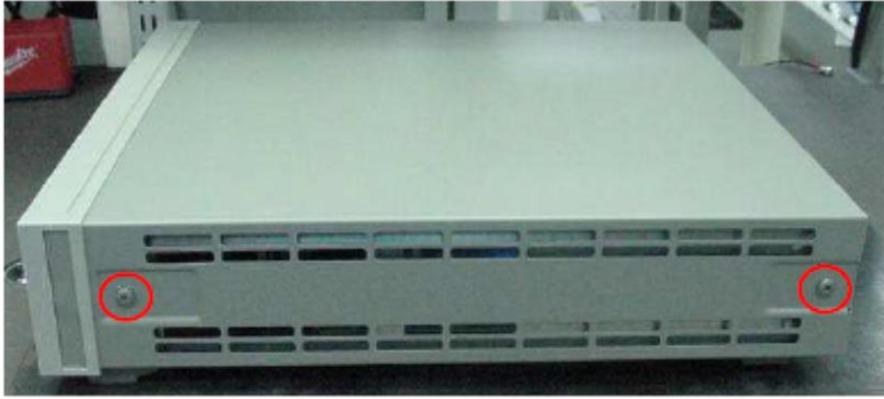
20. Tighten 2 screws of each side of the unit as shown.
