86100C-10

S E R V I C E N O T ESupersedes:
None**86100C Digital Communications Analyzer**

Low Voltage part loaded in 5 V application causes performance to degrade over time. Inspect for low voltage part and replace.**Parts Required:**

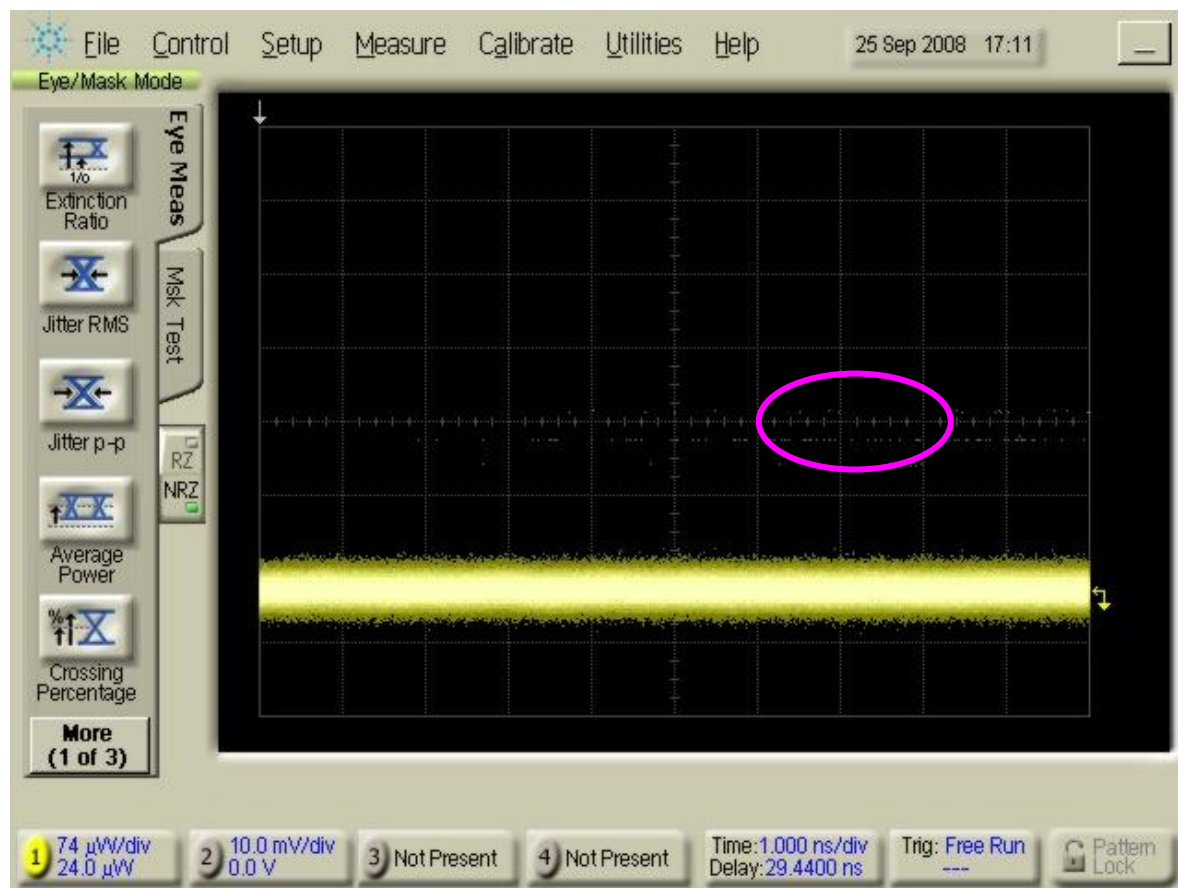
A low voltage part was used in a 5 Volt application. The part will degrade with time and must be replaced. The part is U139 Look Through Memory on the Timebase Acquisition assembly, 86100-68078. There can be various failure symptoms related to the positioning of amplitude samples, like module calibration failures, excessive jitter measurements, failure of look through memory self test, and extraneous amplitude samples. The erroneous samples may not appear at all settings of vertical scale and different settings for different mainframes and modules. There is not a screen for the bad parts other than the manufacturer's part number. Attached are screen shots of examples of the display of erroneous amplitude samples.
