86100C-10A

S E R V I C E N O T E

86100C Digital Communications Analyzer

Low Voltage part loaded in 5 V application causes performance to degrade over time. Inspect for low voltage part and replace.

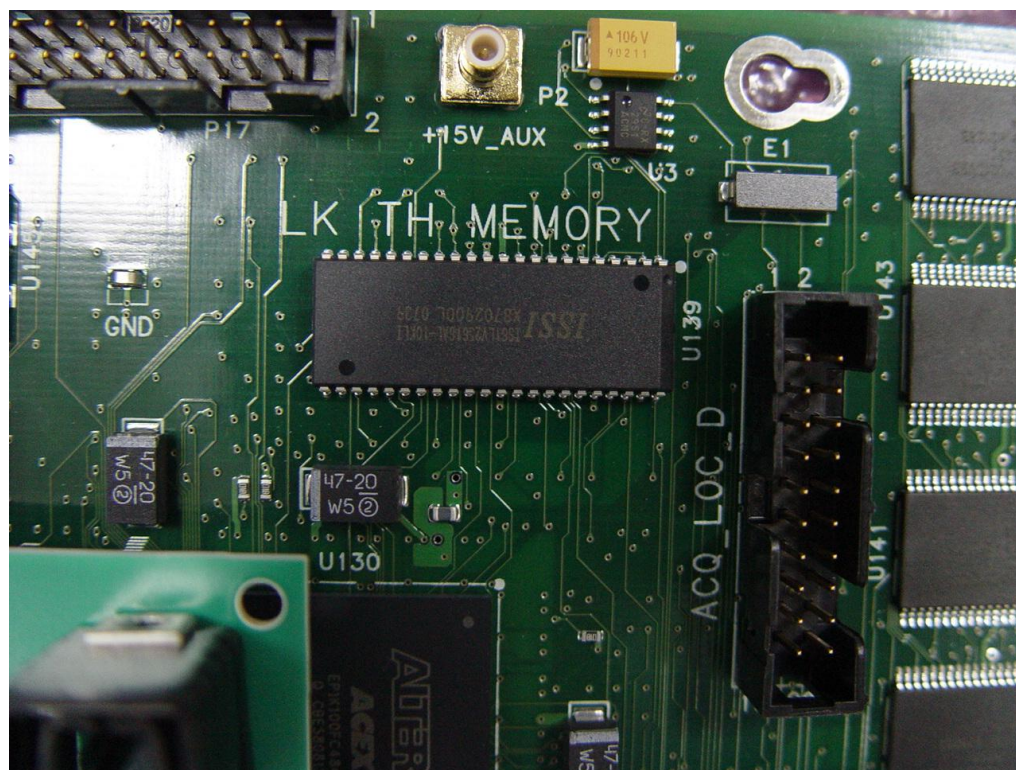
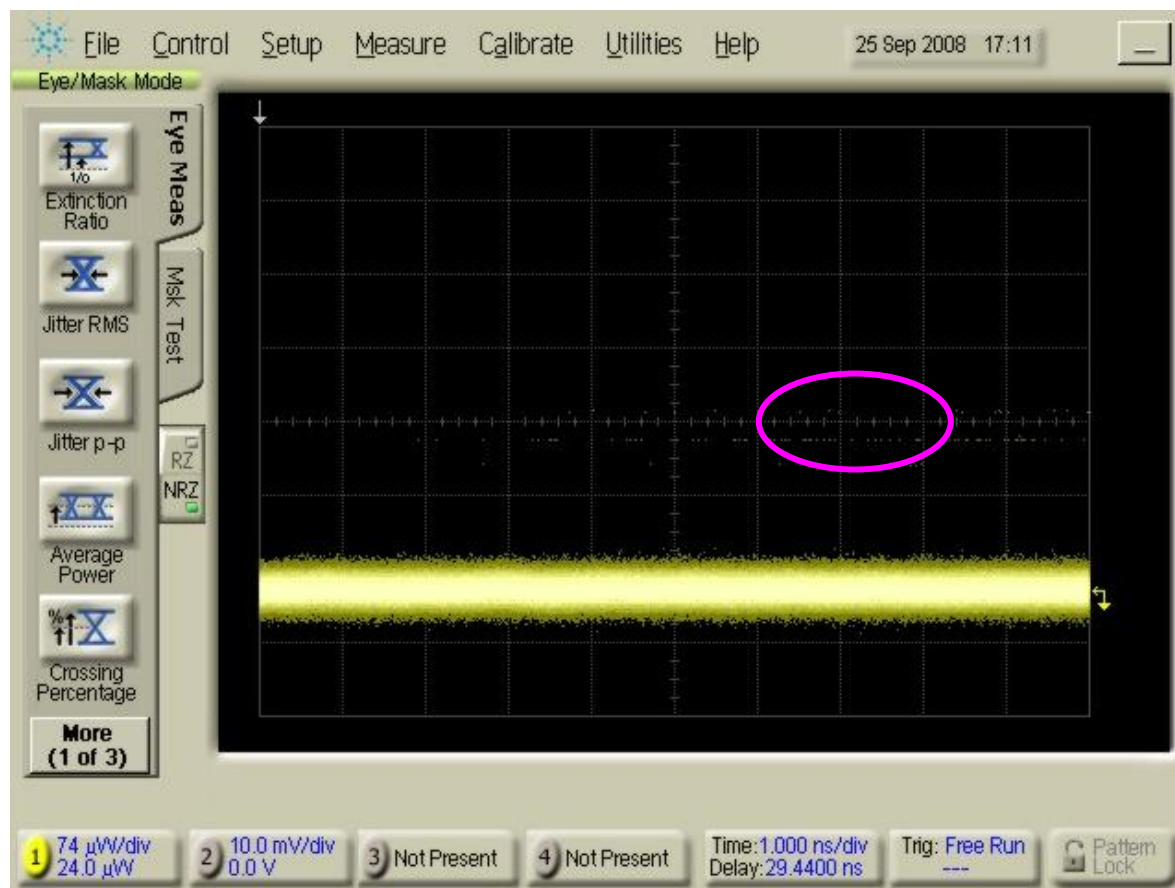
A low voltage part was used in a 5 Volt application. The part will degrade with time and must be replaced. The part is U139 Look Through Memory on the Timebase Acquisition assembly, 86100-68078. There can be various failure symptoms related to the positioning of amplitude samples, like module calibration failures, excessive jitter measurements, failure of look through memory self test, and extraneous amplitude samples. The erroneous samples may not appear at all settings of vertical scale and different settings for different mainframes and modules. There is not a screen for the bad parts other than the manufacturer's part number. Attached are screen shots of examples of the display of erroneous amplitude samples.
