# E3631A-13A

## S E R V I C E N O T E

### E3631A DC Power Supply

#### Procedure to ensure tight fitting of the rear bumper

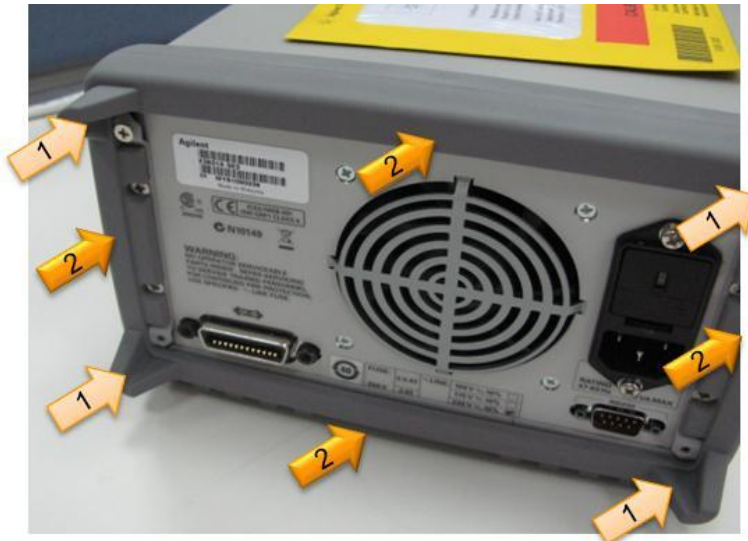
Figure 2: Proper fitting method for instrument rear bumper

1. Make sure all four corners of the rear bumper are completely pushed inwards. A 'click' sound must be heard (Figure 2, see arrows marked '1').
2. Then, push the four sides of the bumper to make sure the whole bumper fits tightly into the instrument chassis. (Figure 2, see arrows marked '2').
3. These 2 steps will ensure a tight fitting of the rear bumper as shown in Figure 3 below.

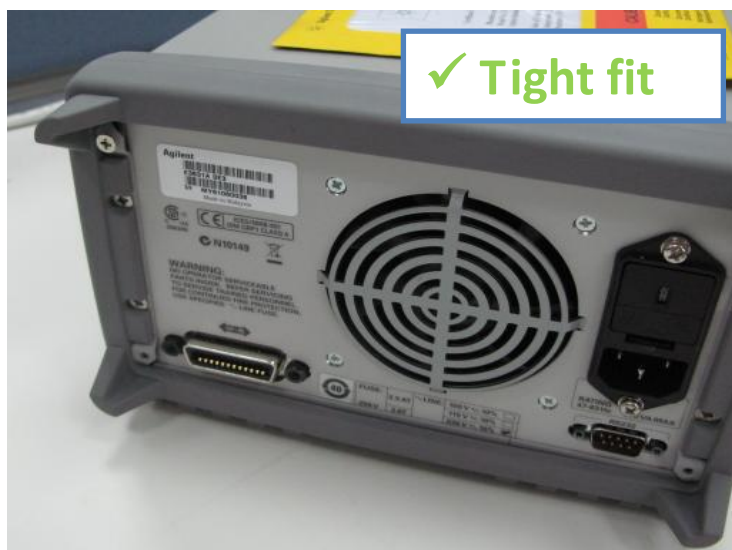
Figure 3: Tightly fitted rear bumper – no gap observed between the bumper and chassis
