**E3632A-04A**

# S E R V I C E N O T E

## E3632A DC Power Supply

### Procedure to ensure tight fitting of the rear bumper

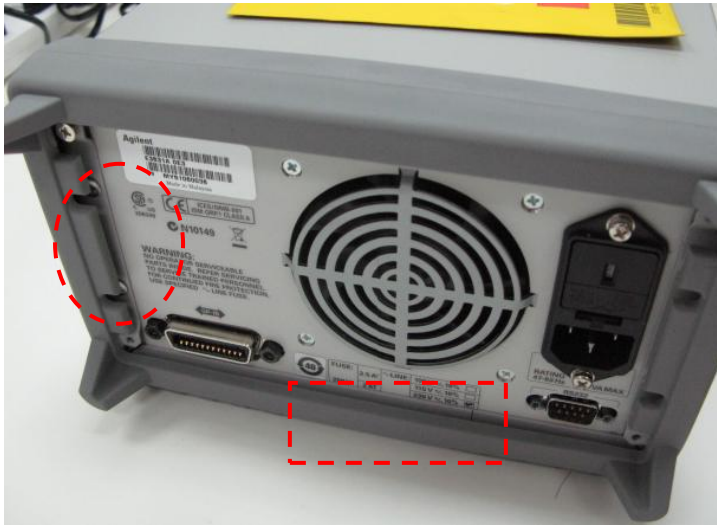
There is a new design rear bumper starting from serial number MY51250037. This bumper fits too tightly into the packaging foam material. During transportation, movements may cause the rear bumper to rub against the packaging foam and the rear bumper may become loose or slip out of the instrument chassis, as shown in the Figure 1 below. The foam design has already been modified to ensure good enough fitting.

Figure 1: Loose rear bumper – gap observed between bumper and chassis

If customers observe that their instrument's rear bumper has become loose or has slipped out, then the customer is advised to follow the following steps to properly fit the rear bumper back into the instrument chassis.

1. Make sure all four corners of the rear bumper are completely pushed inwards. A 'click' sound must be heard (Figure 2, see arrows marked '1').
2. Then, push the four sides of the bumper to make sure the whole bumper fits tightly into the instrument chassis. (Figure 2, see arrows marked '2').
3. These 2 steps will ensure a tight fitting of the rear bumper as shown in Figure 3 below.

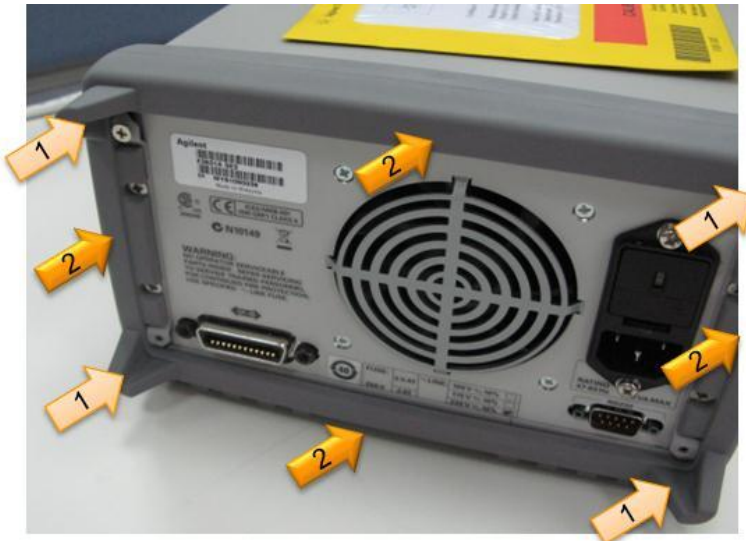
Figure 2: Proper fitting method for instrument rear bumper

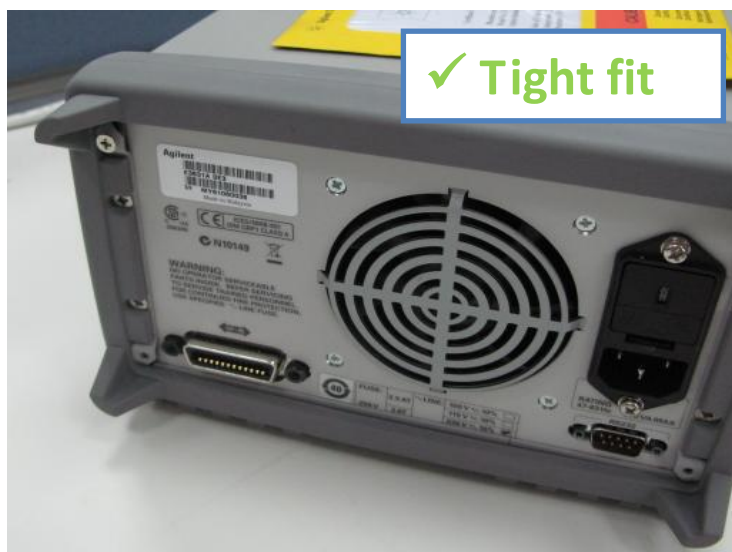
Figure 3: Tightly fitted rear bumper – no gap observed between the bumper and chassis
