# E3632A-04D

# S E R V I C E N O T E

## E3632A DC Power Supply

**Metal Strap Kit for tightening loose bumper and for fitting rear lock link in side-by-side rack mounting**

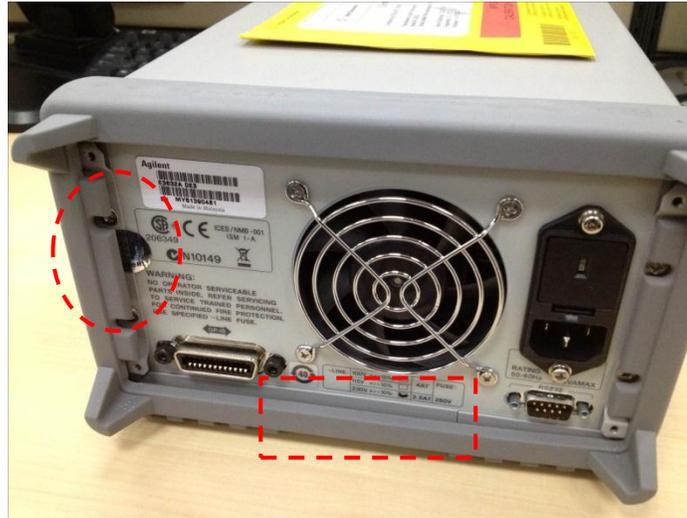
There is a new rear bumper design starting from serial number MY51250037. The rear bumper may become loose or it may slip out of the instrument chassis when force is applied to the rear bumper, as shown in Figure 1 below.

Figure 1: Loose rear bumper – gap observed between bumper and chassis

Use two metal straps (part number E3631-07901) to secure each side of the bumper as shown in Figure 4 below.

Figure 4: Secure with metal straps – no gap observed between the bumper and chassis

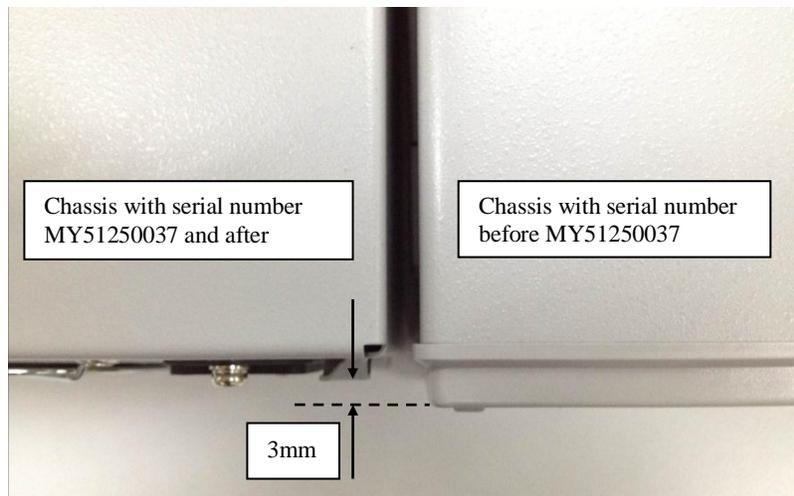
The chassis depth difference between the two designs is 3mm as shown in Table 1 and Figure 2 below.

Serial number range	Chassis depth
MY51250037 and after	345.2 mm
Before MY51250037	348.2 mm

Figure 2: Top view 3mm gap observed between two different chassis designs

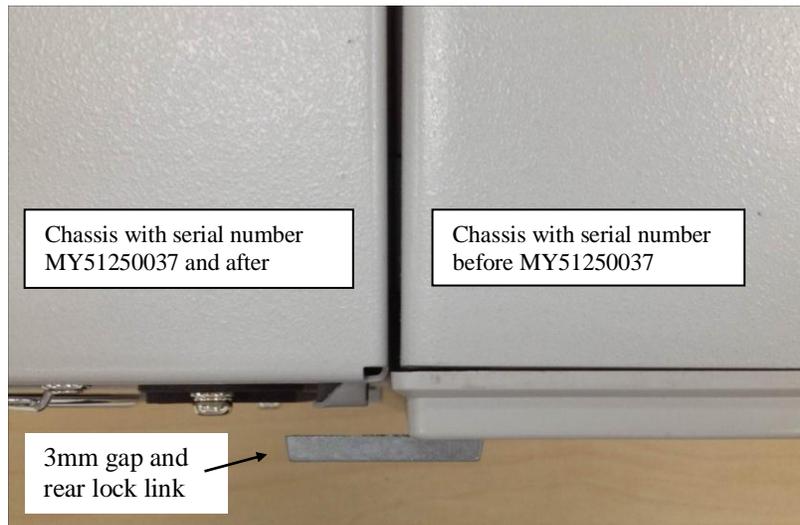
The 3 mm gap between the two different chassis may cause difficulties in securing them together using a rear lock link kit (part number 0050-2167) for side-by-side rack mounting as shown in Figure 3 below.

Figure 3: Top view 3mm gap observed on rear lock link for side-by-side rack mounting

Use metal strap (part number E3631-07901), and stack the provided two metal straps together to form 3mm thickness and secure it with the provided screws on the rear lock link as shown in Figure 5 below.

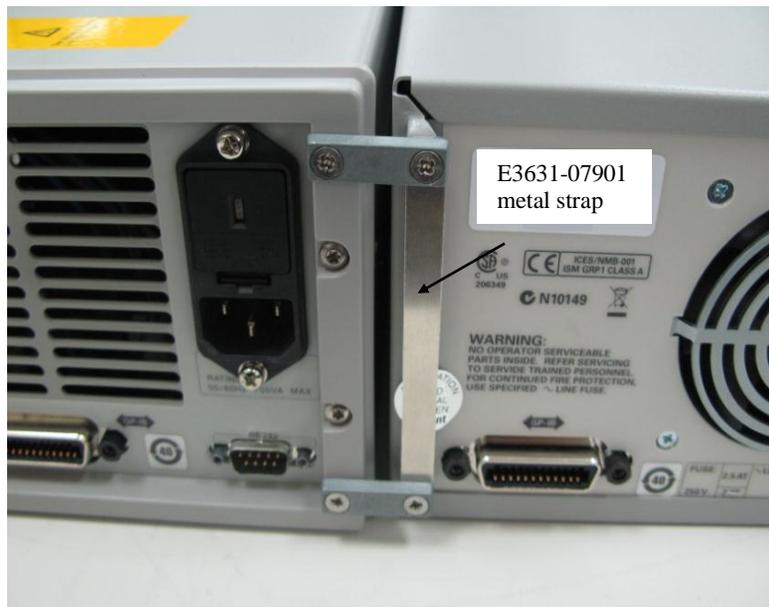
Figure 5: Rear view rear lock link secured with metal straps kit for side-by-side rack mounting
