**E3633A-05A**

# S E R V I C E N O T E

## E3633A DC Power Supply

### Procedure to ensure tight fitting of the rear bumper

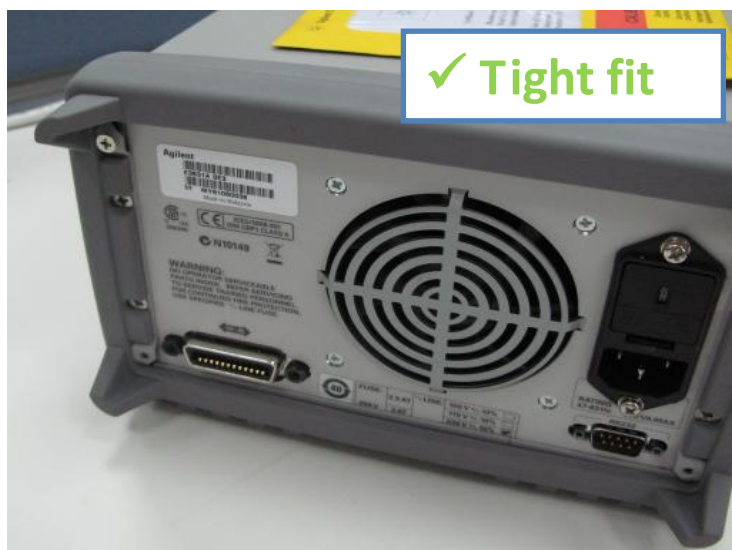
Figure 3: Tightly fitted rear bumper – no gap observed between the bumper and chassis

1. Make sure all four corners of the rear bumper are completely pushed inwards. A 'click' sound must be heard (Figure 2, see arrows marked '1').
2. Then, push the four sides of the bumper to make sure the whole bumper fits tightly into the instrument chassis. (Figure 2, see arrows marked '2').
3. These 2 steps will ensure a tight fitting of the rear bumper as shown in Figure 3 below.
