**E3634A-05**

# S E R V I C E N O T E

## E3634A DC Power Supply

### Procedure to ensure tight fitting of the rear bumper

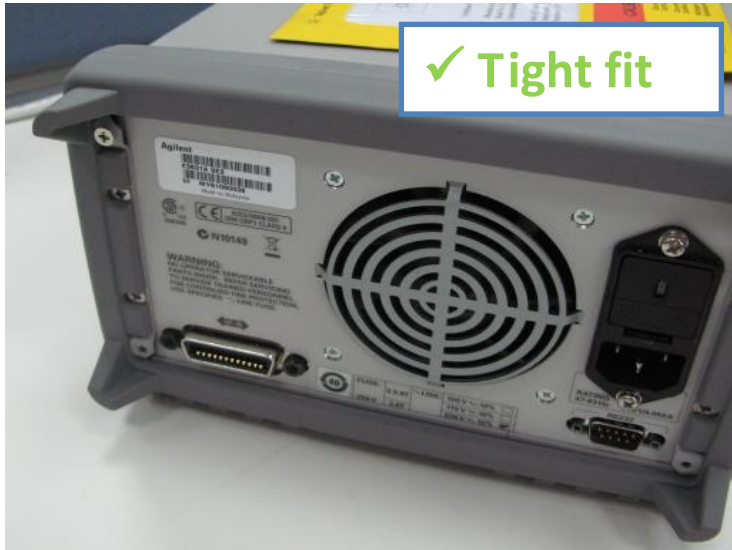
Figure 3: Tightly fitted rear bumper – no gap observed between the bumper and chassis

1. Make sure all four corners of the rear bumper are completely pushed inwards. A 'click' sound must be heard (Figure 2, see arrows marked '1').
2. Then, push the four sides of the bumper to make sure the whole bumper fits tightly into the instrument chassis. (Figure 2, see arrows marked '2').
3. These 2 steps will ensure a tight fitting of the rear bumper as shown in Figure 3 below.
