E3647A-04D

S E R V I C E N O T E

E3647A DC Power Supply

Metal Strap Kit for tightening loose bumper and for fitting rear lock link in side-by-side rack mounting

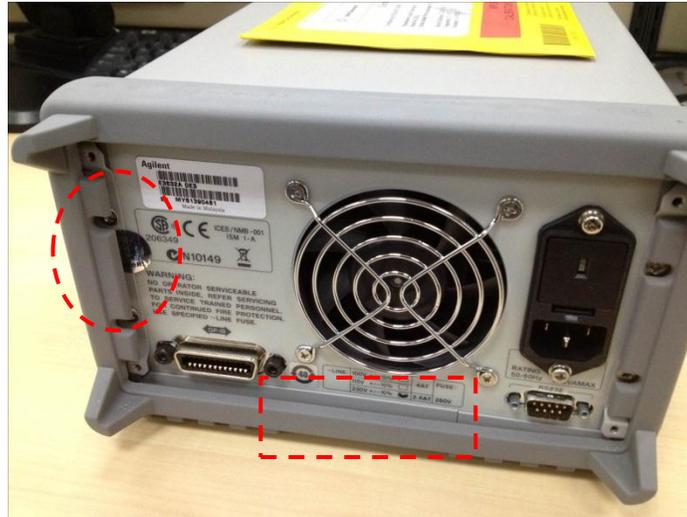
There is a new rear bumper design starting from serial number MY51240108. The rear bumper may become loose or it may slip out of the instrument chassis when force is applied to the rear bumper, as shown in Figure 1 below.

Figure 1: Loose rear bumper – gap observed between bumper and chassis

Use two metal straps (part number E3631-07901) to secure each side of the bumper as shown in Figure 4 below.

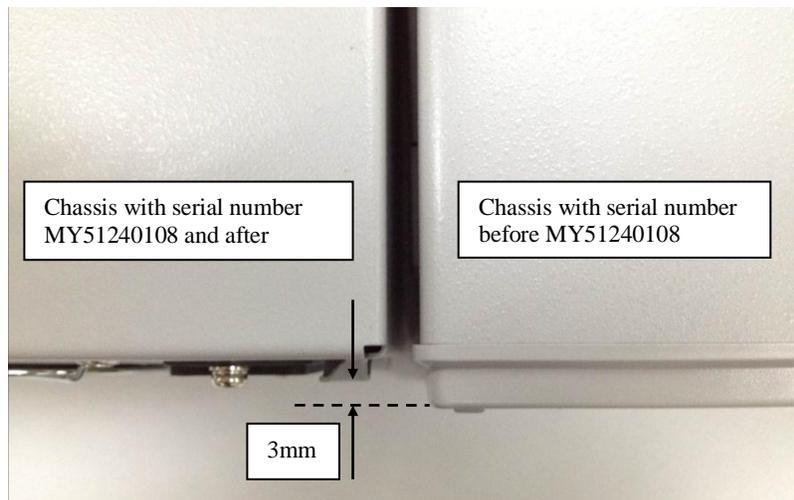
The chassis depth difference between the two designs is 3mm as shown in Table 1 and Figure 2 below.

Figure 2: Top view 3mm gap observed between two different chassis designs

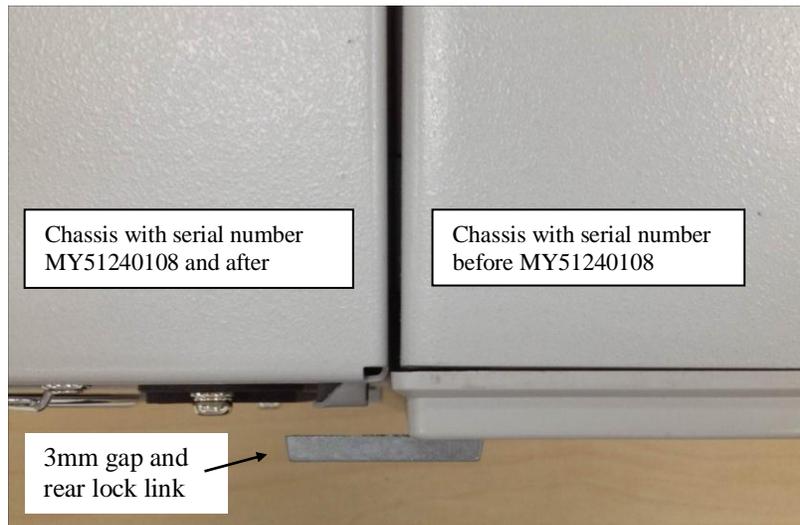
The 3 mm gap between the two different chassis may cause difficulties in securing them together using a rear lock link kit (part number 0050-2167) for side-by-side rack mounting as shown in Figure 3 below.

Figure 3: Top view 3mm gap observed on rear lock link for side-by-side rack mounting

Use metal strap (part number E3631-07901), and stack the provided two metal straps together to form 3mm thickness and secure it with the provided screws on the rear lock link as shown in Figure 5 below.

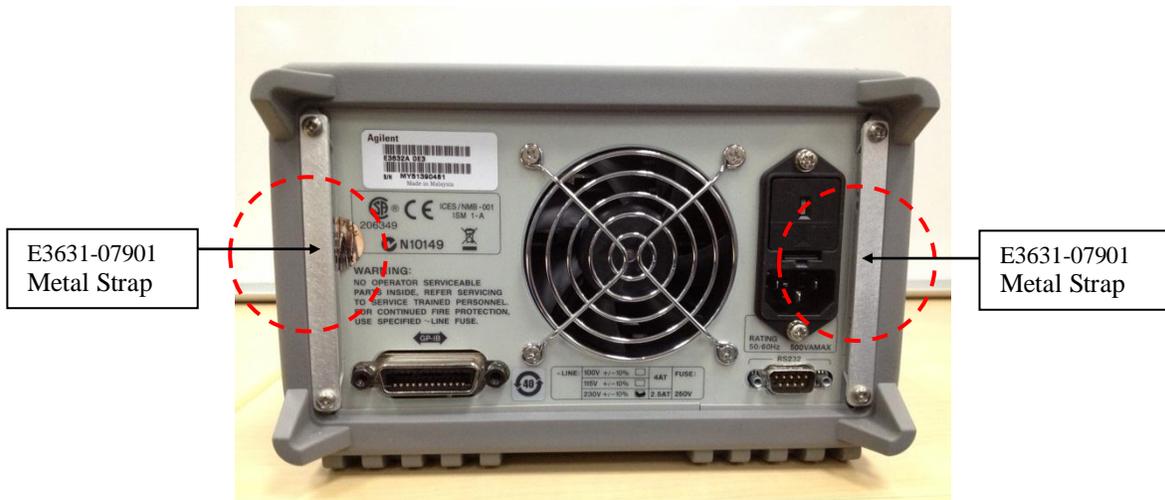
Figure 4: Secure with metal straps – no gap observed between the bumper and chassis

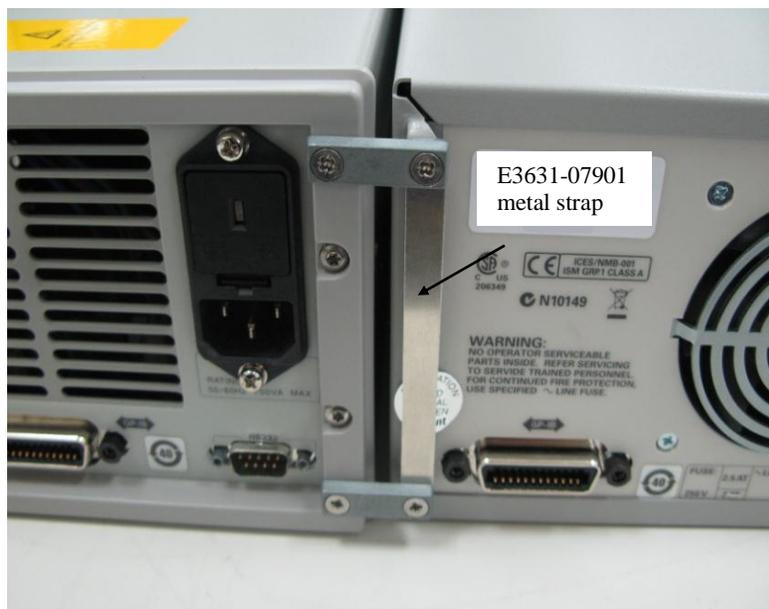
Figure 5: Rear view rear lock link secured with metal straps kit for side-by-side rack mounting
