E3649A-04

S E R V I C E N O T E

E3649A DC Power Supply

Procedure to ensure tight fitting of the rear bumper

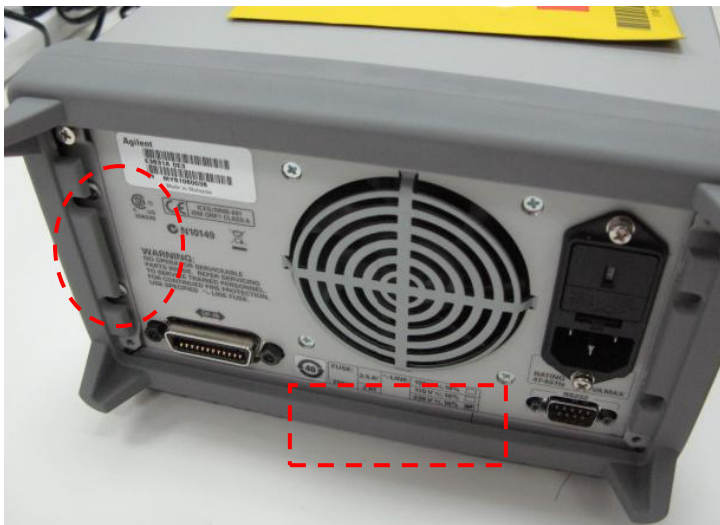
There is a new design rear bumper starting from serial number MY51240078. This bumper fits too tightly into the packaging foam material. During transportation, movements may cause the rear bumper to rub against the packaging foam and the rear bumper may become loose or slip out of the instrument chassis, as shown in the Figure 1 below. The foam design has already been modified to ensure good enough fitting.

Figure 1: Loose rear bumper – gap observed between bumper and chassis

1. Make sure all four corners of the rear bumper are completely pushed inwards. A 'click' sound must be heard (Figure 2, see arrows marked '1').
2. Then, push the four sides of the bumper to make sure the whole bumper fits tightly into the instrument chassis. (Figure 2, see arrows marked '2').
3. These 2 steps will ensure a tight fitting of the rear bumper as shown in Figure 3 below.

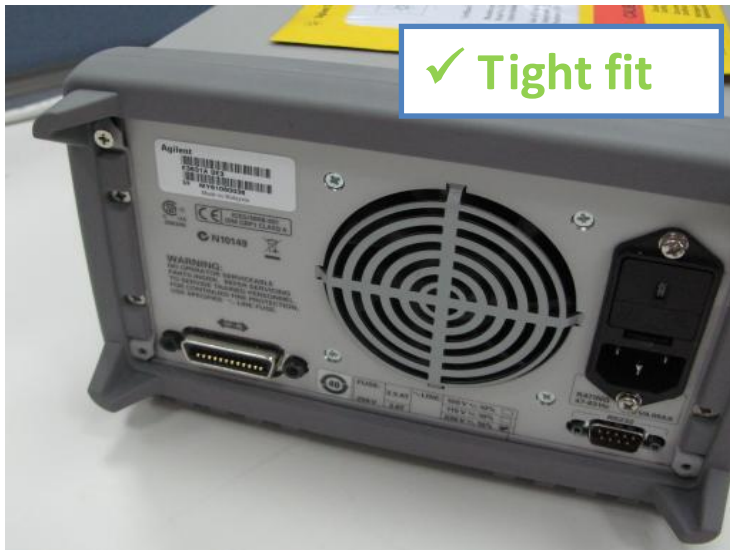
Figure 3: Tightly fitted rear bumper – no gap observed between the bumper and chassis
