**E4418B-08A-S**

# **S E R V I C E N O T E**

## Agilent E4418B EPM Power Meter

## Correct Orientation of the Power Supply's Force-fit Connector

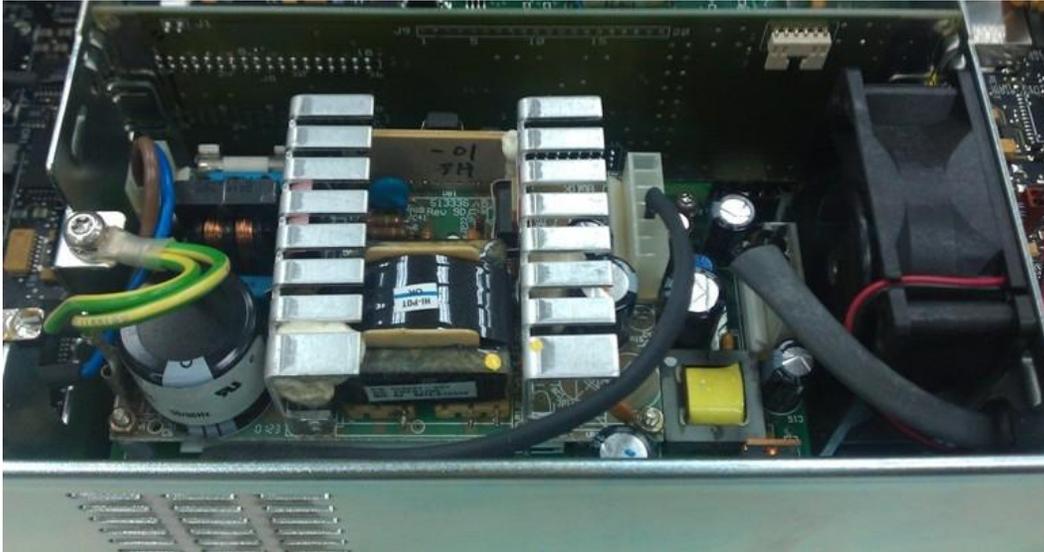
Figure 1: Interior Layout of Power Supply Unit, P/N: 0950-3681

The interior layout of the respective power supply unit is shown in figure 1 and figure 2.

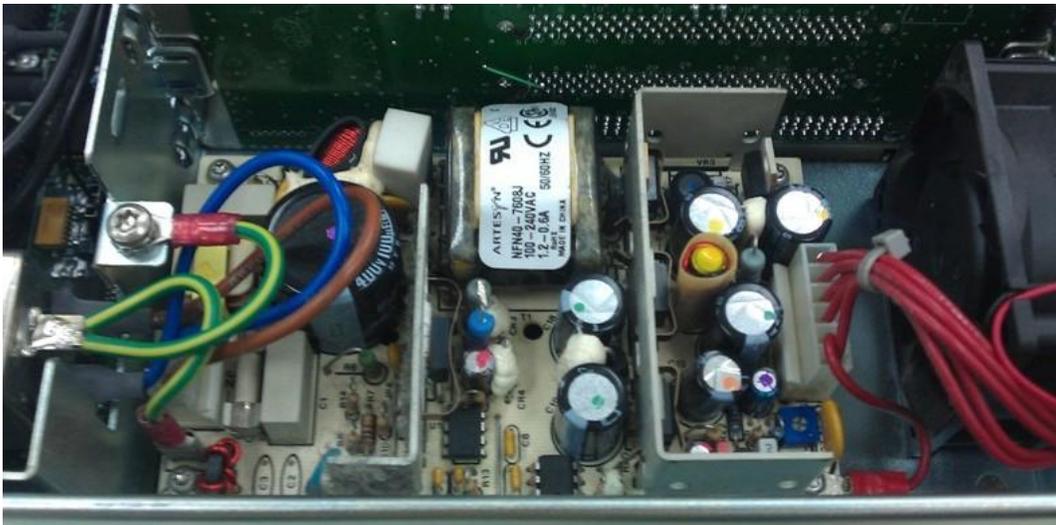
Figure 2: Interior Layout of Power Supply Unit, P/N: 0950-2649

The Power Supply Unit, P/N: 0950-3681 has been replaced by another Power Supply Unit, P/N: 0950-2649 for the standard E4418B since June 2007 for E4419B with serial number MY45102182. The design layout of 0950-2649 is different from 0950-3681 and does not cause the possible shock hazard as described in this service note.

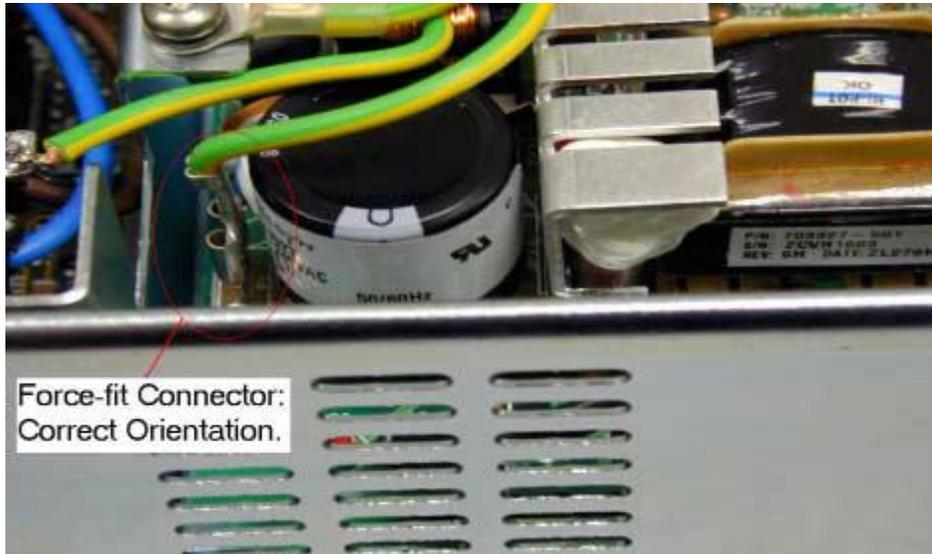
Figure 3: Correct orientation of force-fit connector.

It has been highlighted that the force-fit connector connecting the earth wire to the Power Supply Unit, (P/N: 0950-3681) can be fitted in two different ways on the E4418B.

By fitting the connector with the bottom (flat) side facing the large capacitor on the Power Supply Unit, the gap between them is maximized (approximately 2mm).

By fitting the connector with the top (rounded) side facing the large capacitor on the Power Supply Unit, the gap between them is minimized (approximately 1.2mm).

The gap should be maximized at all times to ensure the unit meets the design and regulatory requirements relating to electrical insulation. This requirement is such that the gap should be at least 1.71mm.

Ensure that this connector is re-fitted such that the bottom (flat) side of it is facing the large capacitor on the Power Supply Unit, P/N: 0950-3681.

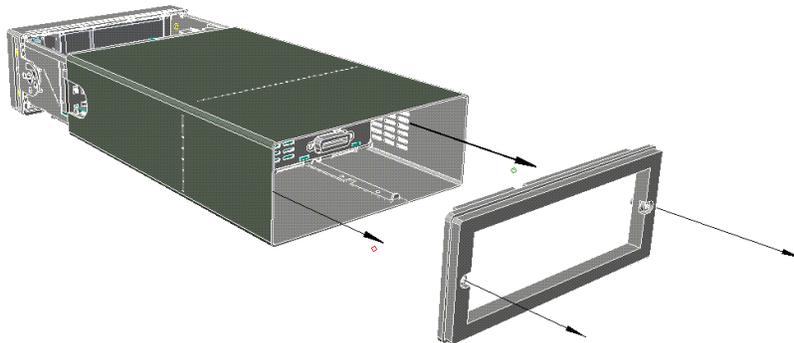
1. Remove the optional battery if fitted before removing the cover as shown below.

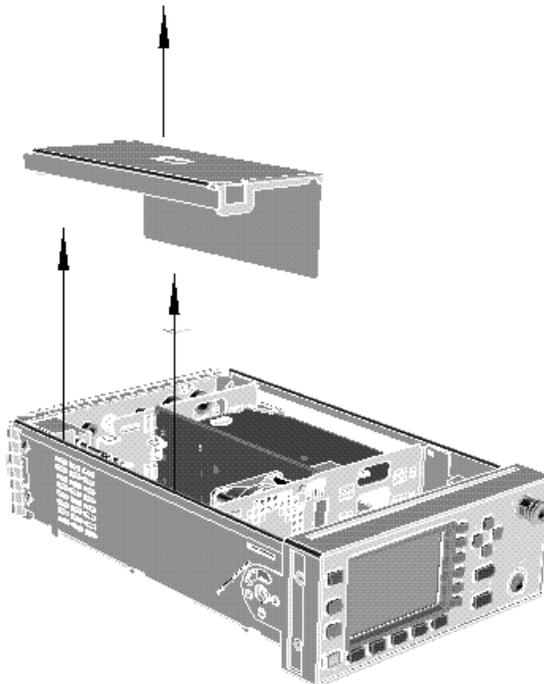
2. Remove the power supply cover by lifting it out as shown below.

3. Check if the bottom (flat) side of the force-fit connector is facing the large capacitor on the Power Supply Unit, P/N: 0950-3681.
