**E4438C-20**

# **S E R V I C E                      N O T E**

## **E4438C Vector Signal Generator**

**Power supply replacement for customer satisfaction purposes.**

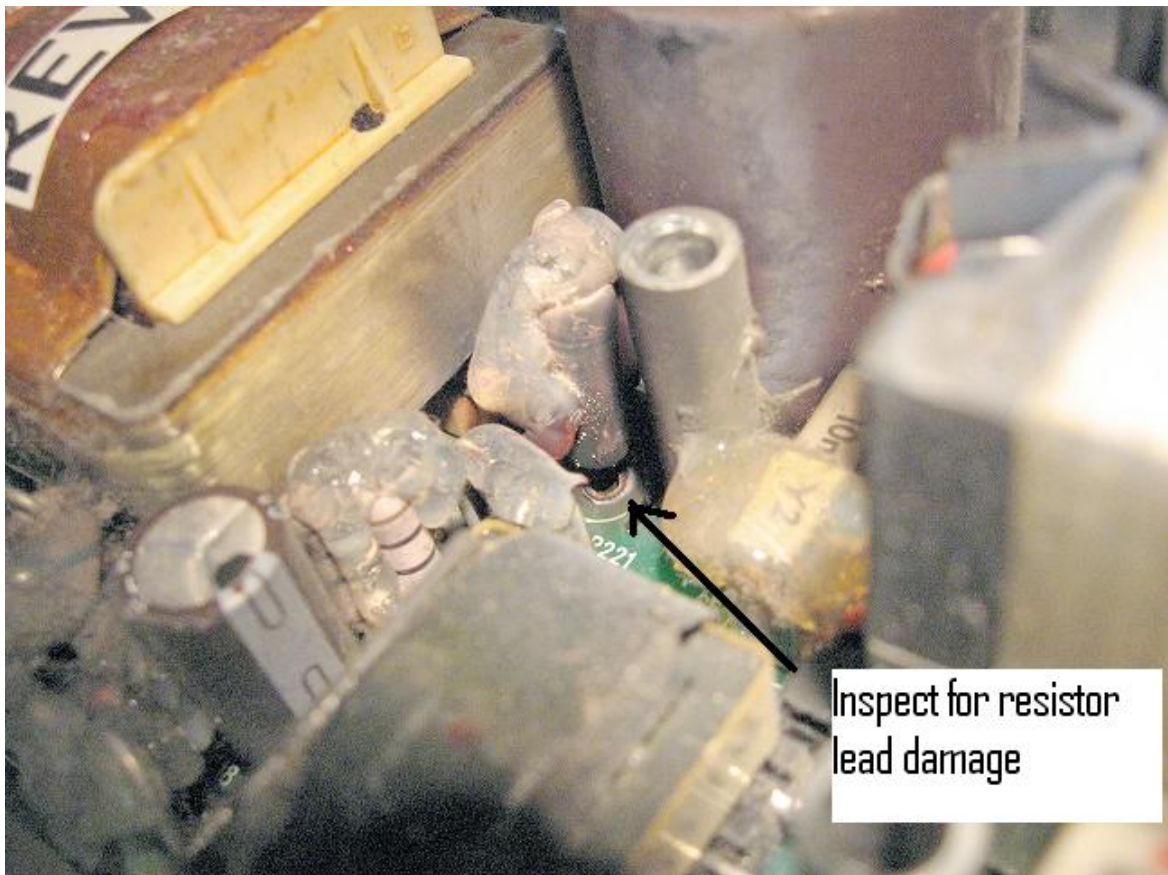
1. ON SPECIFIC FAILURE: Replace failed 0950-4031 Rev B/C power supplies with 0950-4031 Rev D power supplies or, 0950-5037 power supplies after stock of 0950-4031 is gone, in cases where lead failure of R6 or R9 as shown in the photograph below. Other failures are not covered by this Service Note.

An increasing failure rate of 0950-4031 Rev B/C power supplies has been observed. For customer satisfaction certain failed 0950-4031 Rev B/C power supplies is authorized. 0950-4031 Rev D power supplies may be used until gone and then 0950-5037 may be used.
