**E4438C-23**

# **S E R V I C E N O T E**

## E4438C Vector Signal Generator

### **Intermittent CPU boot-up and/or No display**

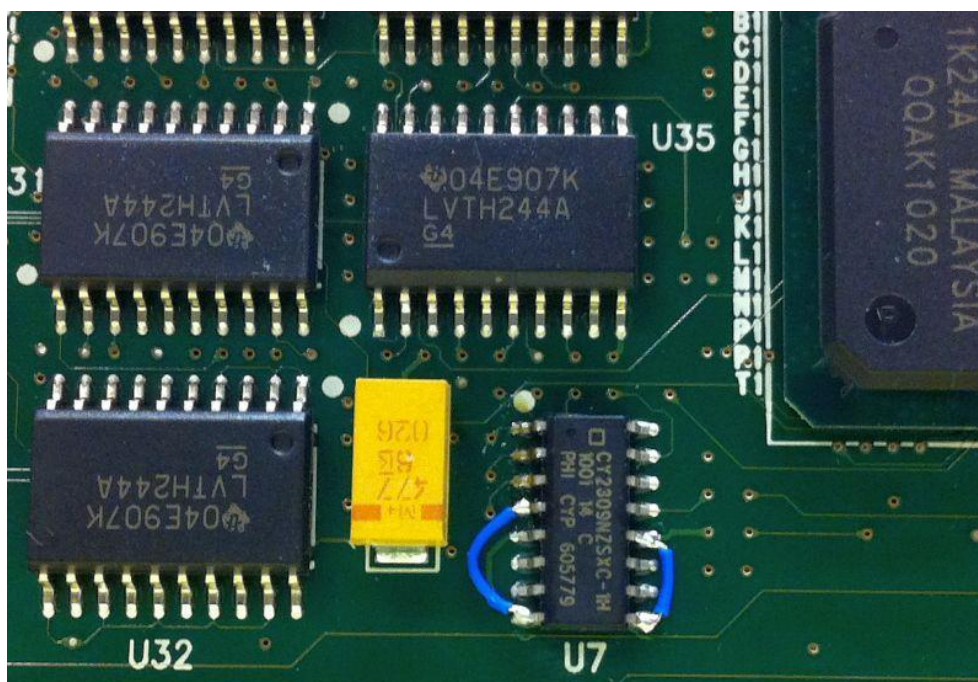
Figure 1 U7 wire modification

The clock buffer, U7 on the A12 CPU board, part number E4400-60500 may cause intermittent boot up and/or no display when the instrument is powered up. It is recommended that this modification is performed on any instrument within the serial numbers above that exhibits an intermittent boot-up and/or a blank display.

Using the appropriate soldering technique and ESD station, perform a modification on the U7 circuit on the A12 CPU board. Connect U7 pin 8 to 3.4V (wire pin 8 to pin 4) and connect U7 pin 9 to DCOM (wire pin 9 to pin 12).

1. Refer to E4428C/38C Service Guide for the A12 CPU removal procedure.
2. Refer to Figure 1 for U7.
3. Use 30 AWG wire for wiring pin 8 to pin 4, and pin 9 to pin 12 per Figure 1.
4. Re-install CPU and cover.
5. Run self test.
6. No calibration is required.
