E5810A-03**S E R V I C E N O T E**Supersedes:
NONE**E5810A – LAN/GPIB Gateway****Serial Numbers:**

E5810A Hang Upon Turned On**Parts Required:**

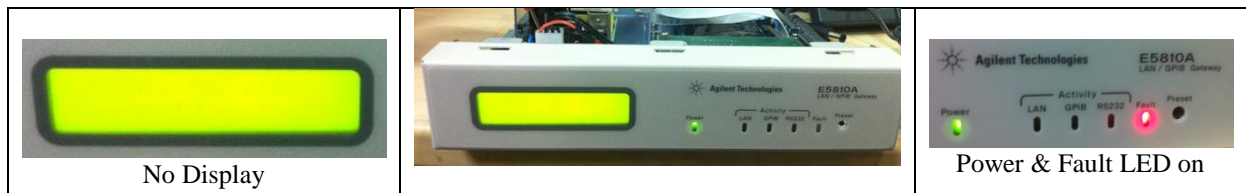
The photos below illustrate the 3 different behaviors that might occur when the Power Supply Module (PSM) is subjected to different voltages range.

Scenario 1: Voltage range between 3.18V-3.27V

Contact your nearest Agilent service center to have your unit serviced based on this service note. Customer may also adjust the Voltage using recommended steps as below.

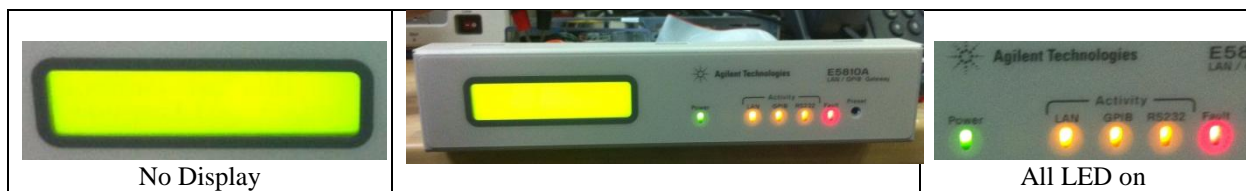
Scenario 2: Variable Voltage more than 3.44V

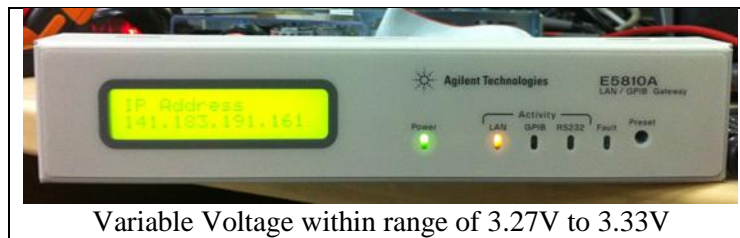
Variable Voltage within range of 3.27V to 3.33V

Good Unit
