E6651A-03

**S E R V I C E N O T E**

E6651A Mobile WiMAX™ Test Set

**Instrument Display Not Properly Aligned**

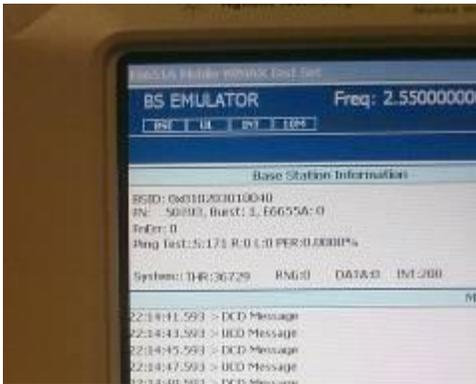
*Figure 1*

Figure 1 shows an example of an instrument that has not been auto-aligned. In this instance the display is visibly shifted to the left by several pixels, causing the leftmost columns to be cropped.

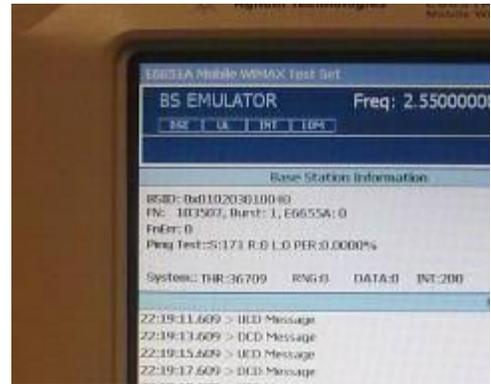
*Figure 2*

Figure 2 shows the same instrument display after auto-alignment. The leftmost characters are now clearly visible, as is the grey border around the “BS EMULATOR” frame.
